# Air Accident Investigation Unit Ireland

## FACTUAL REPORT

**Serious Incident  
Robin HR-200, G-GMKE  
Navan Airfield, Co. Meath**

**7 November 2016**

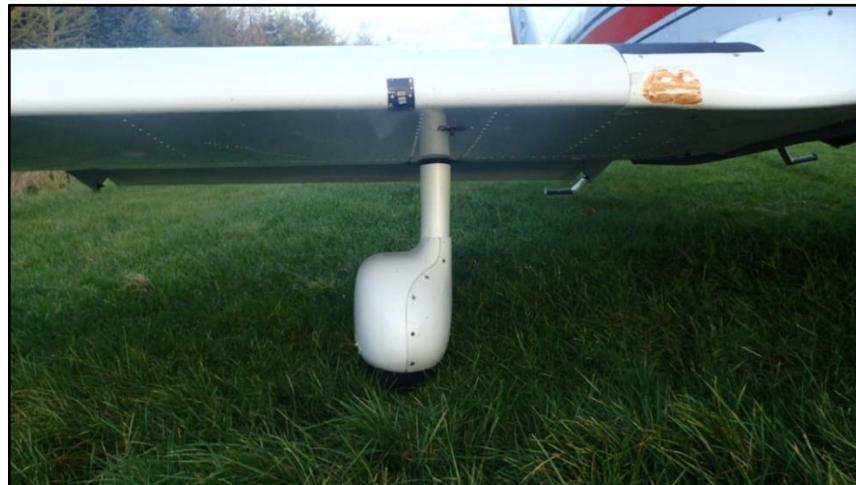
The aircraft suffered minor damage to the starboard wing root (**Photo No. 1**) and the propeller blades (**Photo No. 2**).

**Photo No. 1:** Brown witness mark from impact with fence post

The approach was flown higher and faster than normal, resulting in the aircraft initially touching down near the mid-point of the runway. A bounce on initial landing further reduced the remaining runway distance available for braking. Once braking was commenced, the surface conditions were such that only poor braking action was achieved with the result that the aircraft did not decelerate as expected. Despite the availability of an overrun area, the compromised braking action made a slow-speed impact with the boundary fence unavoidable.

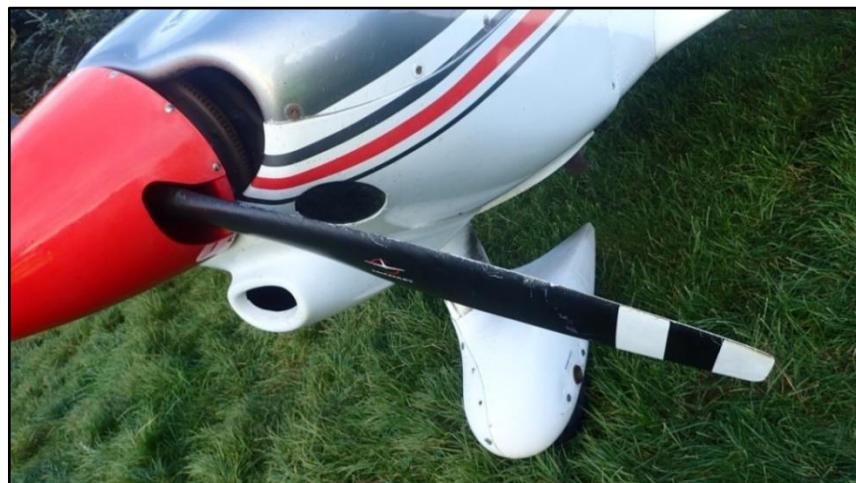
**Photo No. 2:** Propeller blade exhibiting damage from contact with fence wire
