# Air Accident Investigation Unit Ireland

## FACTUAL REPORT

**Serious Incident  
Cessna 177A, N707XJ  
Dunsany, Co. Meath**

**AAIU Report No: 2017 - 017**

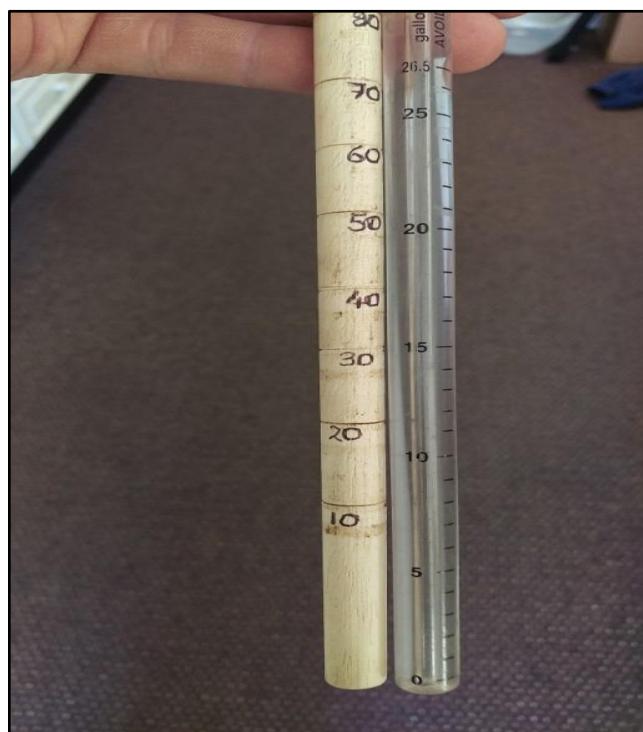
Two AAIU Inspectors subsequently visited EIHH to meet with the Pilot and view the aircraft. There was no evidence of aircraft damage. The Pilot carried out a phased filling of the aircraft fuel tanks and manufactured a wooden dipstick for future use with the 177A aircraft. A comparison between the wooden dipstick (denominated in litres) and the Cessna 172 dipstick (denominated in USG) can be seen at **Photo No. 1**. The Investigation noted that the 177A (wooden) dipstick was non-linear in the lower range i.e. the depth of fuel corresponding to the 10 litres at the bottom of the tank, is more than twice the depth of fuel corresponding to a 10 L increment between 20 L & 30 L, 30 L & 40 L, etc. The effect of this non-linearity can be appreciated by noting that the 172 dipstick would indicate the presence of 5 USG (in excess of 20 L) when the Aircraft's tank would only actually contain approximately 5 L.

**Photo No. 1:** Comparison of dipsticks (left 177A, right 172)

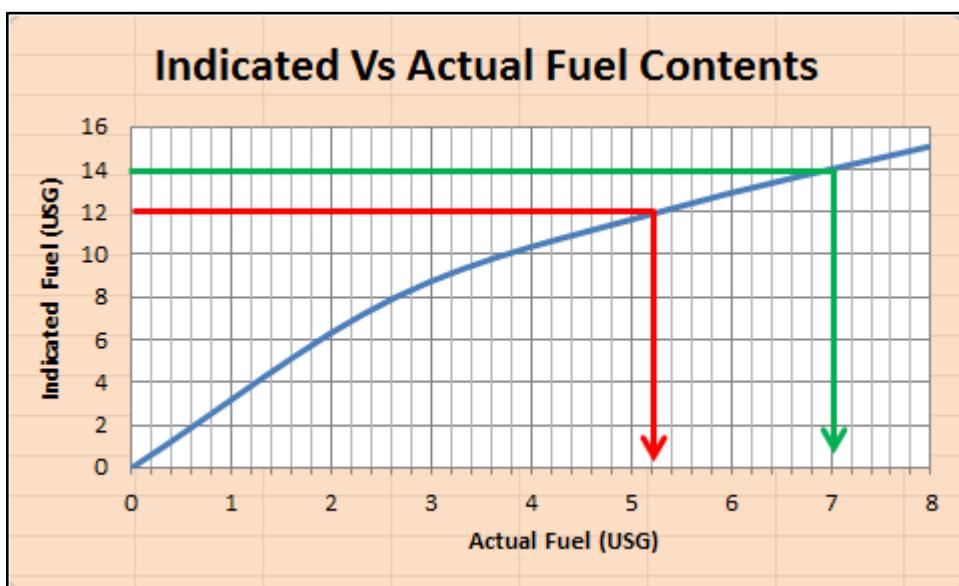
To directly compare the two dipstick indications, the Investigation converted the Litre denominated readings to USG and plotted a comparison (**Figure No. 1**) between the indicated fuel contents (using the 172 dipstick) and the actual fuel contents (using the 177A dipstick). **Figure No. 1** indicates that the left fuel tank, which the dipstick indicated contained 12 USG (red line), actually contained 5.2 USG; the right fuel tank, which the dipstick indicated contained 14 USG (green line), actually contained 7 USG. Thus, the total fuel load aboard the aircraft departing EINN was actually 12.2 USG. With an actual fuel load of 12.2 USG, which was less than half the indicated fuel load of 26 USG, the Aircraft's endurance was also less than half that which was expected on departure from EINN.

**Figure No. 1:** Comparison of indicated and actual fuel loads

Accurate fuel management is essential for safe operation of aircraft. The Pilot was aware that the left hand fuel gauge was inoperable and he considered the right hand one to be unreliable. He therefore relied on a physical dipping of the fuel tanks to accurately estimate the fuel contents. In this case, because the dipstick used was not the correct dipstick for the aircraft type, an erroneously high estimate of the aircraft's fuel state was obtained. This led to the over-estimation of the aircraft's endurance.

This event should serve as a reminder to general aviation pilots of the importance of effective fuel management and of checking the compatibility of ancillary equipment with their specific aircraft.
