# Air Accident Investigation Unit Ireland

## SYNOPTIC REPORT

Accident  
Robinson R44 Clipper II, G-DORM  
Near Carlingford, Co. Louth, Ireland

12 March 2017

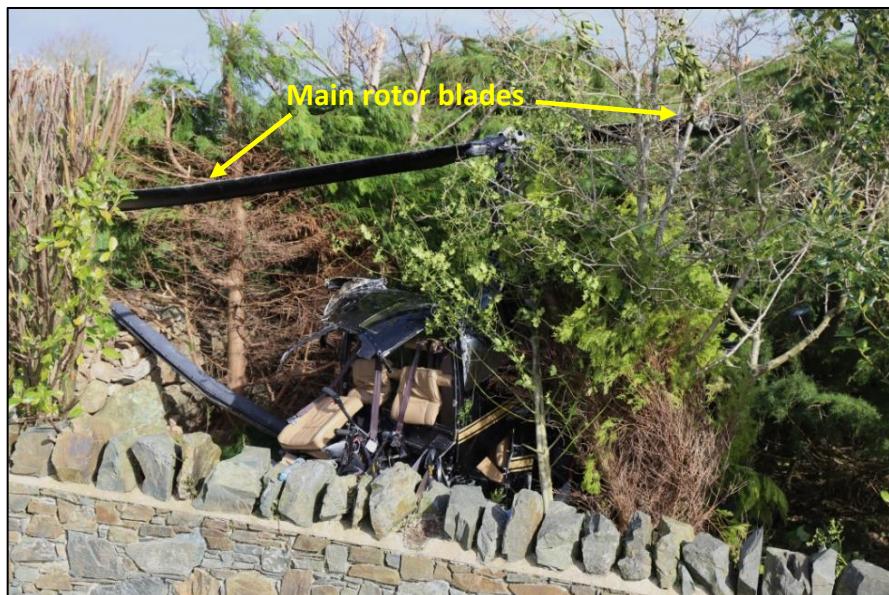
**Photo No. 1:** Final resting position of G-DORM (main rotor blades annotated)

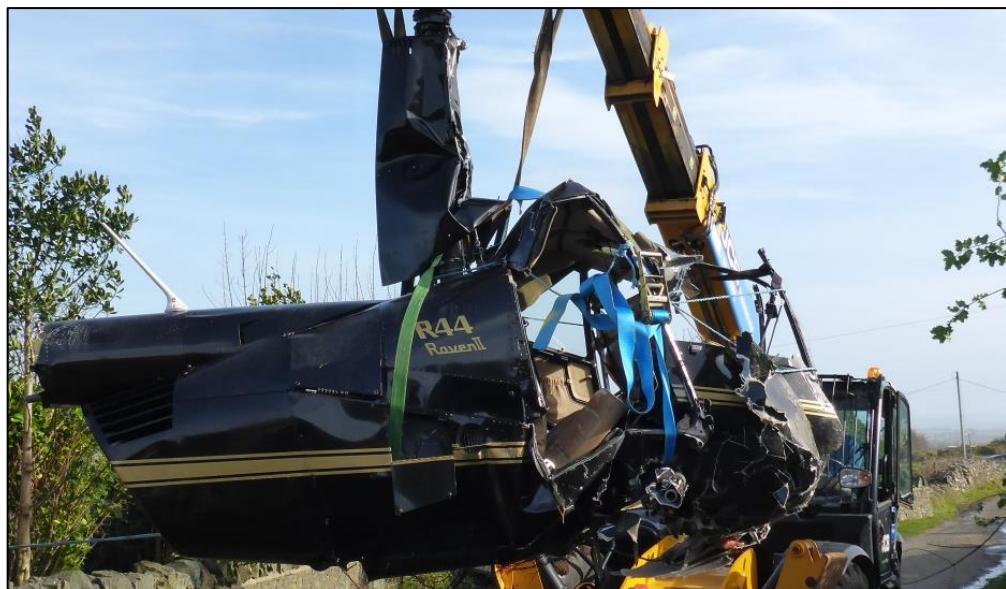
The helicopter was destroyed. There was severe disruption to the cockpit area (**Photo No. 2**) and extensive damage to the main rotor blades, with one blade sustaining more damage than the other. The rotor blade that sustained most damage was bent downwards from approximately 1.3 m from the blade root. The outermost section of the blade, approximately 0.8 m in length, was bent upwards and rearwards (with reference to the direction of rotation). The lower surface of this section bore multiple scrape marks. Similar marks were also present on the lower surface, inboard of the bending point, for approximately another 0.8 m. The outermost section of the other main rotor blade, approximately 0.4 m in length, was bent rearwards (with reference to the direction of rotation). The blade tip cap was missing. The lower surface of this section also contained multiple scrape marks.

**Photo No. 2:** Damage to helicopter (photograph taken during wreckage recovery)

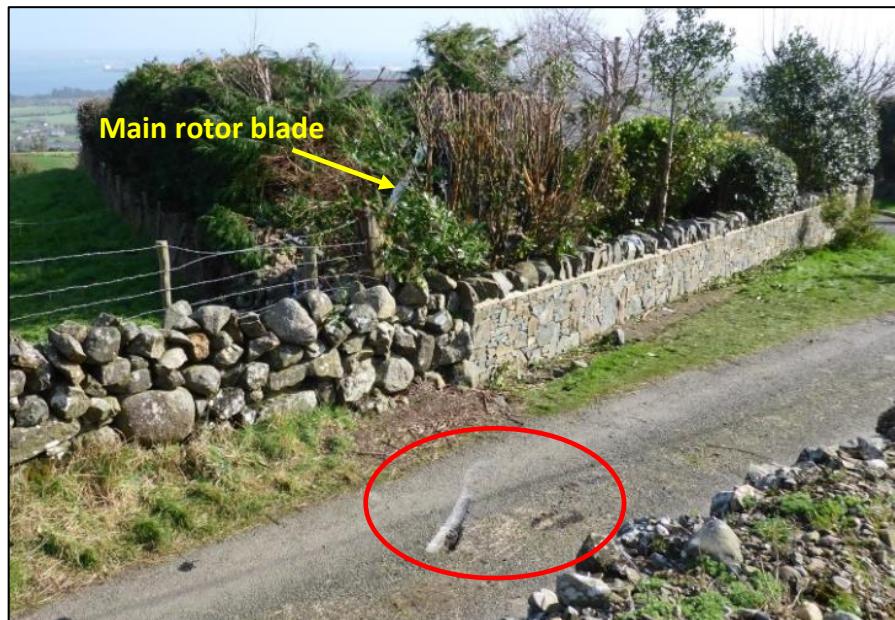
The surface of the road close to the helicopter's final resting position exhibited a gouge approximately 0.8 m in length and a scuff mark extending from this gouge towards where the helicopter lay. An oval-shaped scuff mark was also visible approximately 0.7 m from the gouge. In addition, substantial damage was caused to the trees/shrubs at the helicopter's final resting position. There was no apparent damage to the stone walls which bounded the road (**Photo No. 3** and **Photo No. 4**).

**Photo No. 3:** Damage to road surface in foreground (circled), with helicopter in dense trees/shrubs behind wall in background (main rotor blade annotated)

The damage evident on the road surface adjacent to the helicopter’s final resting position and that observed on the main rotor blades, indicates that at least one main rotor blade made contact with the road during the impact sequence. The damage pattern on the road indicates that when the blade(s) made contact, the centre of the main rotor disc was to the east of the road (i.e. the same side as the final resting position). There was no apparent damage to the stone walls which bounded the road. For this to be the case, the helicopter was likely in an unusual attitude when a main rotor blade made contact with the road; this is supported by witness accounts. The damage to the cockpit area and the leading edge of the mast fairing, within which tree/shrub material was found trapped, indicates that the helicopter had some forward velocity when initial contact was made with the trees/shrubs.

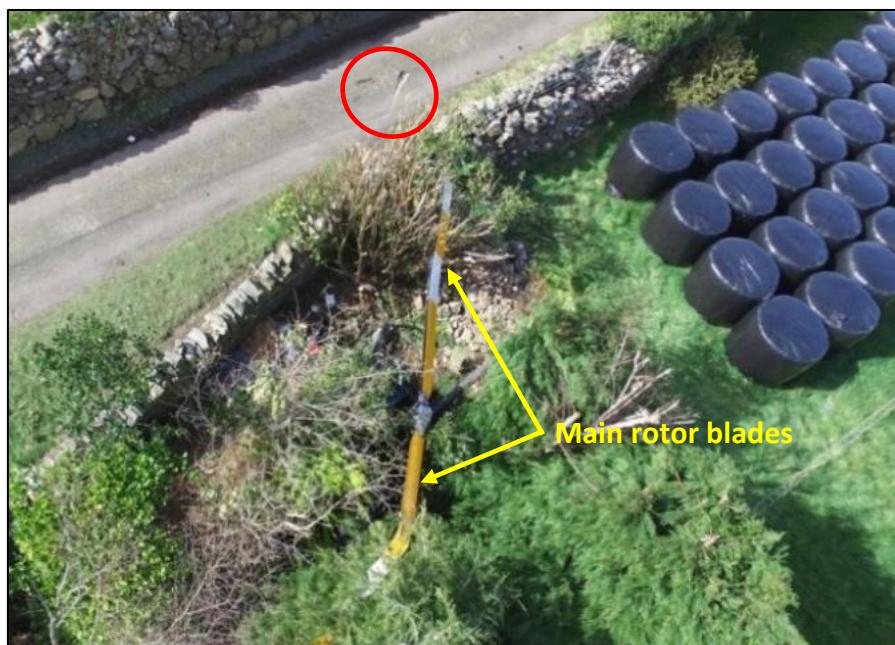
**Photo No. 4:** Aerial image showing damage to road surface (circled), with helicopter in dense trees/shrubs (main rotor blades annotated)
