Air Accident Investigation Unit Ireland

FACTUAL REPORT

**Aerotechnik EV-97 Eurostar, G-LYNI
Inisheer, Co. Galway**

22 June 2018

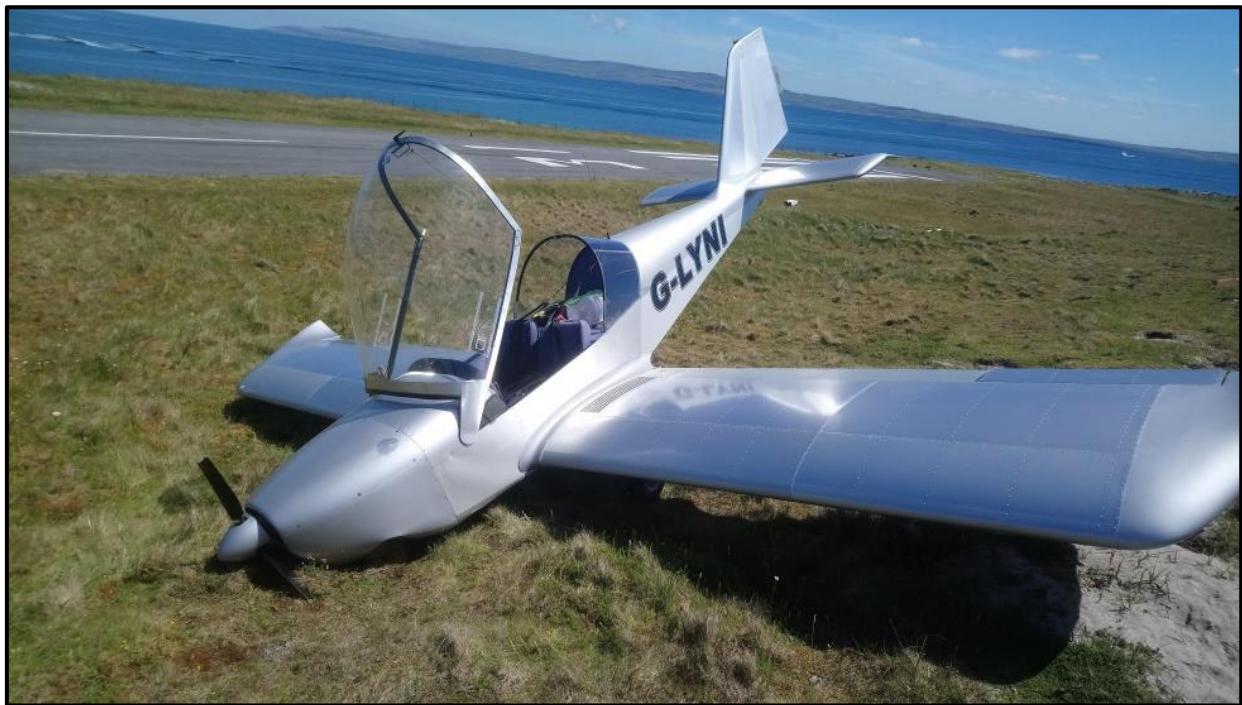
The Pilot stated that as it bounced there was a sudden increase in engine power, and the aircraft veered left and departed the runway. The aircraft impacted an area of raised sand dunes south-west of RWY 31. It came to rest approximately 28 m to the left of the runway centreline, and 114 m from the beginning of the paved surface of the runway (**Photo No. 1**).

Photo No. 1: Aircraft in-situ at accident site.

The aircraft nose gear collapsed and the propeller and lower part of the engine cowling sustained substantial damage. The engine is likely to have suffered shock loading, as it was under power at the time of impact.

The Airport Operator reported that the aircraft impacted the cover of a Precision Approach Path Indicator (PAPI) light assembly situated to the left of the runway, causing the cover to come off. No other damage was sustained by the PAPI assembly, which had been decommissioned prior to the accident.

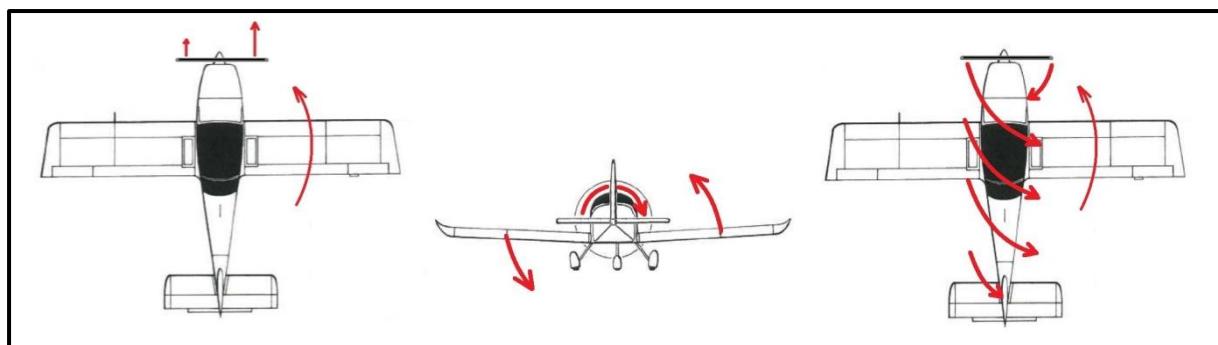
However, the Pilot stated that when the aircraft bounced on touch down, there was a sudden increase in engine power. With the low forward speed, a high angle of attack, and sudden increase in power from the engine, there would have been a tendency for the aircraft to turn to the left as it had a clockwise rotating propeller (as viewed from the cockpit), due to a combination of P-Factor, Propeller Torque Effect, and Prop Wash.
