Air Accident Investigation Unit Ireland

SYNOPTIC REPORT

SERIOUS INCIDENT
Embraer SA, ERJ 190-200 LR, G-FBEM
Dublin Airport
16 October 2017

AAIU Report No: 2018-019

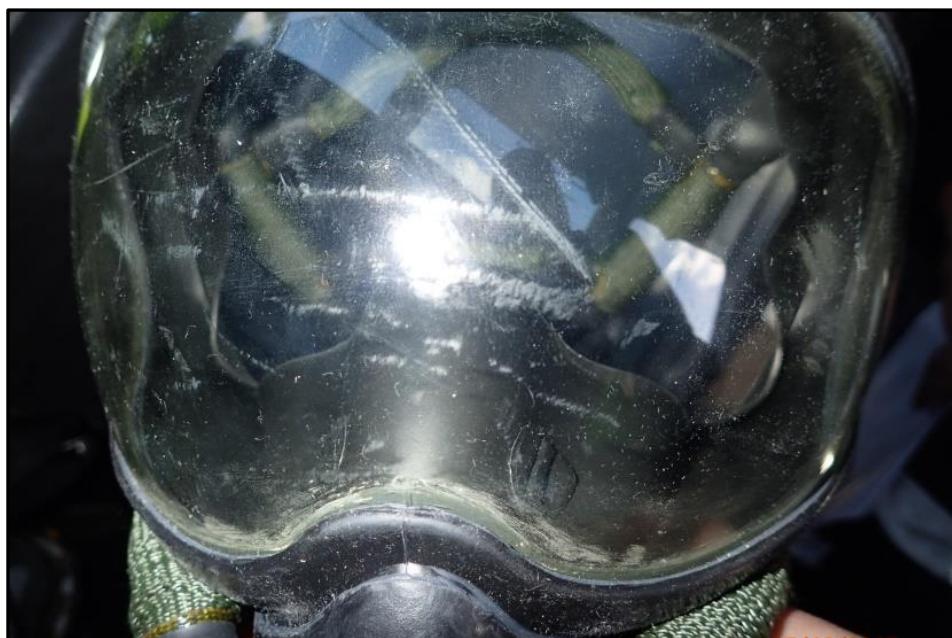
In addition to the difficulties with communication, both pilots experienced restricted visibility through the lens of the smoke goggles due to scratches and an obscuring layer on the lens (Section 1.6.3).

The Commander stated that once he had ordered the donning of the oxygen masks, the Flight Crew established communications between themselves, and the Commander noted that the Co-Pilot made "*a couple of transmissions to ATC before the microphone in the Co-Pilot's mask appeared to fail*". The Commander also told the Investigation that the lenses of both his and the Co-Pilot's smoke goggles were scratched and "*coated in something*" that impaired their vision.

Photo No. 1: Exterior of Commander's Smoke Goggles showing scratches

Immediately following the occurrence, the Investigation requested that the Operator carry out a fleet inspection of all ERJ 170-200 STD and ERJ 190-200 LR masks. The Operator carried out a visual check of remaining lenses, and reported to the Investigation, that out of the 57 masks (the occurrence masks were not included), 17 were found serviceable, 36 required *"cleaning to remove deposits on the surface of the lens, and four required both cleaning to remove deposits, and polishing to remove scratches to the surface of the lens"*.

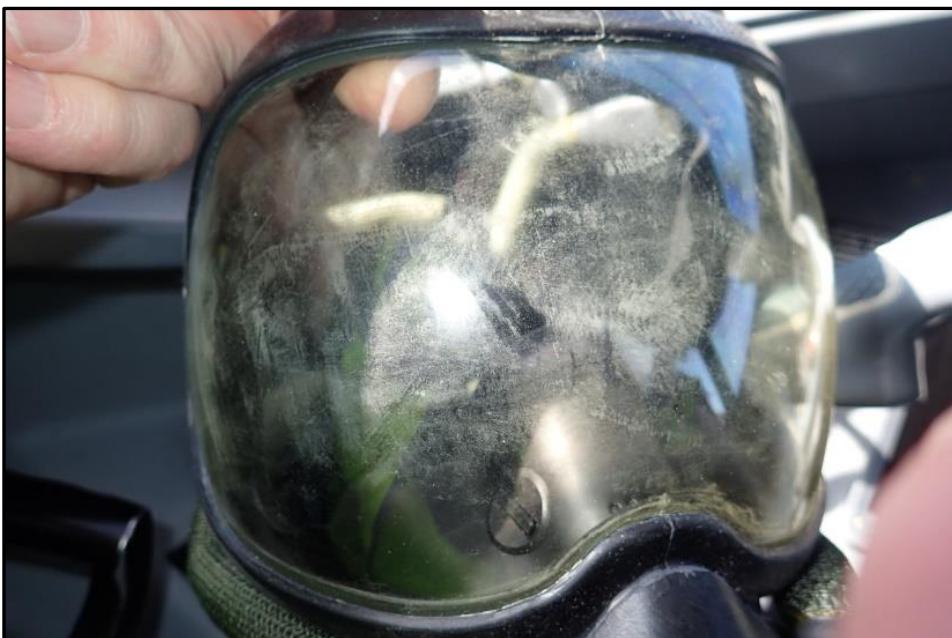
The Co-Pilot informed the Investigation that her oxygen mask lens was scratched and had a "*waxy contamination*" that impaired vision. She stated that initially, following the donning of the masks, both pilots established communications between themselves momentarily before communications failed. The Co-Pilot could hear communications from the Commander and ATC, but the microphone on the Co-Pilot side was not working, so neither ATC nor the Commander could hear her speak.

Photo No. 2: Co-Pilot's Smoke Goggles showing obscuring layer on inner surface

¹² Blooming is a condition of the lens in which additives in the base material (polymer) have migrated and collected on the surface of the lens, thereby causing a reduction in visual clarity.

Inspection of the subject masks following the event identified surface '*blooming*' and scratches on the lenses of the integrated smoke goggles. A further check, carried out by the Operator, of its ERJ fleet revealed a significant proportion of masks lenses showing similar signs of '*blooming*'. Although the aircraft Manufacturer's MPD calls for masks to be inspected every 3,750 flight hours, the Operator is processing a formal amendment to the (AMP) to change the inspection frequency to every A-Check. Consequently, no Safety Recommendation is made to the Operator.

This kind of effect has been reported by some other operators as well and we have issued SIL¹⁴ 1746XX-SIL-001 to inform operators about proper methods for cleaning. Additionally a training video for cleaning can be accessed through our tech publication portal. The procedure as per SIL 1746XX-SIL-001 should be performed at standard maintenance intervals or as required on condition during routine inspections.

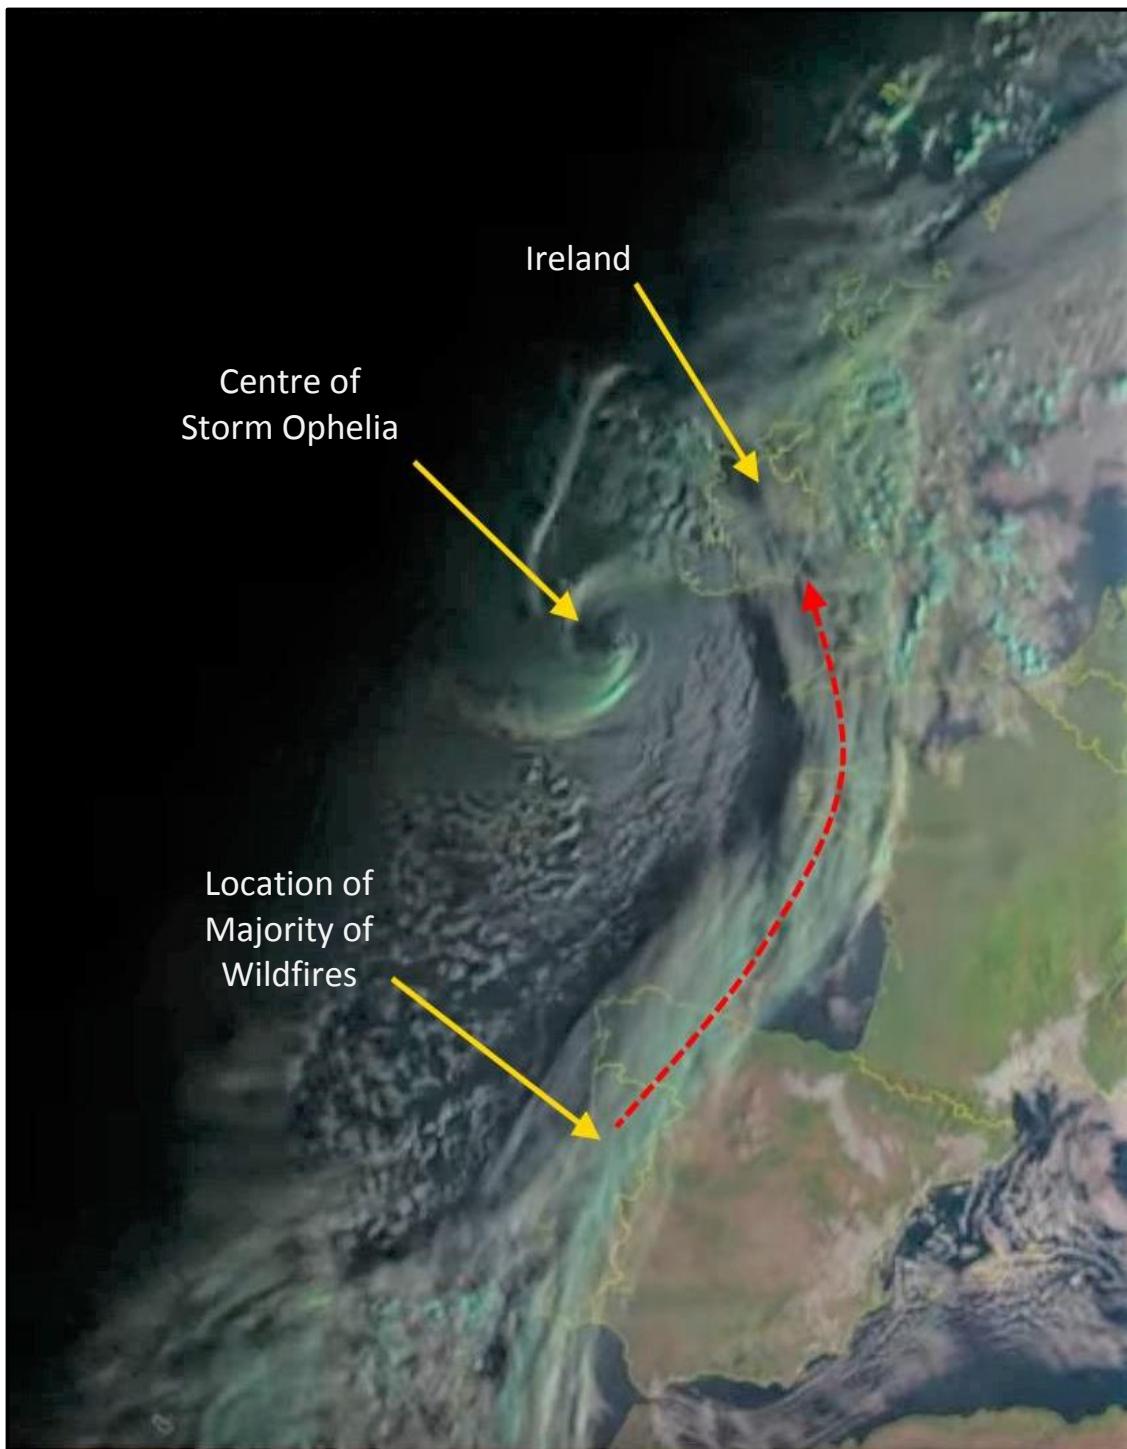
Figure No. 2 is a screen-grab from the animation for time 07.00 hrs, on 16 October 2017, and shows the air mass containing smoke, being drawn by ex-hurricane Ophelia, from Portugal over the Bay of Biscay towards the east coast of Ireland (dashed red line).

Figure No. 2: Satellite image showing path of air (dashed red line) containing smoke from wildfires.

The meteorological conditions on the day of the occurrence were such that smoke from wild fires over the Iberian Peninsula was drawn over the east coast of Ireland and the United Kingdom. In the Dublin area the smoke-laden air appears to have been present in the atmosphere, from approximately 7,000 ft to near the surface. It was this air that the subject aircraft entered as it left the holding pattern and began its approach into EIDW.
