# Air Accident Investigation Unit Ireland

## FACTUAL REPORT

**Alexander Schleicher ASW 17, EI-GMB**

**Alexander Schleicher ASK 21, EI-GLA**

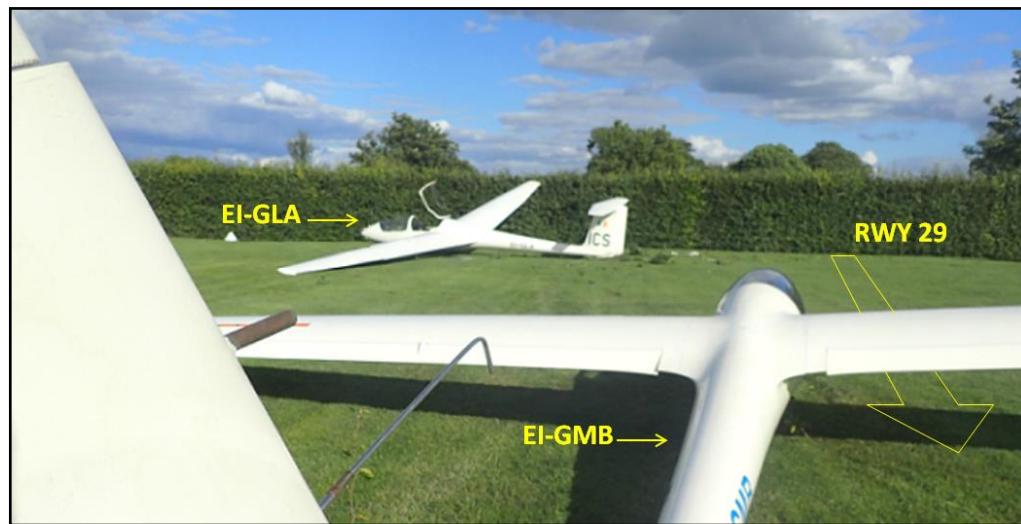
The Pilot stated that the deceleration from the impact with the hedge resulted in the sailplane pitching nose-down. As the sailplane came through the hedge its main landing gear (MLG) wheel impacted the port wing of another sailplane (EI-GLA) which was stationary and positioned adjacent to the hedge on the threshold of RWY 29. EI-GMB subsequently came to rest on RWY 29 approximately 26 m from the threshold hedge and pointing back in the direction from which it came (**Photo No. 1**).

**Photo No. 1:** Resting positions of both sailplanes on threshold RWY 29

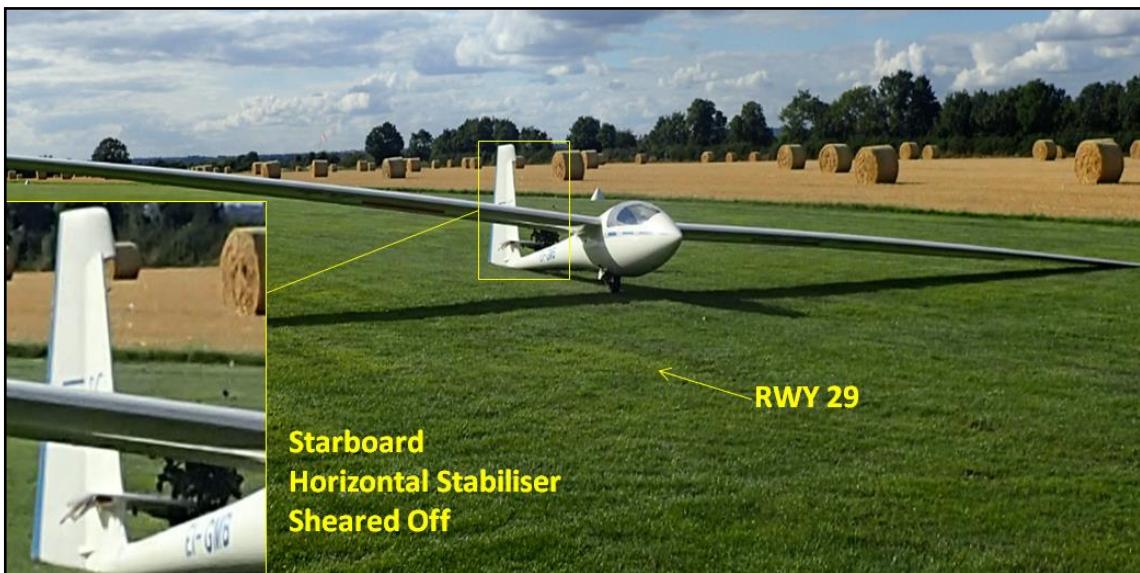
Both EI-GMB and EI-GLA sustained substantial damage. EI-GMB's starboard horizontal stabiliser was sheared off and its port horizontal stabiliser, although still attached, was severely damaged with traces of hedge present (**Photo No. 2**). In addition, one of the MLG undercarriage doors and the tail skid of EI-GMB were broken off.

**Photo No. 2:** EI-GMB resting position post-accident

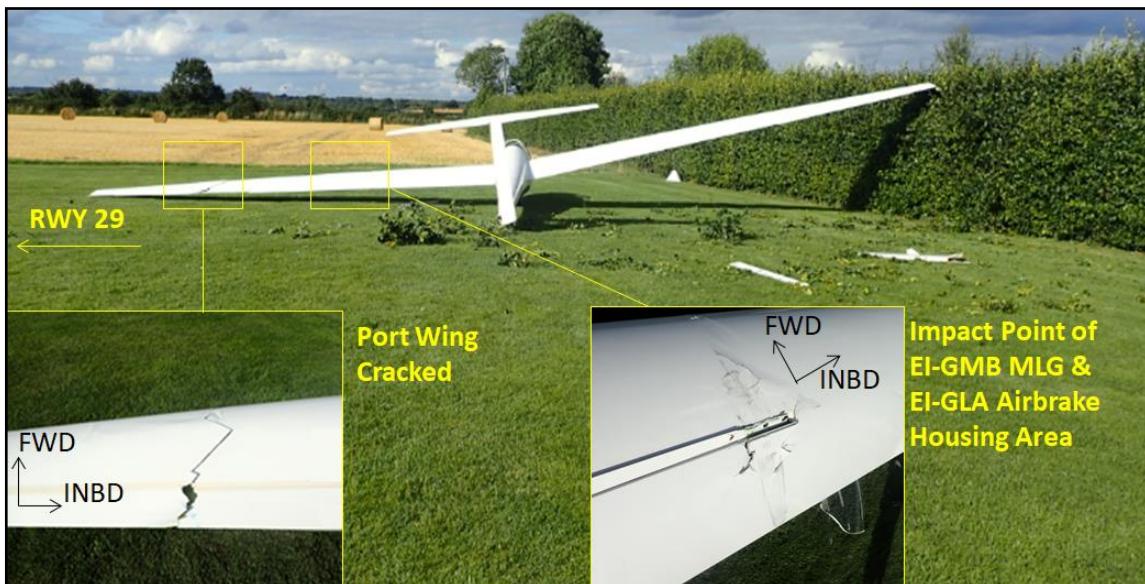
The impact of EI-GMB with EI-GLA resulted in the port wing of EI-GLA being significantly damaged in two distinct areas (**Photo No. 3**). The port wing was cracked from its leading to trailing edge approximately 6 m from the port wing root. The impact of the MLG of EI-GMB onto the airbrake housing area of EI-GLA, approximately 3 m from the port wing root resulted in the airbrake assembly being damaged and the surrounding skin being perforated in several areas from leading to trailing edge (**Photo No. 4**). In addition, the Pilot was of the opinion that the impact between the two sailplanes caused the rear canopy of EI-GLA to slam closed resulting in it being shattered.

**Photo No. 3:** EI-GLA resting position post-accident

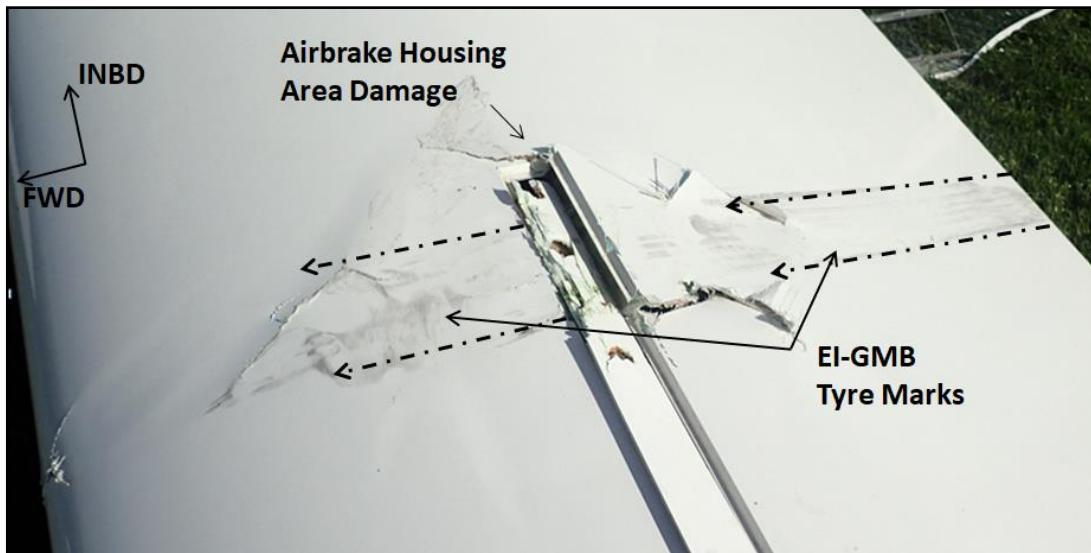
**Photo No. 4:** Impact point on EI-GLA port wing and damage to airbrake housing area
