# Air Accident Investigation Unit Ireland

**FORMAL REPORT**

**ACCIDENT  
BRM Land Africa, EI-EOH  
Near Ballina, Co. Mayo  
4 May 2018**

AAIU Report No: 2019-002

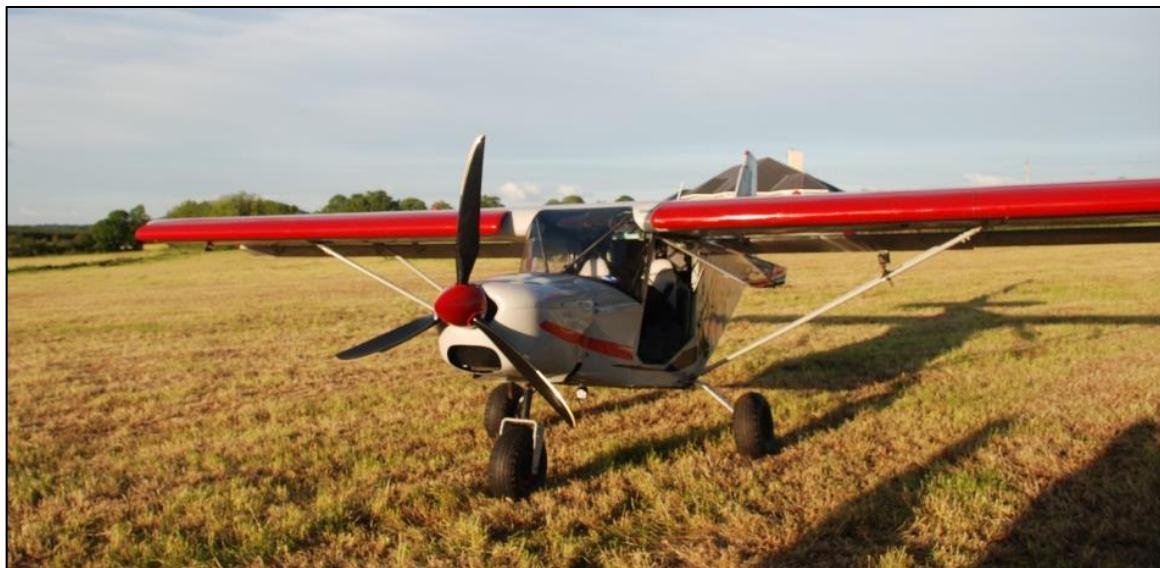
**Photo No. 1:** EI-EOH (courtesy of Pilot's family)

EI-EOH was a factory-built microlight aircraft of all-metal construction (**Photo No. 1**). It had a strut-braced high wing, and an enclosed cockpit with two seats, in a side-by-side configuration. Each seat was equipped with a four-point restraint harness. The aircraft wingspan was 8.63 metres (m). It was equipped with a fixed tricycle landing gear and a Rotax 912ULS four-stroke petrol engine. The aircraft had a maximum take-off weight of 450 kg. The aircraft's airspeed indicator was calibrated in miles-per-hour (mph) and the aircraft never exceed speed ( $V_{NE}$ ) was 109 mph, or 94 knots (kts).

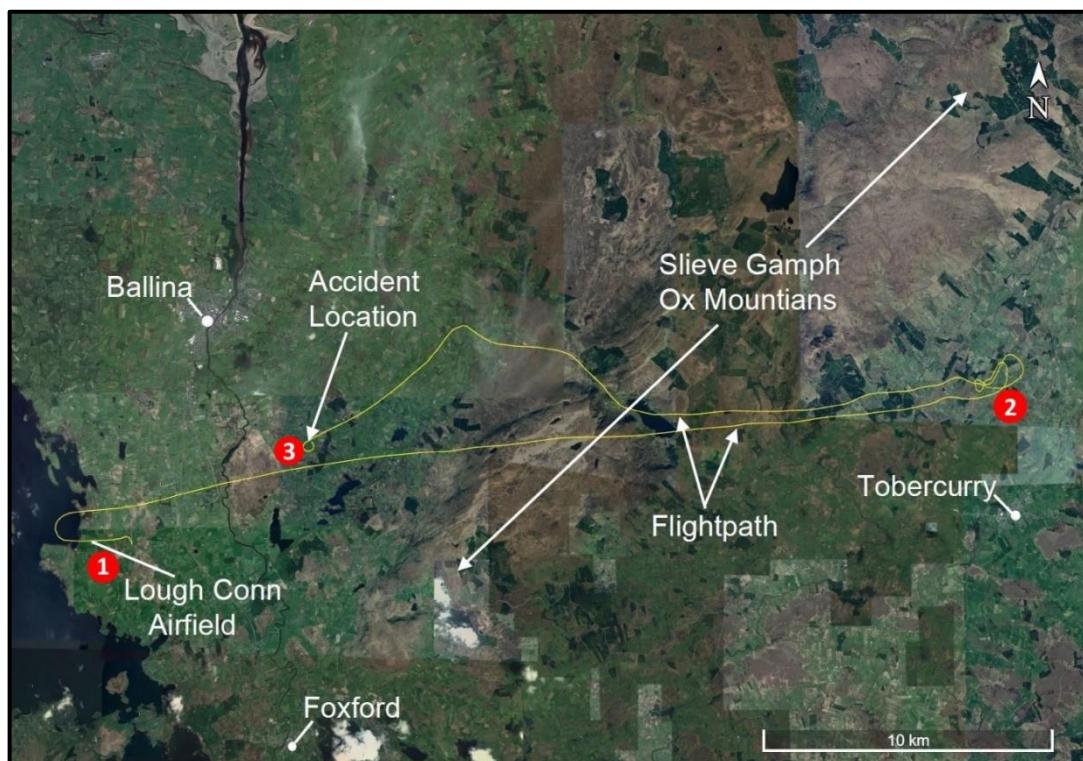
**Graphic No. 1:** Aircraft track flown, recreated from GPS Data. (*Google Earth*)  
Approximate witness Locations in Red Circles (**Section 1.1.1**)

A Garmin GPS Unit (GPSMap 296) was recovered from the aircraft. It was found in a '*powered on*' state. The unit was powered off at the scene, secured and transported to the AAIU facilities for further examination. When examined, it was found that data logging was enabled, and a successful download of time, position and altitude data was made. The Investigation was able to recreate the flight path of the aircraft from the period prior to the touch-and-go, until just before the accident, (**Graphic No. 1**).

6. Data from the GPS unit on the aircraft, and video evidence show that the aircraft entered a descending left-hand turn commencing approximately 1,000 ft above the ground, which continued until impact.
