# Air Accident Investigation Unit Ireland

## FACTUAL REPORT

### ACCIDENT Cessna 140, EI-AEM Snug Beag Airfield, Co. Westmeath

2 June 2018

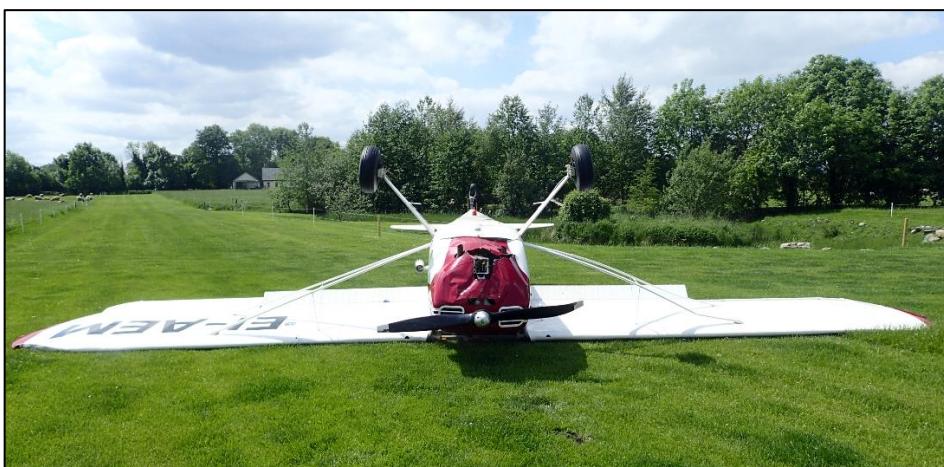
Whilst landing at a private airfield, near Delvin, Co. Westmeath, the Cessna 140 aircraft, with one Pilot on board, experienced a bounced landing. Following the bounced landing, the Pilot applied the brakes in an attempt to bring the aircraft to a halt. The aircraft subsequently pitched forward, overturned and came to rest, inverted, on the runway. The Pilot sustained minor bruising. There was no fire.

The Pilot said *"he arrested the bounce with power, rolling out in a level attitude on a downward section of runway"*. In addition, the Pilot applied full back elevator, in order to keep the tail-wheel in contact with the runway while maintaining directional control of the aircraft through the rudder. At approximately 175 m from the threshold of RWY 19, the Pilot applied the brakes. The aircraft pitched forward, overturned and came to rest inverted on the runway pointing back in the direction from which it came (**Photo No. 1**). The Pilot exited the aircraft having sustained minor bruising during the accident.

**Photo No. 1:** Final resting position of EI-AEM on RWY 19

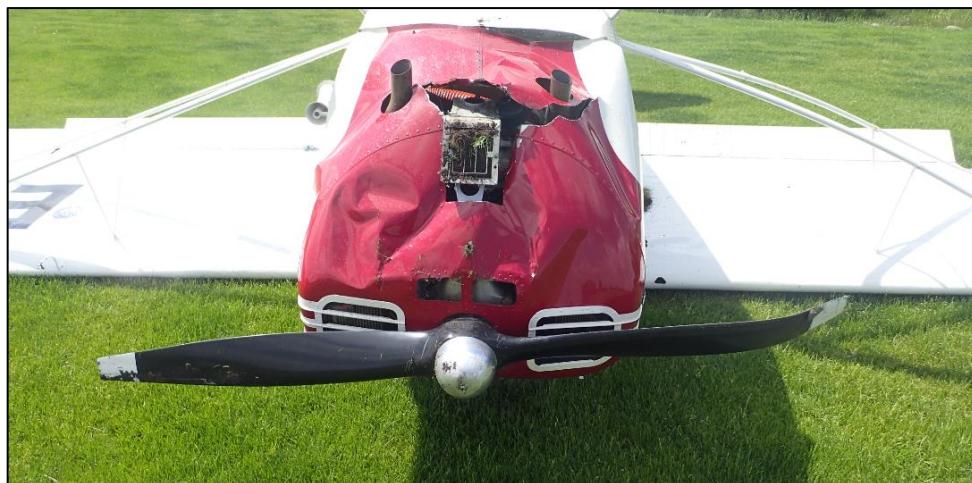
The aircraft sustained substantial damage as a result of the accident. The engine, propeller and forward fuselage suffered impact damage (**Photo No. 2**), the starboard wing strut was buckled (**Photo No. 3**) and the leading edge of the port wing tip area had impact damage evident (**Photo No. 4**). The tail sustained significant creasing and buckling to the vertical stabiliser and rudder area (**Photo No. 5**).

**Photo No. 2:** Damage to propeller blades and engine fairings

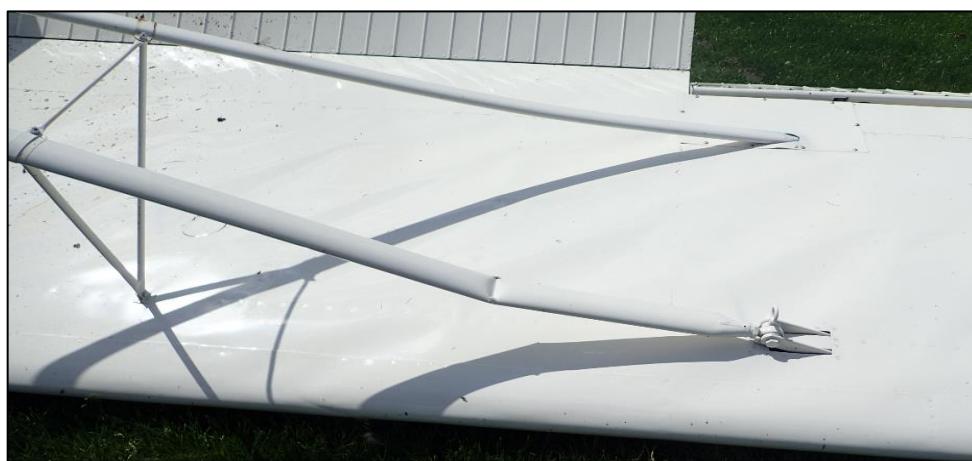
**Photo No. 3:** Damage to starboard wing strut

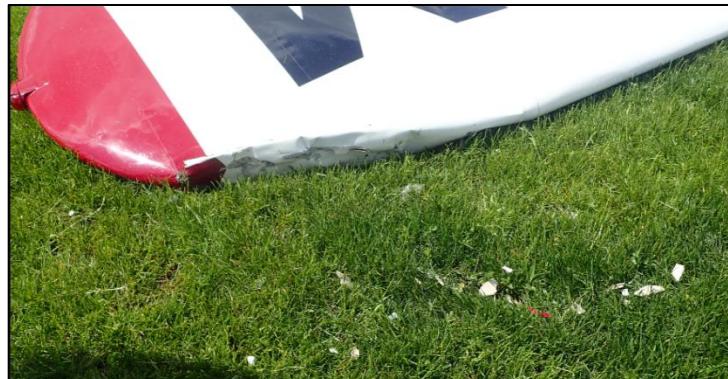
**Photo No. 4:** Damage to port wing leading edge

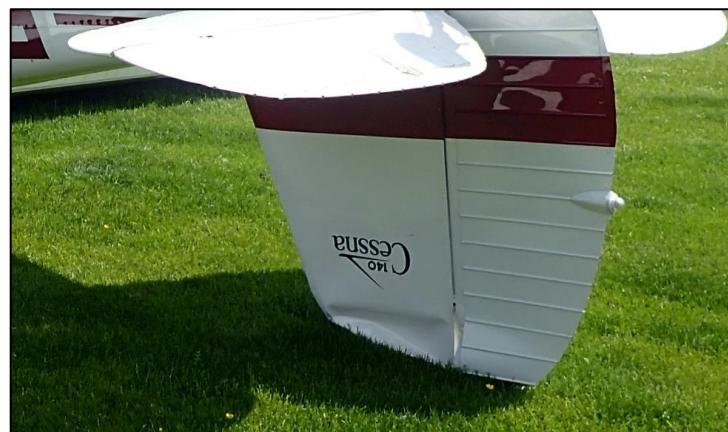
**Photo No. 5:** Damage to vertical stabiliser and rudder
