Air Accident Investigation Unit Ireland

FORMAL REPORT
ACCIDENT
Cessna 750, Citation X+, N752TX
Cork Airport

22 July 2018

AAIU Report No: 2019 - 009

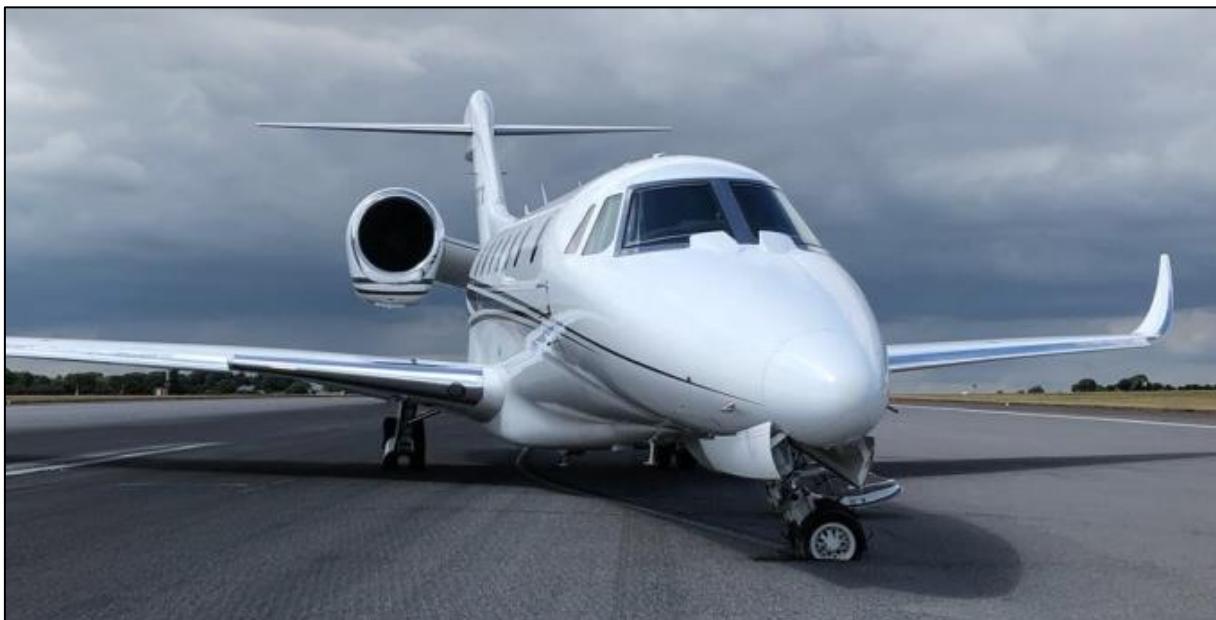
The nose gear leg and nose structure of the aircraft suffered significant damage (**Photo No. 1**). During the accident sequence, the lower part of the nose gear leg turned through approximately 90 degrees, both tyres burst and disintegrated, leading to significant wear on the hub of the forward wheel (**Photo No. 2**). There was no fire.

Photo No. 1: Final Resting Position of Accident Aircraft on RWY 16 at EICK

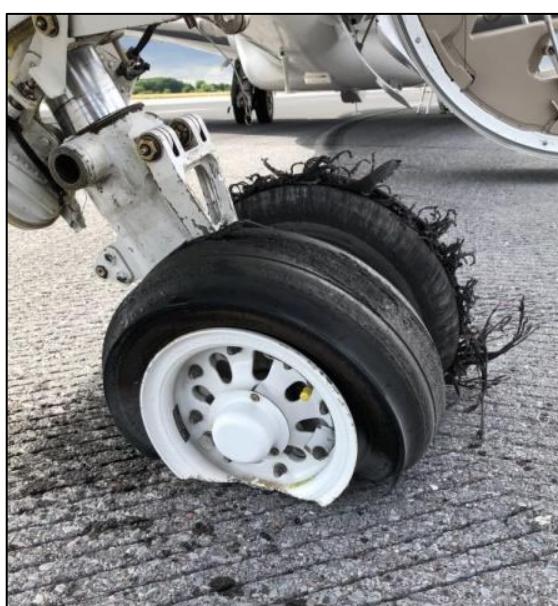
Photo No. 2: Damage to Nose Gear Leg and Nose Structure

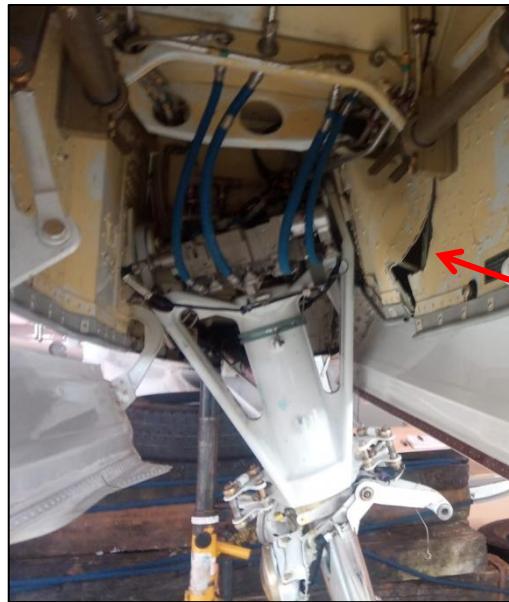
The nose gear bay doors experienced bending damage and the aircraft's nose structure suffered a significant tear and distortion (**Photo No. 3**). The actuator used to extend and retract the nose landing gear also sustained bending damage.

Damage to nose structure

Photo No. 3: Damage to Aircraft Nose Structure

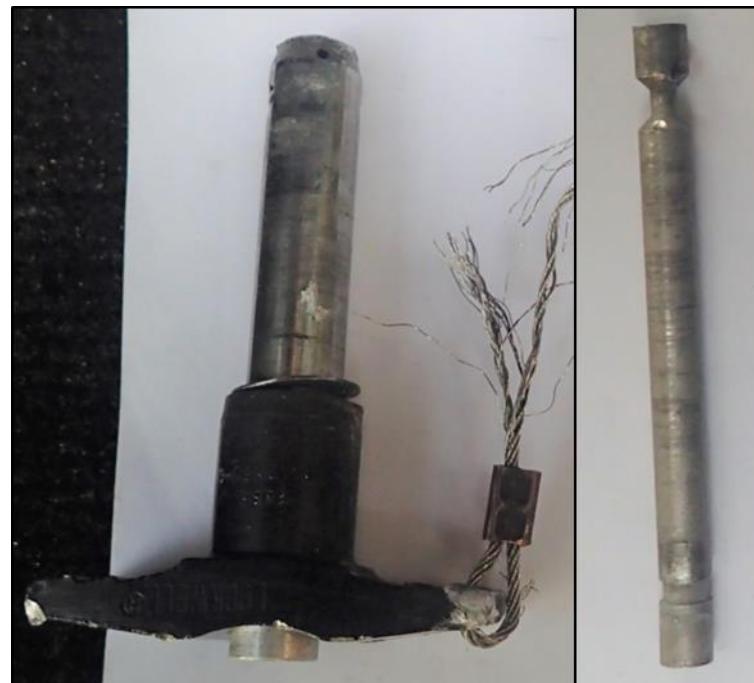
Several components were recovered along the runway. Amongst these was the nose gear leg Torque Link Release Pin, which is used to connect the upper and lower torque links on the nose gear leg (**Figure No. 1**). A pin which forms part of the internal retention mechanism of the Torque Link Release Pin was found in a separate location on RWY 16. Both are shown in **Photo No. 4**. There was no evidence of pre-existing mechanical damage. The safety pin that would normally be attached by a lanyard to the upper torque link was not recovered. However, the lanyard was found, still intact, and attached to the upper torque link.

Photo No. 4: Torque Link Release Pin with Damaged Lanyard (Left) and Internal Retention Pin (Right)

The Torque Link Release Pin was found on RWY 16 having become separated from the aircraft due to the failure of the attaching lanyard. The retention pin which is part of the Torque Link Release Pin was found in a different location on the runway. The Investigation consider it probable that the retention pin became detached due to the forces experienced by the Torque Link Release Pin as it separated from the aircraft and bounced on the runway. A CT scan of the Torque Link Release Pin was carried out and did not reveal any pre-existing defects that would have led to a failure of the Torque Link Release Pin mechanism.

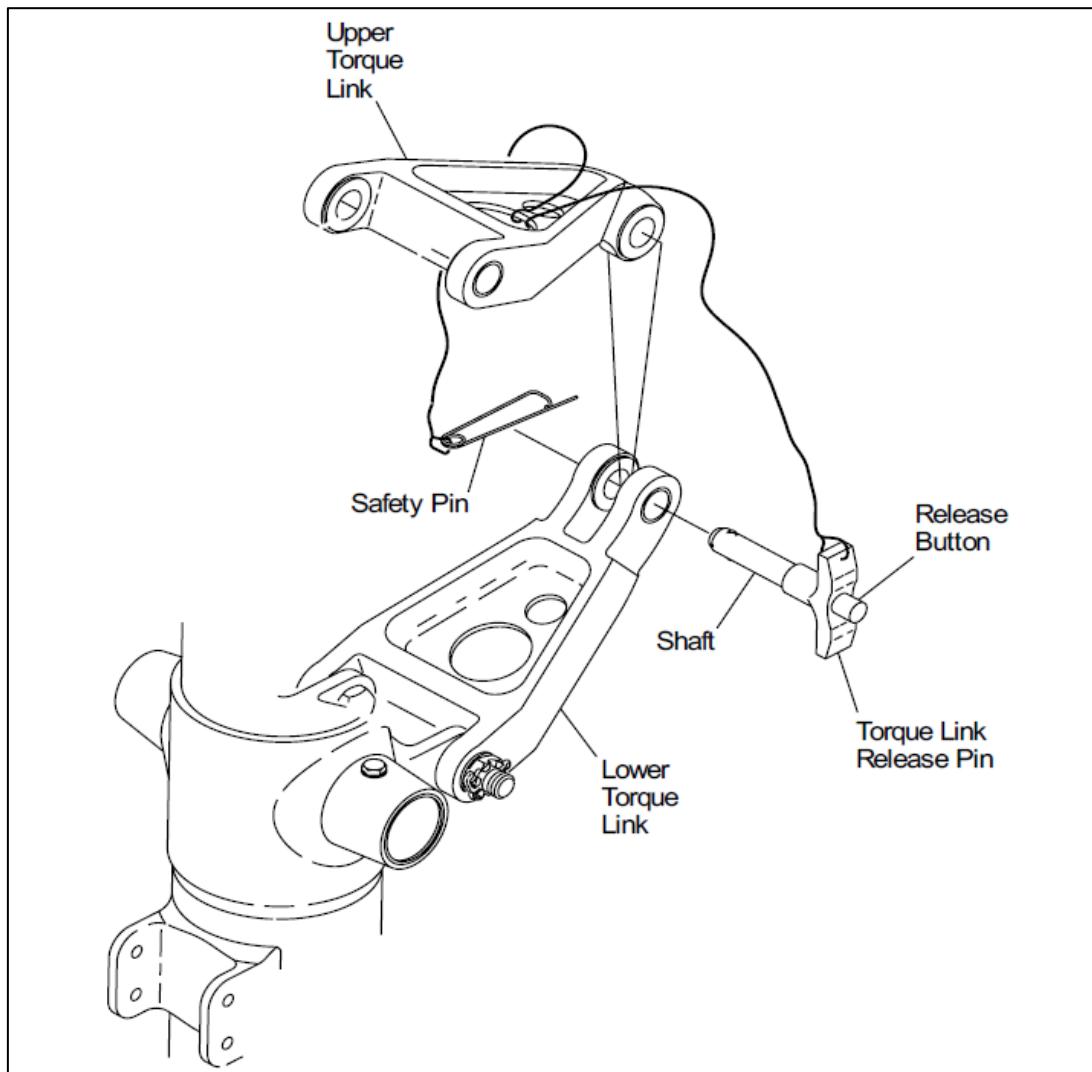
The torque link is disconnected for towing by removing a safety pin, and Torque Link Release Pin. The safety pin and Torque Link Release Pin are attached to the upper torque link by thin, stranded-wire lanyards. When the torque links are disconnected, the lower leg and nose wheel are free to turn, allowing the aircraft to be steered (within certain Manufacturer limits) when it is under tow. **Figure No. 1** shows the torque link in a disconnected configuration.

Figure No. 1: Disconnected Nose Gear Leg Torque Link (Courtesy of Textron Aviation)

When inspecting the aircraft, the Investigation noted that the lower torque link was not spring-loaded, and had fallen, under gravity, between the wheels. The Manufacturer informed the Investigation that by design, the lower torque link was not spring-loaded and that the AMM description was incorrect. The Manufacturer advised the Investigation that it now intends to amend the AMM.

No.	It is Recommended that:	Recommendation Ref.
1.	Textron Aviation should undertake a review of the torque link design and associated operational procedures on the Cessna Citation 750 series with a view to implementing measures which will increase the probability that disconnected torque links will be detected prior to taxiing the aircraft.	IRLD2019-002

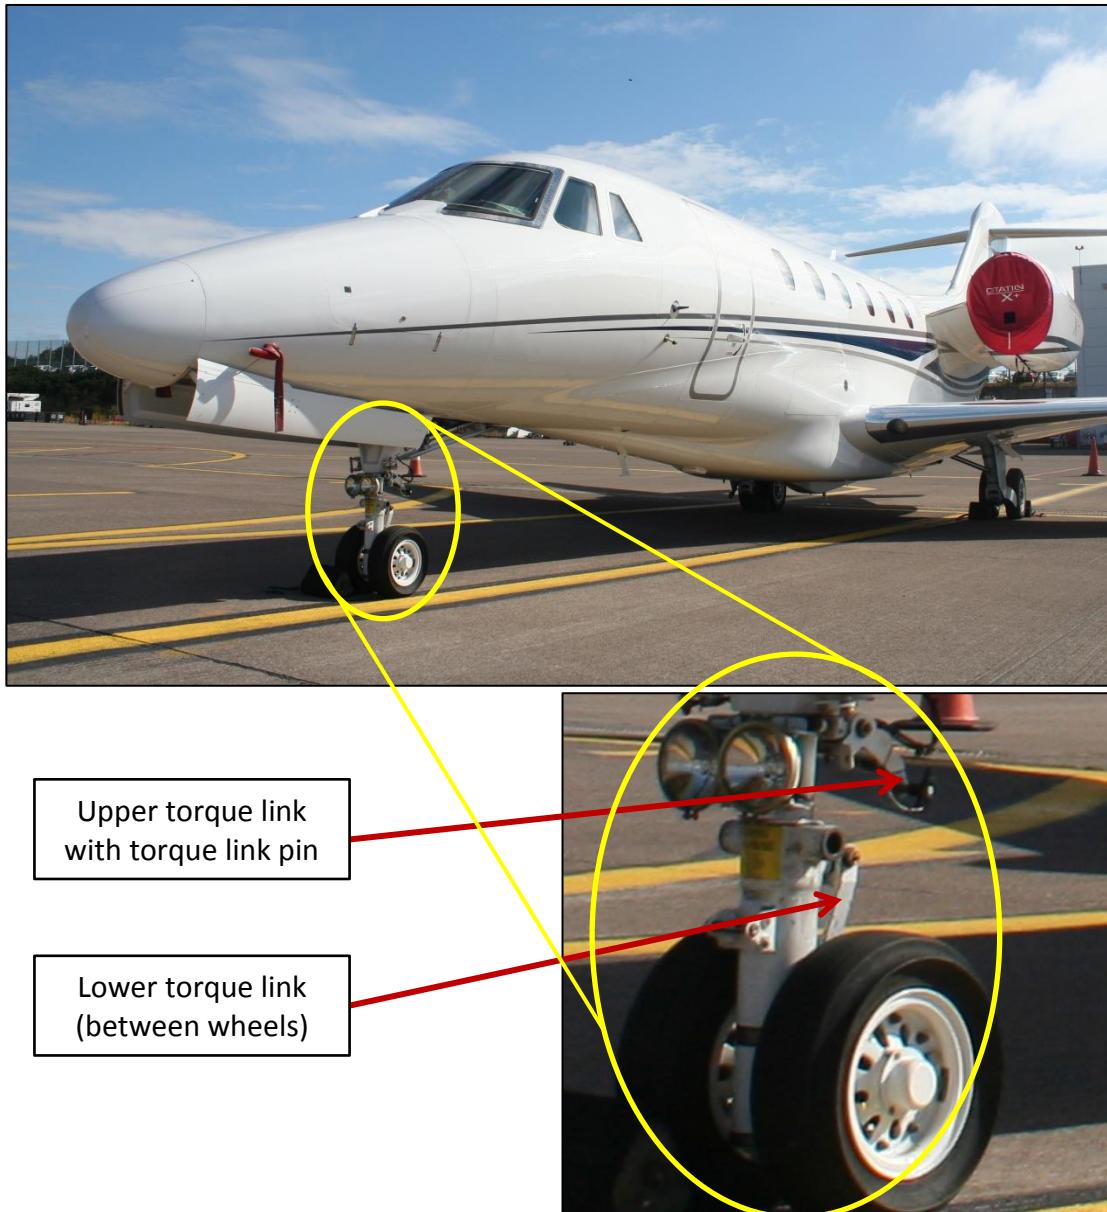
The Investigation was also supplied with a number of photographs taken on the morning of the accident at Cork Airport. In these photographs the torque links are disconnected (**Photo No. 5**).

Photo No. 5: Occurrence Aircraft Parked at EICK taken on 22 July 2018 at 09:22 hrs

By design, it was intended that when disconnected, the Torque Link Release Pin would be suspended from the upper torque link by its lanyard. This would provide a visual indication that the link was disconnected. However in this case, photographs taken of the aircraft on the day of the occurrence, show that the Torque Link Release Pin was re-installed in the upper torque link after the torque links had been disconnected. The occurrence Pilots informed the Investigation that this was relatively common practice amongst pilots to prevent damage to the nose gear leg which could be caused by the Torque Link Release Pin blowing in the wind. The '*Normal Checklist*' for the aircraft does not specifically prohibit storing the Torque Link Release Pin in this manner, and it is understandable that pilots who are trained to be cognisant of potential damage to the aircraft, might take basic measures to prevent damage from occurring.

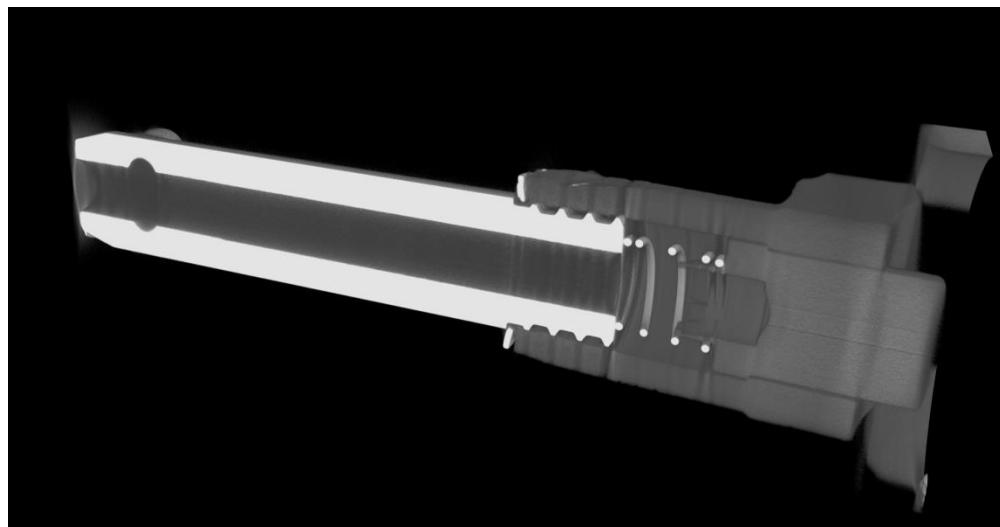
The Torque Link Release Pin was found after the occurrence on RWY 16. The lanyard which attached the pin to the nose gear leg appears to have failed during the accident sequence. An inspection of the pin mechanism was not immediately possible due to the fact that it was largely a sealed unit. The pin was subsequently taken by an Inspector of Air Accidents to a specialist CT⁷ scanning facility where a full scan was carried out. The resulting images showed no evidence of a pre-existing failure that would have prevented the correct functioning of the pin. **Figure No. 3** shows an example CT cross-sectional scan through the pin.

Figure No. 3: Example Cross-Section through the Quick Release Pin
