Air Accident Investigation Unit Ireland

SYNOPTIC REPORT

SERIOUS INCIDENT
Bombardier, BD100 1A10, 9H-VCJ
Dublin Airport
15 January 2017

AAIU Report No: 2019 - 012

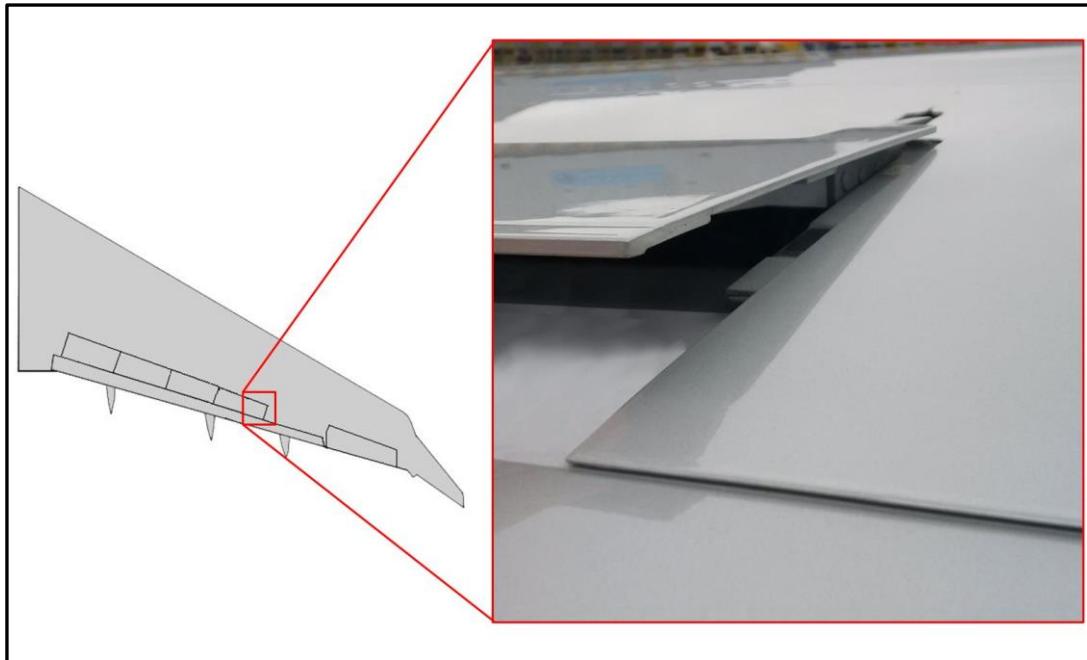
Figure No. 1: Right Outboard Multi-Function Spoiler (post-flight)

Once the aircraft was parked and the engines were shut down, the Commander took a photograph of the right outboard MFS. **Figure No. 1** shows the position of the right outboard MFS, as found by the Commander.

- 13
2. Following retraction of the flight spoilers, the right outboard MFS extended to, and remained at, approximately 7° for the remainder of the flight.

7. The right outboard MFS uncommanded extension to 7° was most likely caused by a failure of the right outboard MFS PCU connection, due to a wiring/connector continuity fault.

Roll control difficulties experienced during approach, resulting from a right outboard MFS which deployed uncommanded, most likely due to a wiring/connector continuity issue, and then remained at seven degrees.

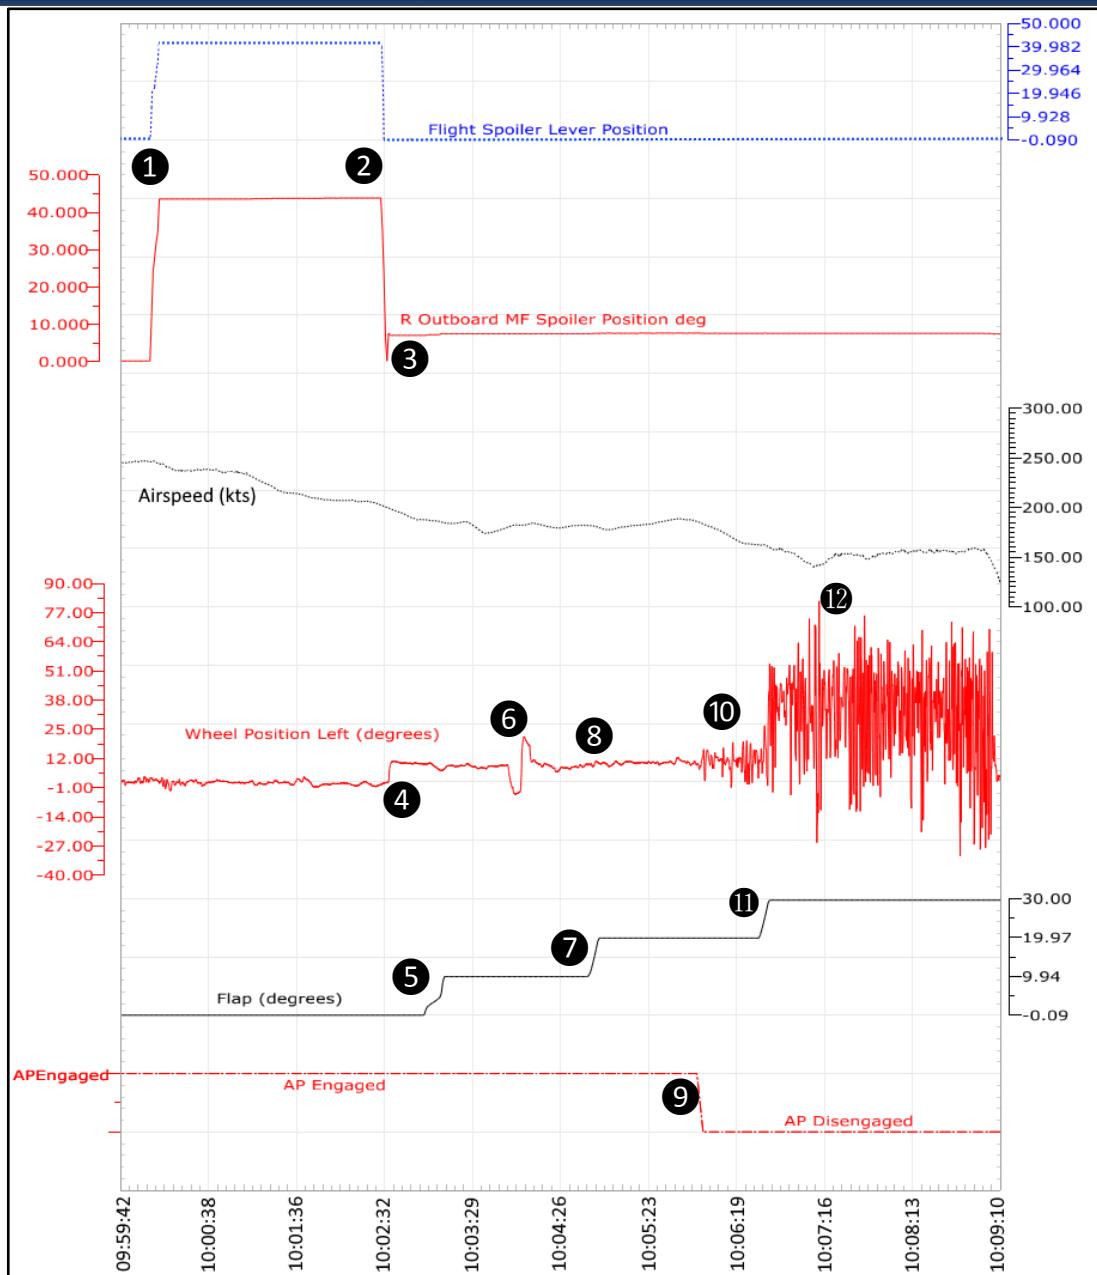
Figure No. 3: Graph of six FDR parameters

The data showed that during flight-spoiler extension all spoilers extended to approximately 45°. Following flight-spoiler retraction, all flight-spoilers retracted to 0°, following which the right outboard MFS initially re-extended to 7.6°. The angle then reduced to approximately 7°, and remained at this angle for the remainder of the flight.

- 1 At time 10:00:01 the flight spoiler lever was extended.
- 2 At time 10:02:32, at 15.3 NM, the flight spoiler lever was pushed to zero.
- 3 At time 10:02:33, at 15.0 NM, the right outer MFS extended up to 7.6°.

- 4 At time 10:02:33, 10° left control wheel input by autopilot to maintain wings level.
- 5 At time 10:02:58, at 13.5 NM, Flap 10 was selected.
- 6 At time 10:03:53, at 10.2 NM, the ILS localiser was captured.

- 7 At time 10:04:44, at 9.3 NM, Flap 20 was selected.
- 8 Left control wheel input by autopilot of approximately 10°.
- 9 At time 10:05:56, at 6.5 NM, the autopilot was disengaged.

- 10 Manual left and right control wheel inputs, by PF, commenced at up to $\pm 18^\circ$.
- 11 At time 10:06:33, at 4.77 NM, Flap 30 was selected.
- 12 Manual left and right control wheel inputs by PF increased significantly, peaking at 80° left control wheel input and 35° right control wheel input.
