Air Accident Investigation Unit Ireland

FACTUAL REPORT

ACCIDENT
Cessna 172S, G-THYB
Cork Airport

12 June 2018

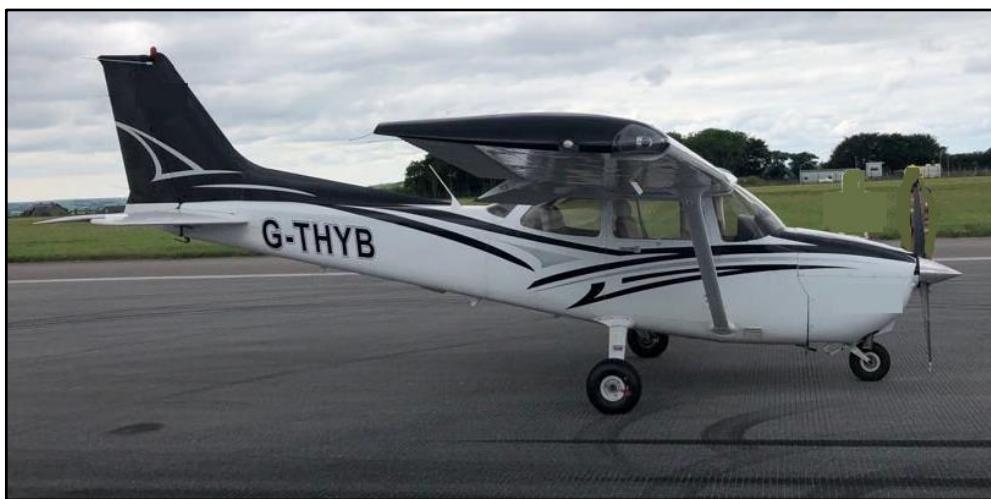
The aircraft nose wheel partially collapsed during the landing (**Photo No. 1**), causing damage to the nose gear strut and mounting points.

Photo No. 1: The aircraft on the runway after the landing.

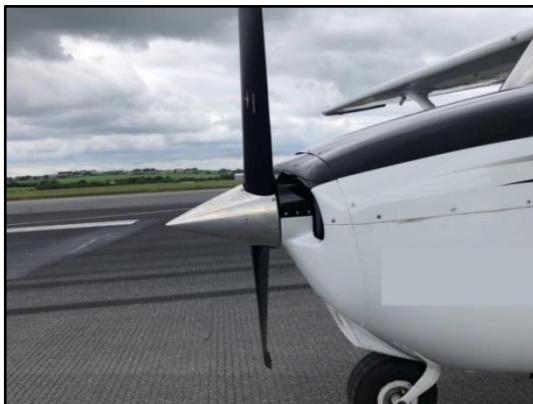
The propeller struck the runway during the landing, causing the blade tips to separate on impact (**Photo No. 2**). The blade tips were recovered from the runway approximately 30 metres behind the aircraft's final position (**Photo No. 3**). The Instructor informed the Investigation that the engine was shock-loaded during the accident sequence.

Photo No. 2: The propeller with missing blade tips

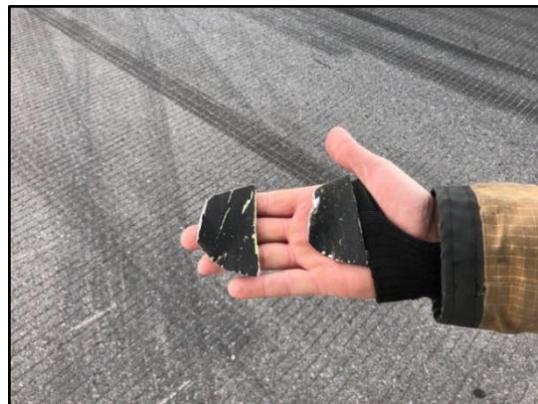
Photo No. 3: The recovered blade tips
