Air Accident Investigation Unit Ireland

SYNOPTIC REPORT

ACCIDENT
Tecnam P2002-JF, EI-GIS
Waterford Airport

11 March 2019

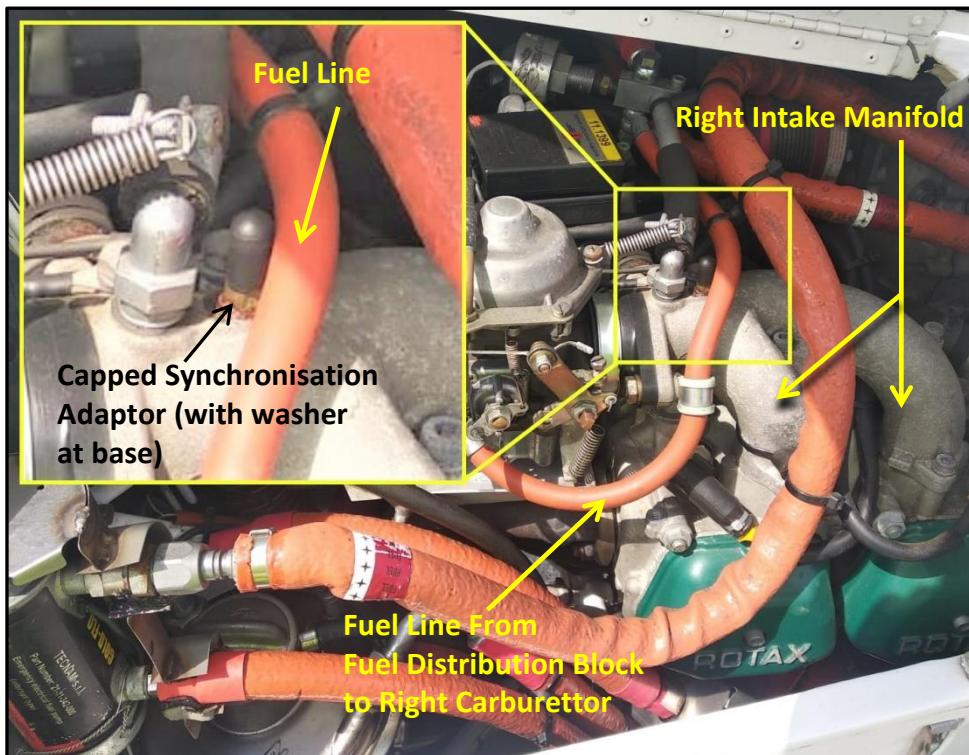
Photographic evidence, provided by the DTO, showed that a synchronisation adaptor, sealing cap, and washer, were in place on the right intake manifold, on the subject engine, when purchased by the DTO in July 2018 (**Photo No. 2**).

Photo No. 2: Engine in the accident aircraft, at time of purchase by DTO, showing the right intake manifold. Inset shows carburettor synchronisation adaptor

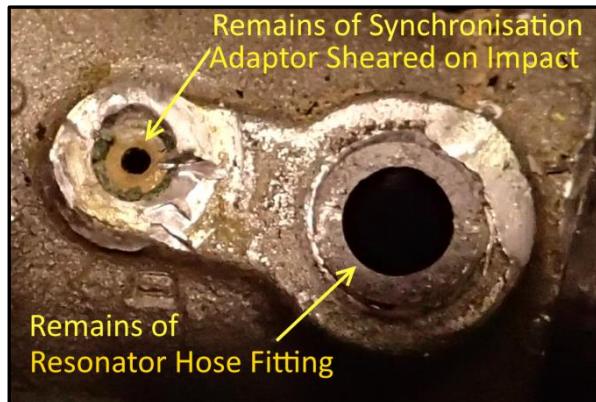
On examination of the left intake manifold, it was found that the synchronisation adaptor had sheared; the threaded portion was in place in the tapped hole in the intake manifold and the remainder was found within the engine compartment. In addition, the resonator hose fitting was found sheared (**Photos No. 3 & 4**).

Photo No. 3: Top of Left Intake Manifold

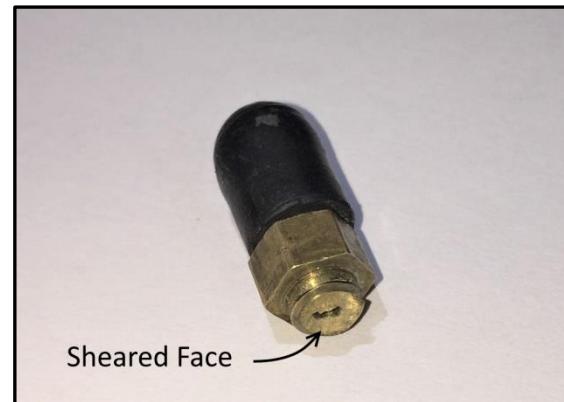
Photo No. 4: Left Synchronisation Adaptor

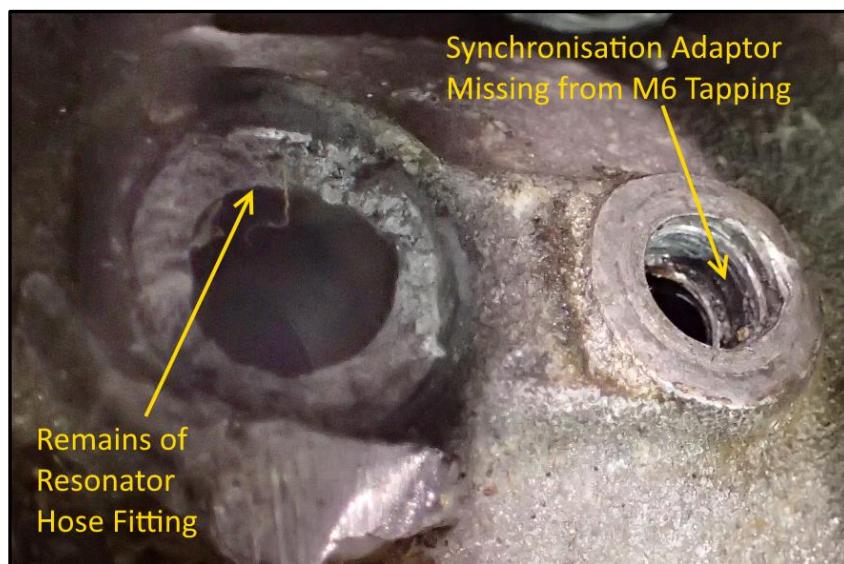
On examination of the right intake manifold, it was found that threads in the tapped hole of the intake manifold were stripped, and the right synchronisation adaptor was missing (**Photo No. 5**). The right resonator hose fitting had sheared due to the impact.

Photo No. 5: Top of Right Intake Manifold showing M6 Tapped hole for Right Synchronisation Adaptor

The presence of the open M6 tapping in the right manifold would allow additional air to enter the manifold downstream of the carburettor, thus leaning the fuel/air mixture ratio to engine cylinders one and three.

It is possible that, over time, with normal engine vibration experienced during engine operation, the right carburettor synchronisation adaptor had been forced out of the M6 tapped hole, allowing a small amount of additional air to enter the intake manifold. As previously stated, this would account for the evidence of a lean mixture being burned in cylinders one and three.

The Investigation believes that a side-load exerted by a fuel hose, on the carburettor synchronisation adaptor fitted to the right intake manifold of the subject engine, may have, over time, caused it to become loose and detach from the intake manifold.

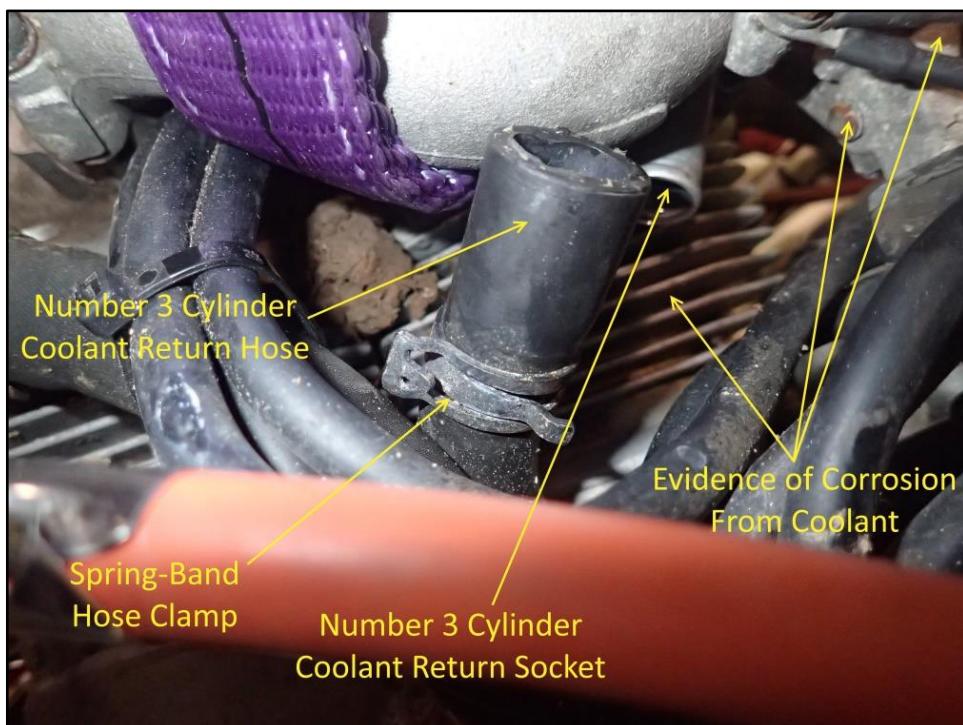
During examination of the engine it was found that the number three cylinder coolant return hose had detached from its corresponding cylinder head coolant return socket (**Photo No. 6**).

Photo No. 6: Number three Cylinder Coolant Return Hose Found Detached.
(Note: Purple strap is not part of engine)

Examination of witness marks on the number three cylinder coolant return hose showed that the spring-band hose clamp had not been secured at the end of the hose that fits over the cylinder coolant return socket at number three cylinder. The hose was removed from the engine for further examination (**Photo No. 7**). With both spring-band hose clamps removed, witness marks indicated that the clamp at the coolant expansion tank end of the hose had been correctly fitted. However, witness marks at the end of the hose normally attached to the number three cylinder coolant return socket indicated that this particular clamp had not been fitted in the correct location to ensure secure attachment of hose and cylinder head coolant return socket.

During examination of the number three coolant return hose it was found that the spring-band hose clamp had not been fitted in the correct location to ensure secure attachment of the hose and cylinder head coolant return socket. It was also noted that during a visual inspection of this area of the engine it was possible to miss this unsecured hose. During the Draft Final Report comment process, the Engine Manufacturer informed the Investigation that it had taken the following Safety Action:

The evidence of some corrosion in the vicinity of the number three coolant return hose indicates that during the time it had been installed, the hose had likely lost some of its elasticity, and without its spring-band hose clamp in place, coolant was beginning to escape from around the unclamped end of the hose. Whilst the amounts may have been quite small initially, it is possible that coolant loss had increased in the days prior to the accident. This would account for the need to top up the coolant in the system prior to the accident.

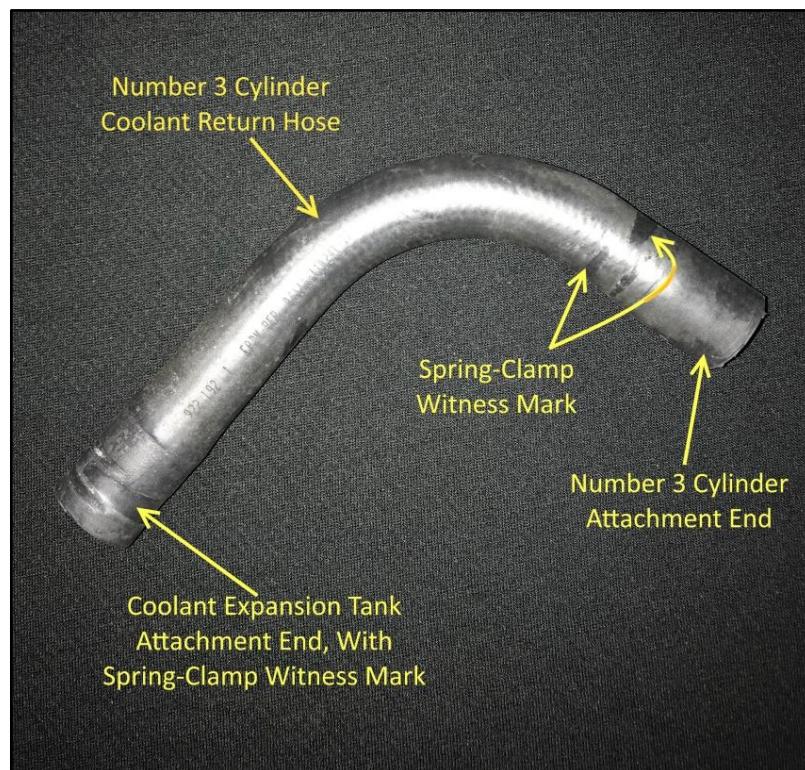
There were also signs of corrosion to some components in the immediate vicinity of the number three coolant return hose. The signs of corrosion were confined to this area of the engine only.

Photo No. 7: Number three Cylinder Coolant Return Hose

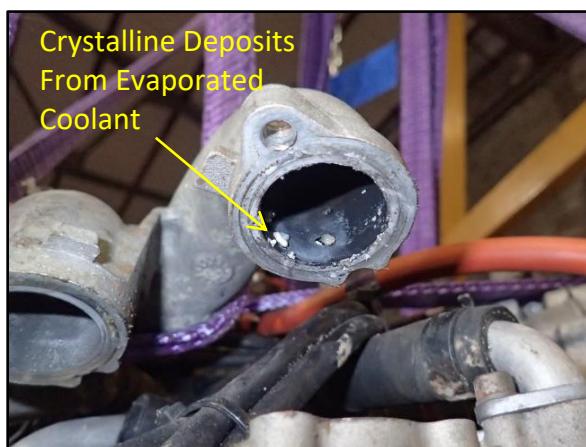
The right air intake manifold was removed from the top of engine cylinders one and three. The internal surfaces of the manifold and air intake flange were examined and this revealed evidence of liquid having entered the intake manifold during engine operation. The liquid had subsequently evaporated due to engine temperatures, leaving a crystalline deposit on the internal surfaces of the manifold and engine cylinder air intake flange, consistent with evaporated coolant liquid (**Photo No. 8** and **Photo No. 9**).

Photo No. 8: Right Manifold

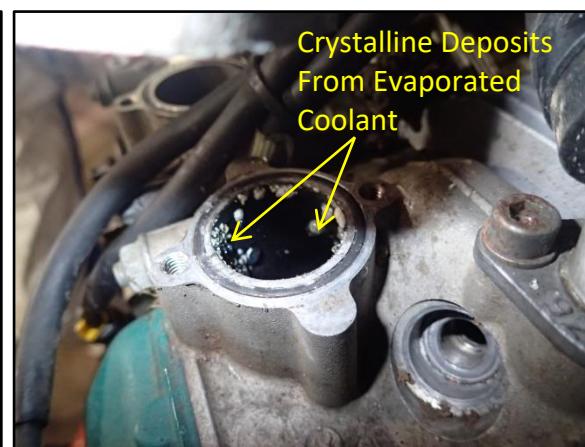
Photo No. 9: Number Three Cylinder Air Intake Flange

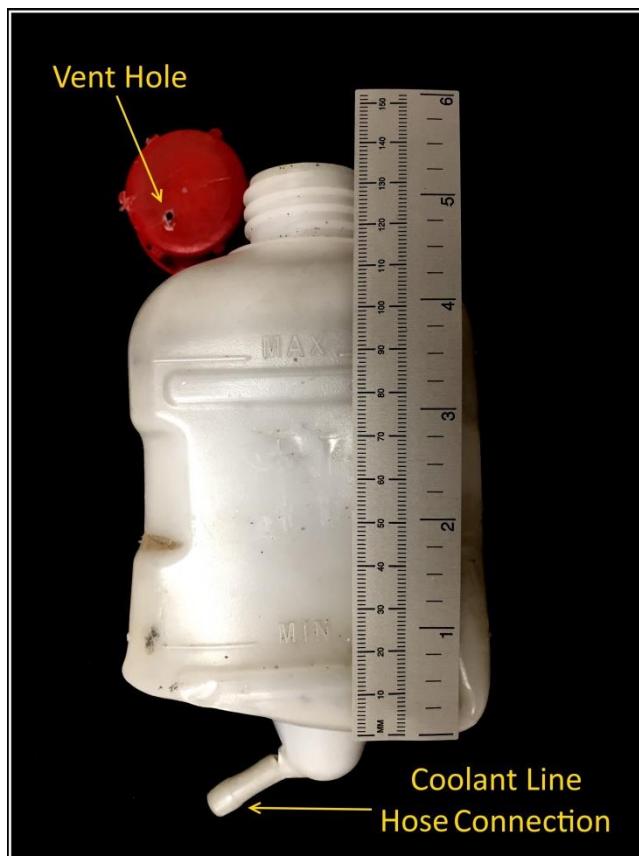
The coolant overflow bottle was examined and it was determined that it had sustained some damage due to rearward displacement of the engine during the accident sequence (**Photo No. 10**).

Photo No. 10: Coolant Overflow Bottle from Subject Aircraft

Note the vent hole in the red bottle cap. This was measured and found to be 2.2 mm. The entire volume of the overflow bottle was determined to be 700 ml.

The air vent-hole in the overflow bottle filler cap is quite small and is present to allow the air pressure within the bottle to equalise with atmospheric pressure. It is likely that the excess fluid, due to the unserviceable expansion tank pressure cap, could not escape from the bottle's air vent-hole fast enough. Consequently, a back-pressure would have built up within the coolant system. This back-pressure likely caused the unsecured coolant return hose to separate from the number three cylinder head coolant return socket, allowing coolant to spray over the number three cylinder and right intake manifold, where an induction leak was present.

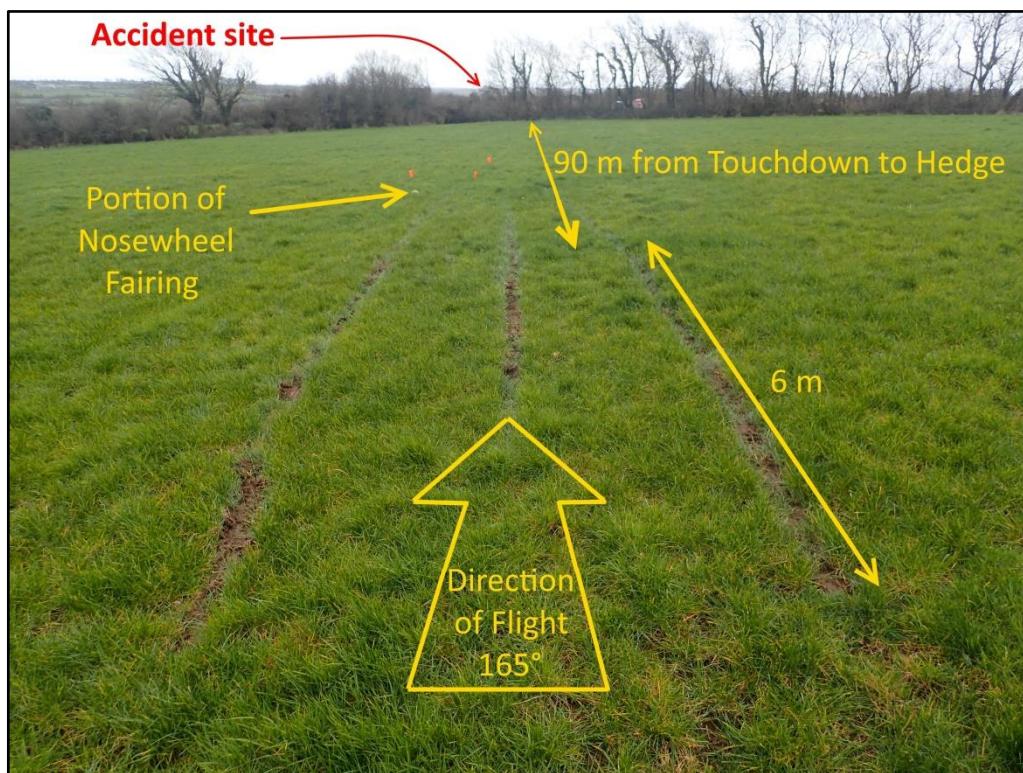
The main aircraft wreckage was located in a small agricultural field, 0.6 NM north-northwest of the threshold of EIWF RWY 21. In an adjacent large field, to the north of the main wreckage site, the Investigation found witness marks from the three aircraft wheels. The marks were a distance of 90 m from the boundary hedge between the two fields, and 130 m from the main wreckage (**Photo No. 11**). A small portion of the fibreglass fairing from the aircraft nose wheel was also found at this location.

Photo No. 11: Initial touchdown point during forced landing

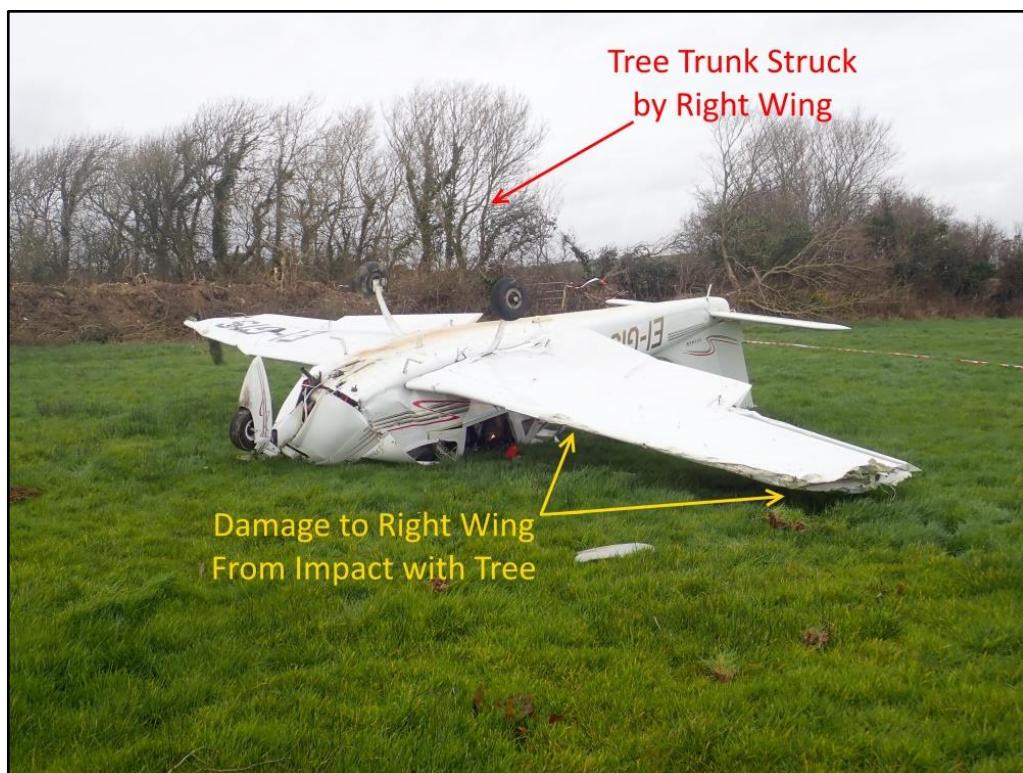
The main wreckage site was located 40 m beyond the boundary hedge, and contained all major parts of the aircraft. The aircraft was found inverted (**Photo No. 12**).

Photo No. 12: Final position of aircraft

- Outer half of the right wing leading edge and the wingtip damaged by impact with tree.
- Nose area of aircraft including the engine, was rotated up, and to the left of the aircraft's fore/aft axis, due impact with the ground.
- Left wingtip damage due impact with the ground.
- Upper frame of cockpit canopy crushed due impact with the ground.
