Air Accident Investigation Unit Ireland

FACTUAL REPORT

ACCIDENT
Solar Wings Pegasus XL-R, G-MNBI
Rathcash East, Co. Kilkenny

AAIU Report No: 2020-006

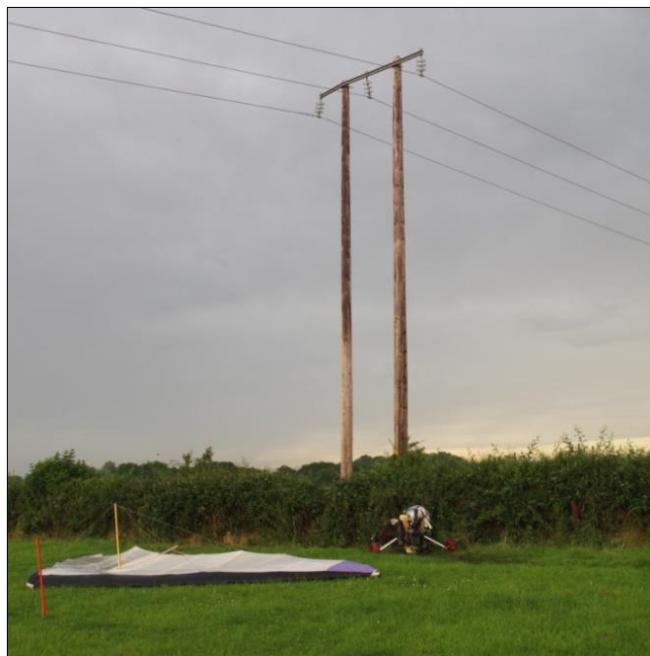
The Pilot had flown the microlight earlier that day and reported no problems when he spoke with the registered owner later by phone. That flight, which lasted approximately 15 minutes, took place between 16.00 hrs and 16.30 hrs. The microlight, which was kept fully rigged, had been removed from the hangar earlier that day to allow the space to be used for a family function and was positioned on the airstrip near the windsock. Later that evening, the Pilot decided to fly the microlight again. It was reported that the microlight was airborne for three to four minutes before the collision occurred. Witnesses reported that the Pilot was manoeuvring at low level to the north of the R702 road before proceeding in the direction of the hangar. The microlight was observed pitching and banking somewhat erratically before turning and colliding with one of two poles supporting high-voltage power lines. The engine noise was heard to decrease before impact. Following the collision, the microlight fell to the ground adjacent to a hedgerow in which the poles were situated (**Photo No. 1**). The Pilot was fatally injured in the accident. There was no fire.

Photo No. 1: Power lines, supporting poles and disposition of wreckage

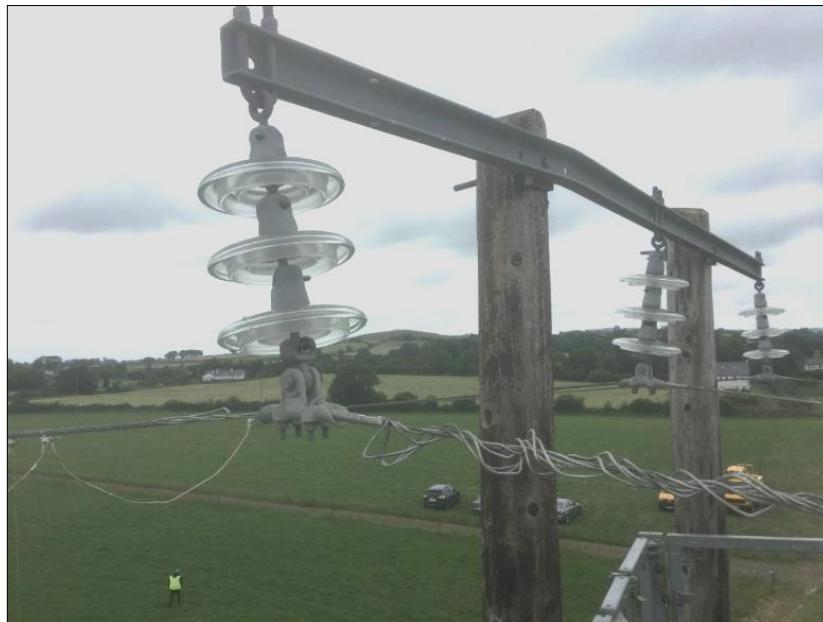
The impact occurred with the southern-most pole, causing a deflection of the pole structure resulting in the '*stranding*'⁵ of the nearest electrical conductor and deformation of the cross beam (**Photo No. 2**).

Photo No. 2: Damage to line and cross beam

Subsequent commissioning tests by the electricity network provider showed that no fault occurred on the Kilkenny-Goresbridge 38 kV circuit, nor did the overhead line trip.

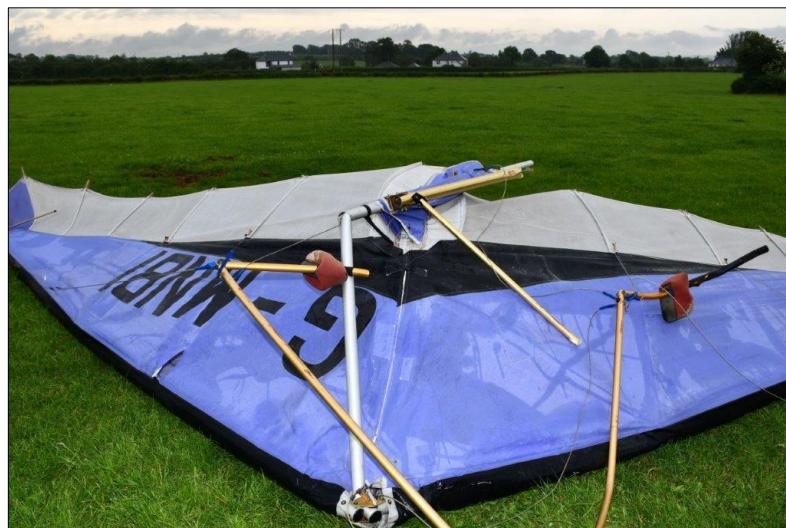
The wing and trike were initially located together. The first responders to the accident lifted the wing and placed it aside in order to gain access to the Pilot who was lying on the ground beside the trike. The Investigation found the wing a few metres away from the trike unit, in an upright position but with fracture of control-frame components (**Photo No. 3**).

Photo No. 3: Under-side of wing, showing fracture of control-frame components

There was some tearing damage found in areas of the sail covering and impact damage was evident to the leading edge. The control bar and associated tubing showed significant distortion through compression and fracture. The main fore-aft tubular component was compressed and fractured. The entire wing structure exhibited distortion.

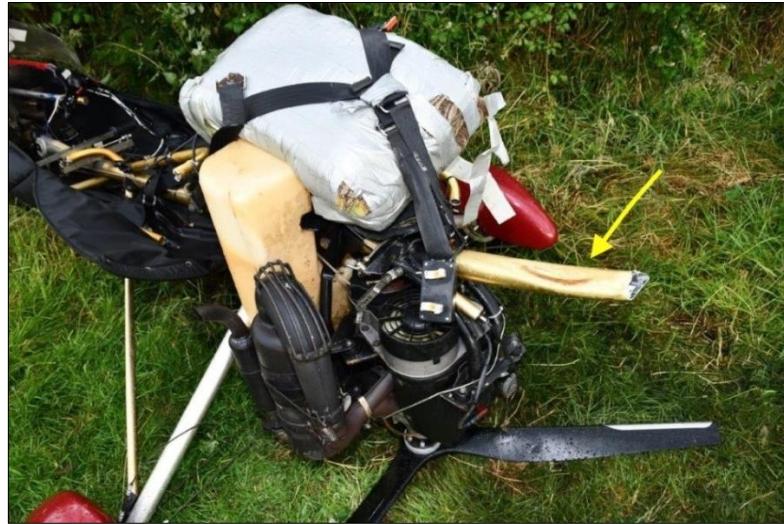
The vertical support post was distorted in compression and had fractured, separating the entire wing structure and control bar from the trike. Following the fracture, the engine and fuel tank, which were attached to the support post, rotated downwards about the remaining lower pivot point of the post (**Photo No. 4**).

Photo No. 4: Vertical support post with evidence of buckling and fracture

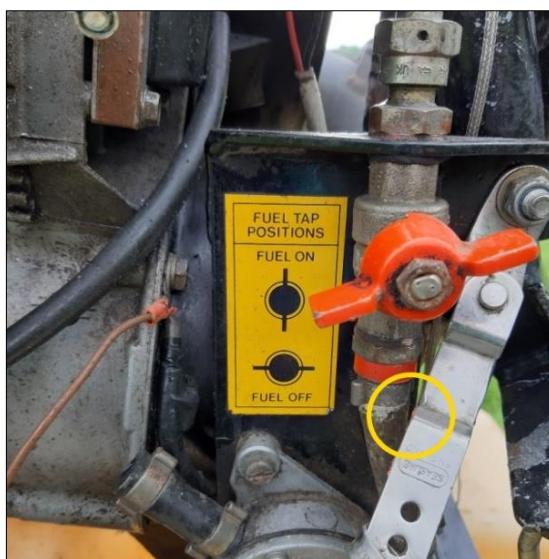
The fuel tank, situated under the engine, had been distorted during impact with the ground. The plastic fuel filler cap was dislodged resulting in the majority of the fuel tank's contents spilling onto the ground. A small amount of fuel remained in the tank, which was recovered by the Investigation for subsequent testing. The spilled fuel stained a significant area of the grass to the rear of the tank. The fuel shut-off tap, (**Photo. No. 5**), located on the right-hand side of the engine, was noted to be in an intermediate position (between 'FUEL-ON' and 'FUEL-OFF').

Photo No. 5: Fuel tap as found in intermediate position (red paint transfer indicated)

The Investigation is satisfied that the position of the fuel tap on the right-hand side of the engine, which was found in an intermediate position, was not causal to the accident. Paint transfer on the bracket indicates that the fuel tap was most likely moved from its normal 'ON' position by contact from the adjacent steel bracket due to distortion of the microlight structure under impact forces.

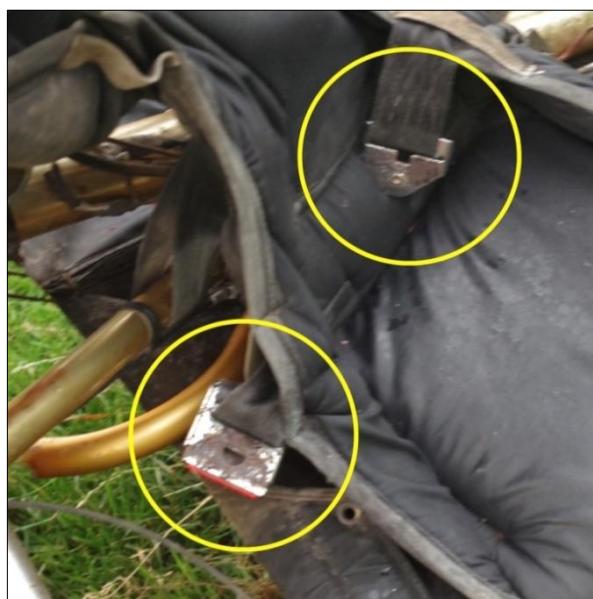
The Pilot was located on the ground lying face down by the first persons at the scene. He was not wearing a helmet – according to family members he normally did so. The microlight was equipped with a two-point lap-belt in the forward seating position and a four-point harness in the rear. The Pilot occupied the forward position, the position from which solo flight must be conducted. The rear seat had a soft, tape-wrapped package installed for the purposes of a backrest and the rear harness was latched and secured. The front lap-belt, which was used by the Pilot, was found in the open (unlatched) position and there was no evidence that the belt was opened by any person at the accident site prior to its inspection by the AAIU. When examined on site, the lap-belt was found to close and latch. Subsequent examination showed that the mechanism could open with force applied against the rear of the latching mechanism. Both the front and rear seat latching mechanisms exhibited significant corrosion and wear (**Photo No. 6**).

Photo No. 6: Front seat lap-belt ends (indicated) exhibited significant corrosion of the latching mechanism

The microlight's front seat, occupied by the Pilot, was equipped with a two-point lap-belt. This was found open at the accident site and the lap-belt latching mechanism was found to be significantly corroded. Lap-belt designs provide limited protection in the event of a collision as there is no upper-body restraint. The forces experienced in the collision were significant and it is likely that the latching mechanism opened under these loads at impact thus failing to secure the Pilot. The fact that the latching mechanism exhibited significant corrosion may have contributed to the opening of the lap-belt.
