Air Accident Investigation Unit Ireland

SYNOPTIC REPORT

ACCIDENT
Piper PA-28R-180, G-FBWH
Sligo Airport

5 August 2018

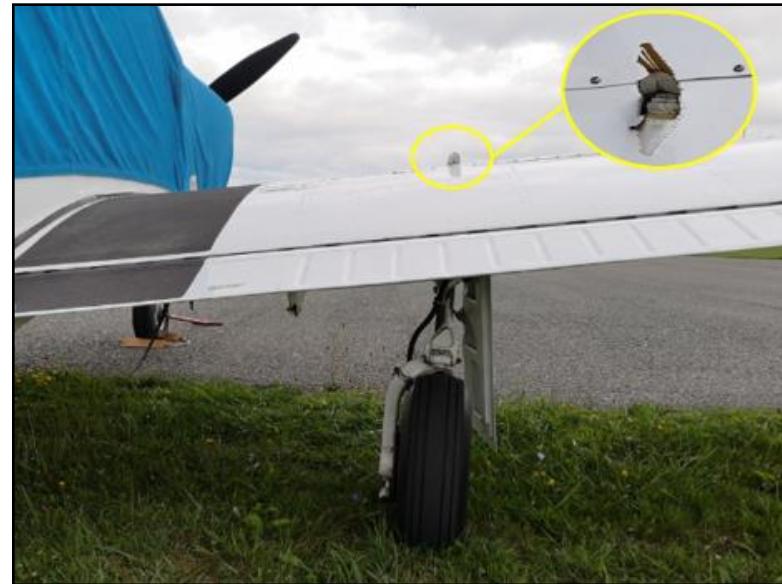
The right-hand main undercarriage assembly sustained considerable damage during the occurrence. The right-hand wing was punctured as a result of the top of the right-hand undercarriage shock strut coming through from beneath (**Photo No. 2**). The right-hand undercarriage door was damaged beyond repair and a significant amount of the associated undercarriage hardware was also damaged and required replacement.

Photo No. 2: Top of undercarriage strut protruding through the wing surface

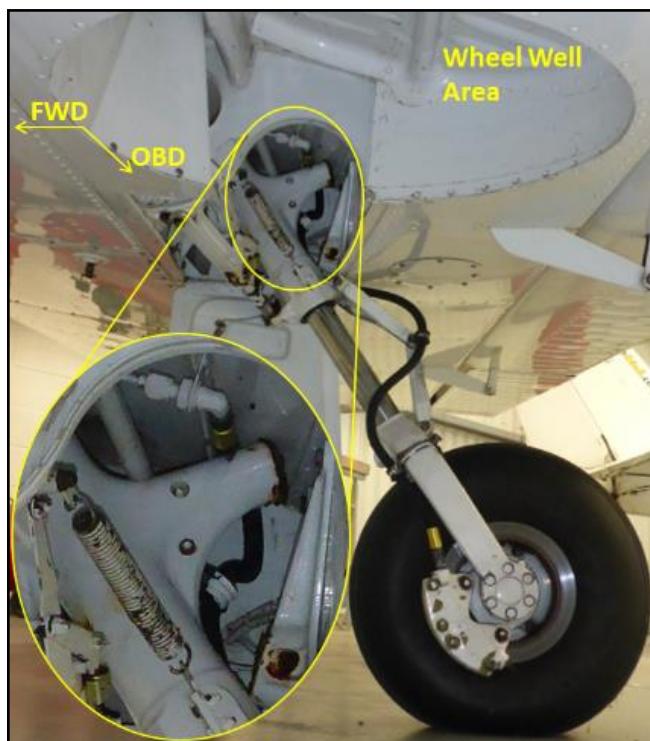
A photograph (**Photo No. 3**) taken at a local maintenance facility in EISG following the occurrence shows the underside of the aircraft looking outboard (OBD) and captures the undercarriage position post-incident. The aft undercarriage housing (ringed in yellow) was found to have detached from its aft support fitting.

Photo No. 3: Right-hand undercarriage position post-occurrence

During the rollout from the landing at EISG, as the weight of the aircraft acted on the undercarriage, the lower part of the right-hand side main shock strut moved rearwards as it was unsecured in the longitudinal direction due to the absence of the retainer tube. Pivoting about the forward support fitting, the top of the undercarriage strut moved forward and up through the skin of the upper wing (refer to **Photo No. 3** and **Photo No. 8**).

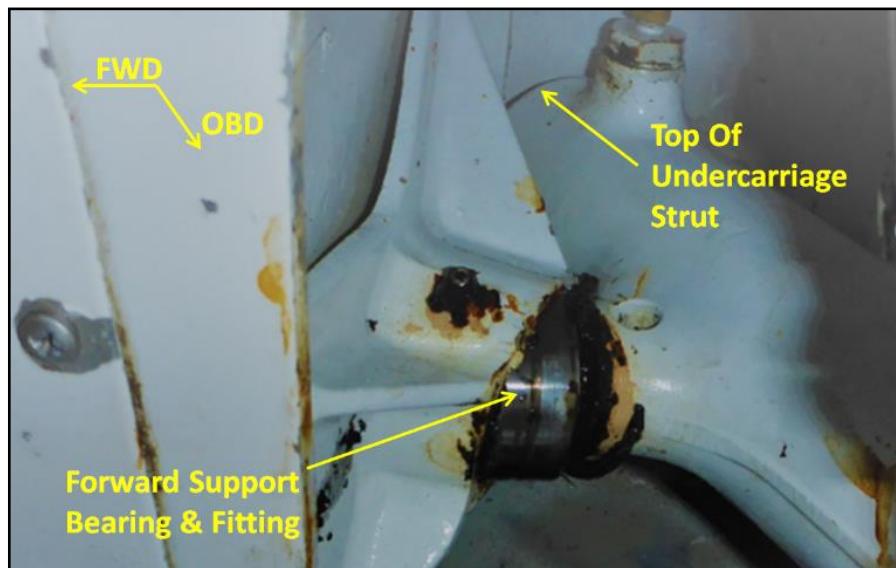
The forward support fitting, although significantly damaged (**Photo No. 4**) remained partially attached and prevented the total collapse of the right-hand undercarriage.

Photo No. 4: Forward support fitting damage

14. The right forward support fitting, although significantly damaged from the occurrence, remained sufficiently connected to the aircraft, which prevented the total collapse of the right-hand undercarriage.

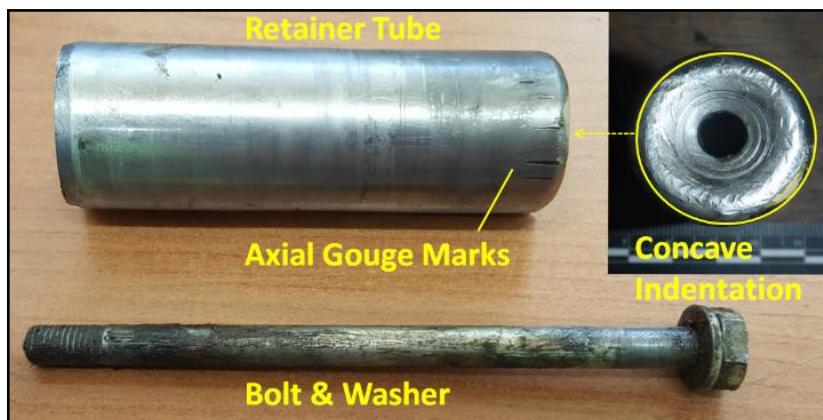
On inspection of the right-hand undercarriage installation, the retainer tube and its attachment bolt and washer, (**Photo No. 5**), were noted to be missing from their installed locations and were found loose within the right-hand wing space adjacent to the undercarriage attachment area. The bolt had evidence of old grease on the shank and threads. The surface of the retainer tube had a number of axial gouge marks about its circumference at the bearing end of the tube, which were found to be 9 mm in length. The end face of the retainer tube exhibited a distinct concave indentation damage signature.

Photo No. 5: Retainer tube and attachment bolt & washer found in right-hand wing space

The attachment bolt was accompanied by a washer as shown in **Photo No. 5**. The washer, 1.7 mm in thickness, displayed a concave distortion similar to that observed on the face of the retainer tube. The aircraft Service Manual does not show the inclusion of a washer between the retainer tube and the attachment bolt. The Aircraft Manufacturer informed the Investigation that it had:

The attachment bolt and washer found in the wing space following the occurrence had evidence of old grease on the shank and threads, indicating that it had not been tightened into the barrel nut for a considerable, but indeterminate, period of time.

Examination of the attachment bolt, found loose within the right wing, showed evidence of aged grease on the shank and threads, indicating that it had not been tightened into the barrel nut for a considerable but indeterminate period of time. The incorrect installed position of the retainer tube, combined with the addition of a washer on the tube's attachment bolt, reduced the effective grip length of the attachment bolt and the overall security of the installation. The washer was found to display the same concave distortion as that witnessed on the retainer tube face.

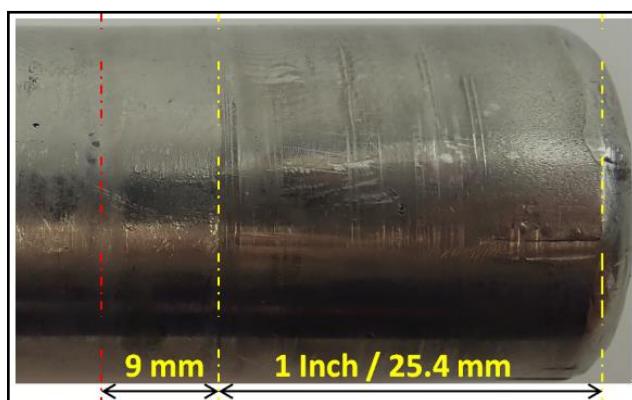
The retainer tube displayed two distinct wear patterns which indicate that the retainer tube had been fitted in two distinct positions over its operating lifetime. The spherical bearing has a nominal width of 1 inch / 25.4 mm and this wear pattern was clearly visible. An additional wear line was evident and located approximately 9 mm forward of the normal spherical bearing position. A close-up photo of the retainer tube showing these two wear marks is presented in **Photo No. 6**.

Photo No. 6: Retainer tube wear pattern

When correctly installed and secured with the retainer bolt, the retainer tube should be secured within the undercarriage strut housing and aft support fitting bearing in one position only. However, a detailed examination of the retainer tube to bearing contact surface identified a wear pattern, which indicates that the retainer tube had been fitted in at least two distinct positions over its operating lifetime – one correct, and one incorrect. The contact surface for the correct position displayed a heavier wear pattern than for the incorrect position.

In addition, the wear pattern on the retainer tube surface that had been in contact with the bearing suggests that, while the retainer tube had been incorrectly located, the undercarriage had been cycled over an indeterminate period of time. Therefore, at some point during its operating life, the retainer tube had not been secured in the correct position by its attachment bolt. The measured difference in the seating of the retainer tube between correct installation and incorrect installation was approximately 9 mm. This was also the length of the axial gouge marks on the retainer tube.

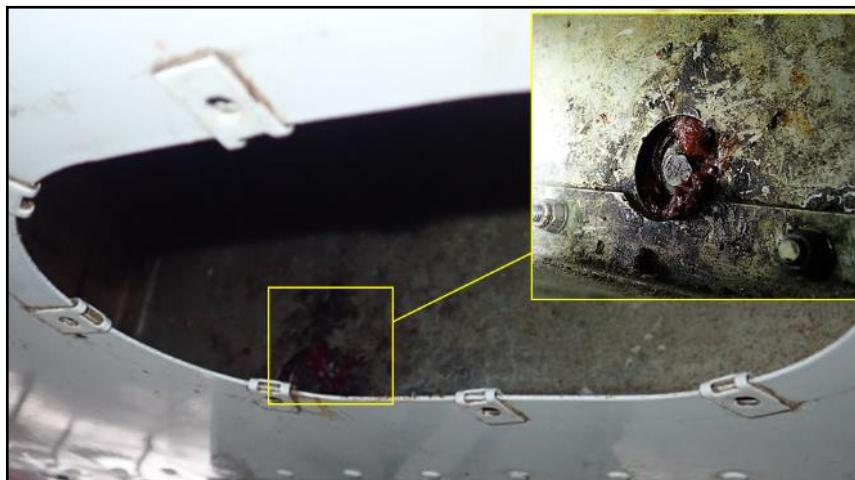
The right-hand wing space is accessed by removing an access panel on the underside of the wing. This access opening is used for the installation, removal and inspection of the bolt and retainer tube during maintenance (**Photo No. 7**).

It is possible for servicing grease applied to the aft support bearing (**Photo No. 7** inset) to obscure the head of the bolt and end face of the retainer tube. Section II of the aircraft's Servicing Manual, *Handling and Servicing*, paragraph 2-8b *Torque Requirements*, step *d*, instructs the maintainer as follows:

Photo No. 7: Under-wing access panel (L/H side shown)

A visual inspection of the attachment point is through an inspection hole on the underside of the wing, and although the retainer tube and bolt would protrude from the aft fitting when incorrectly located, the exact position may be obscured by servicing grease. In addition, there is no requirement to torque check the undercarriage attachment bolts as part of the recommended maintenance schedule. The Investigation asked the Aircraft Manufacturer if there is a requirement to perform a scheduled torque check on the landing gear attachment bolts after initial installation. The Aircraft Manufacturer referred to the aircraft Service Manual, Section II, paragraph 2-8b, step d, Torque Requirements, which instructs the maintainer as follows:

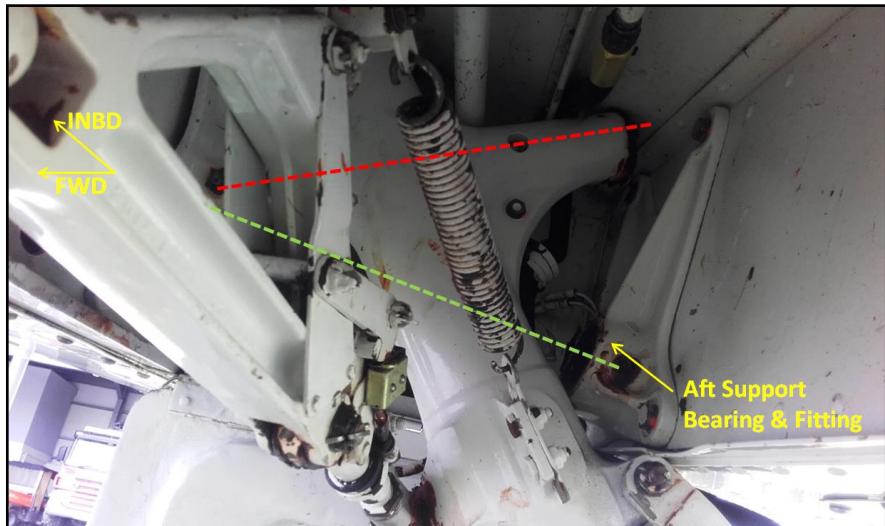
Relative movement between the correct position and the subsequent position after the occurrence is illustrated in **Photo No. 8**. The dotted red line indicates the position of the undercarriage aft attachment fitting after the partial collapse. The dotted green line indicates the location of the attachment fitting and axis of rotation of the retainer tube as normally installed and secured to the undercarriage aft attachment fitting.

Photo No. 8: Relative movement during partial collapse

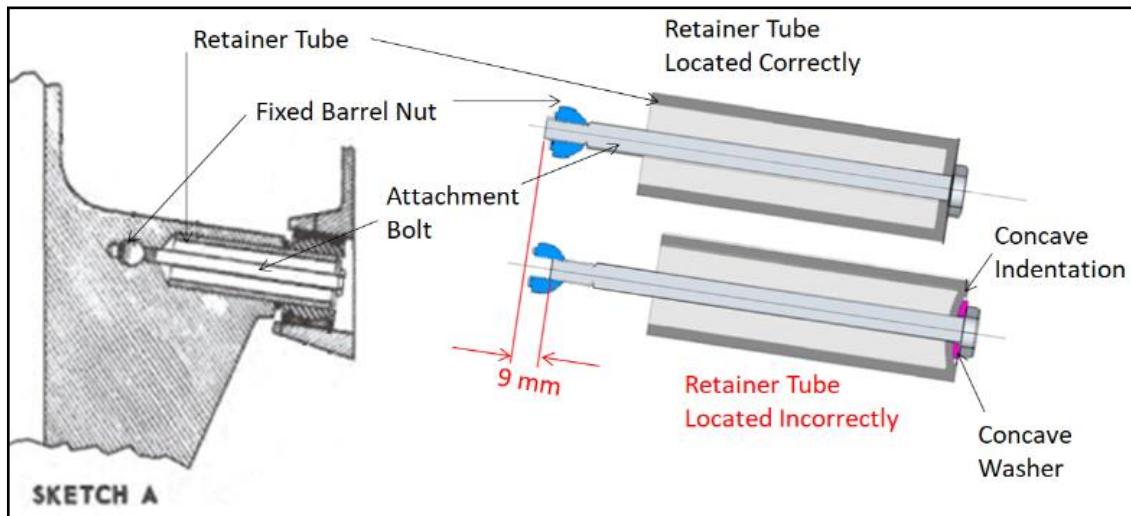
For reference purposes, **Figure No. 2** represents a 9 mm shift in the position of the retainer tube and associated attachment bolt. Refer also to **Figure No. 1** for additional orientation.

Figure No. 2: Consequence of a 9 mm shift in location of retainer tube
(Refer also to **Figure No. 1**)

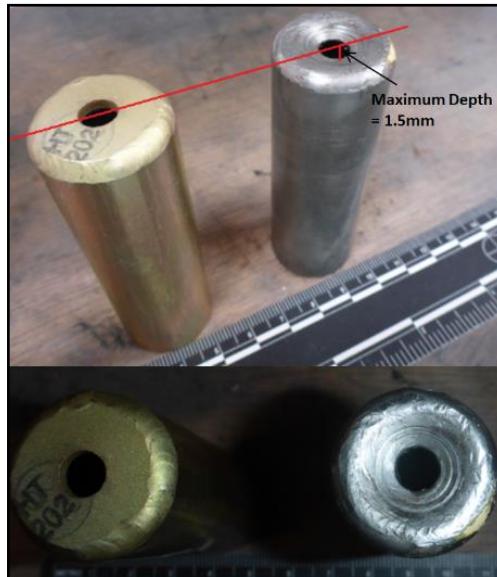
In addition to the wear marks (highlighted in **Photo No. 6**), the retainer tube had sustained damage to two distinct areas: axial gouge marks (highlighted in **Photo No. 5**) and concave distortion on its face, (**Photo No. 9**). The damage noted on the face and body of the retainer tube suggests that, at some point during the insertion of the retainer tube into the aft support fitting, and onward into the landing gear housing, it had been installed incorrectly and with considerable force.

The axial gouge marks are approximately 9 mm in length, which is approximately the extent by which the retainer tube was misaligned within the spherical bearing as evidenced by the wear pattern on the retainer tube. The concave distortion, of 1.5 mm at its maximum, on the face of the retainer tube, was found to be consistent with the concave distortion of the washer which was used with the attachment bolt. There is no requirement for a washer to be installed in this area.

The gouging and distortion damage may indicate that, during a previous landing gear installation, the retainer tube and the bolt-washer-barrel nut combination were used in an attempt to pull the retainer tube into place in order to overcome any resistance experienced by either a tight fit or pre-existing axial gouging.

Photo No. 9: New retainer tube (gold-coloured) and old retainer tube
