REPORT ON THE ACCIDENT TO

SIKORSKY S-76B G-HAUG

AT OMEATH, CO. LOUTH

AIRCRAFT ACCIDENT REPORT 01/98

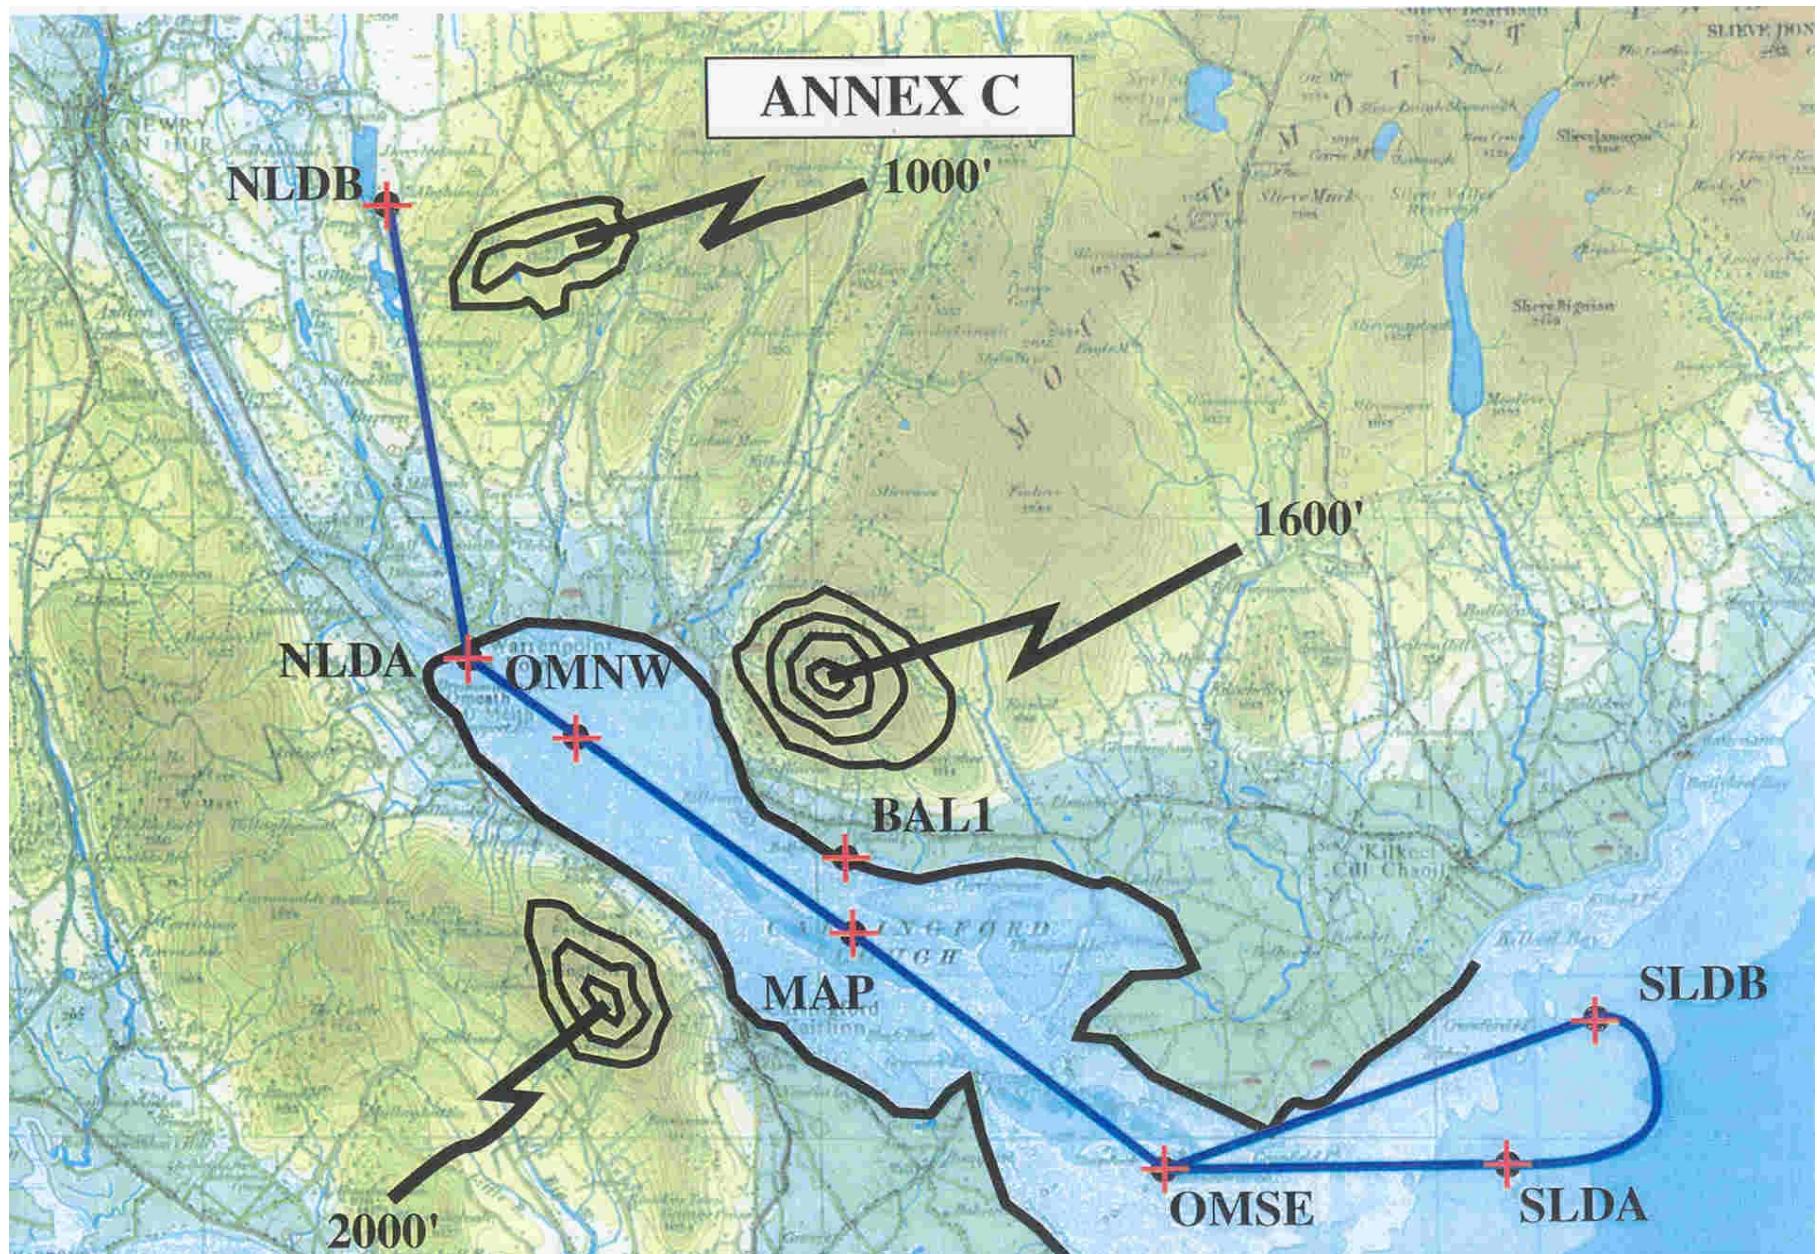
ANNEX C

In the wreckage, a sketch of an approach procedure was found. An enhanced reproduction of this sketch, overlaid on a map of the area, is shown in Annex C. Discussions with a previous Chief Pilot of the operation, and also with a frequent passenger in the aircraft, indicates that the original poor weather approach procedure was to fly at altitude to a waypoint SLDA which was 2.75 nm east of the Haulbowline lighthouse, using GPS, but cross checked by the VOR Station in the Isle of Man. The aircraft would descend in this area until visual contact was made with the sea.

This annex shows an enhanced copy of the approach procedure to Ballyedmond found in the wreckage of G-HAUG. The original measured 10 cm by 8 cm and was drawn in a plain lined paper note book. The note book also contained several pages of waypoints used in the operation. In this copy, the contents of the original sketch are shown in a heavy outline, and the sketch has been superimposed on an Ordnance Survey map, with a scale of 1/2" : 1 mile, to assist the reader.

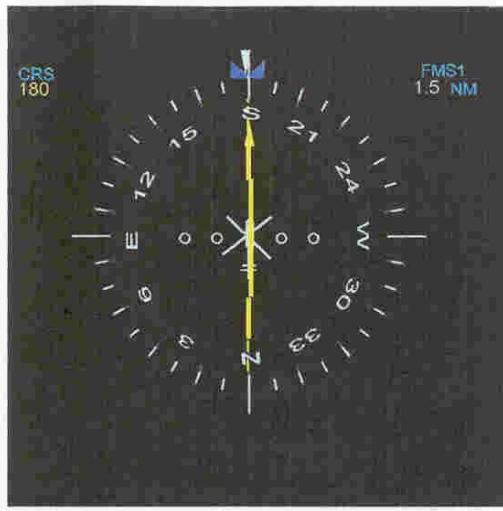
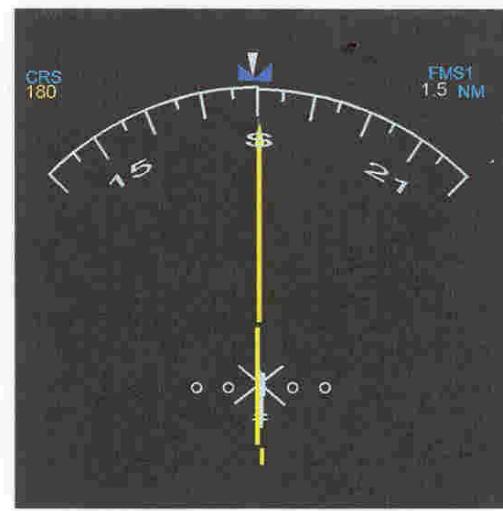
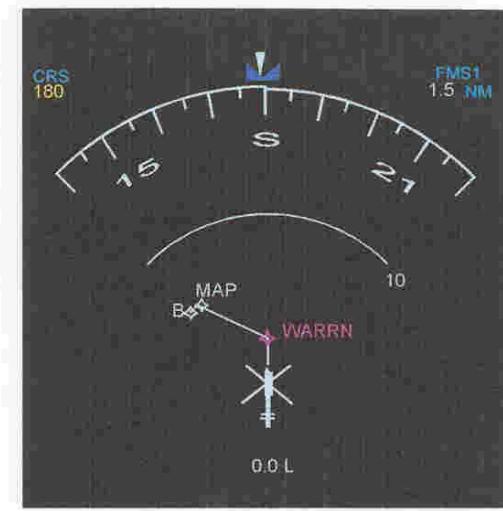
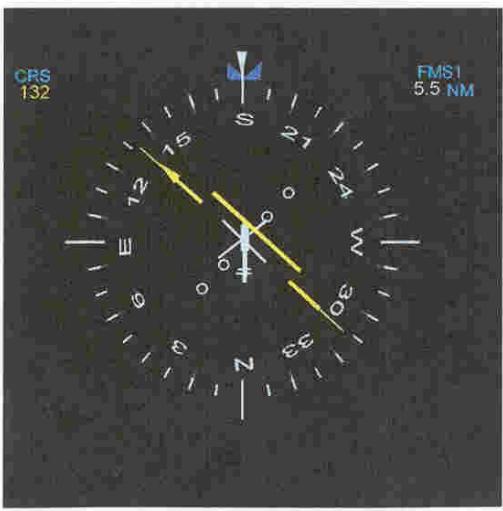
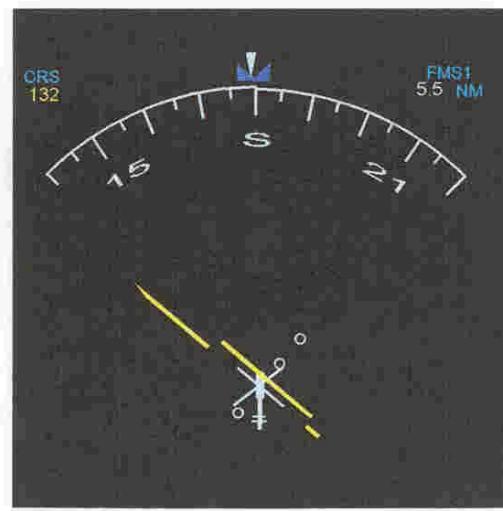
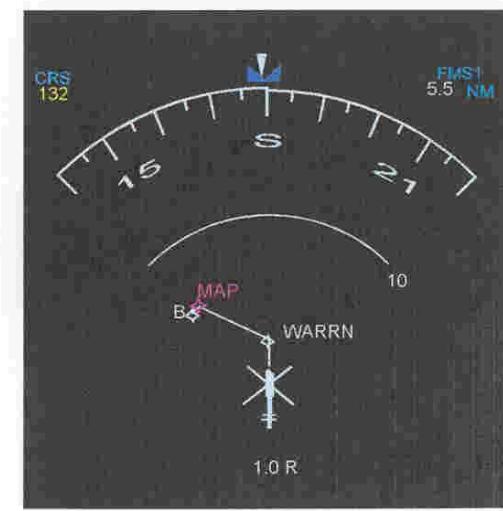
FIG 1

The small degree of change in the display after the anticipated turn point, especially after passing WARRN, would not give a strong visual clue to a pilot, especially one unfamiliar with the area, that significant and potentially dangerous deviation off track was in train.
