# FINAL REPORT

**AAIU Synoptic Report No:2005-006**

<b>Aircraft Type and Registration:</b>	Boeing 737-500, EI-CDE
<b>No. and Type of Engines:</b>	2 x CFM56-3-B1
<b>Aircraft Serial Number:</b>	25115
<b>Year of Manufacture:</b>	1991
<b>Date and Time (UTC):</b>	8 Sept 2003 @ 18.04 hrs
<b>Persons on Board</b>	Crew - 6      Passengers - 19
<b>Injuries:</b>	Crew - Nil      Passengers - Nil
<b>Location:</b>	On landing at Cork Airport
<b>Type of Flight:</b>	Scheduled Public Transport
<b>Nature of Damage:</b>	LH main landing gear trunnion pin sheared
<b>Commander's Licence:</b>	Not applicable
<b>Commander's Details:</b>	Not applicable
<b>Commander's Flying Experience:</b>	Not applicable
<b>Information Source:</b>	Aer Lingus Safety Office AAIU Investigation

## **SYNOPSIS**

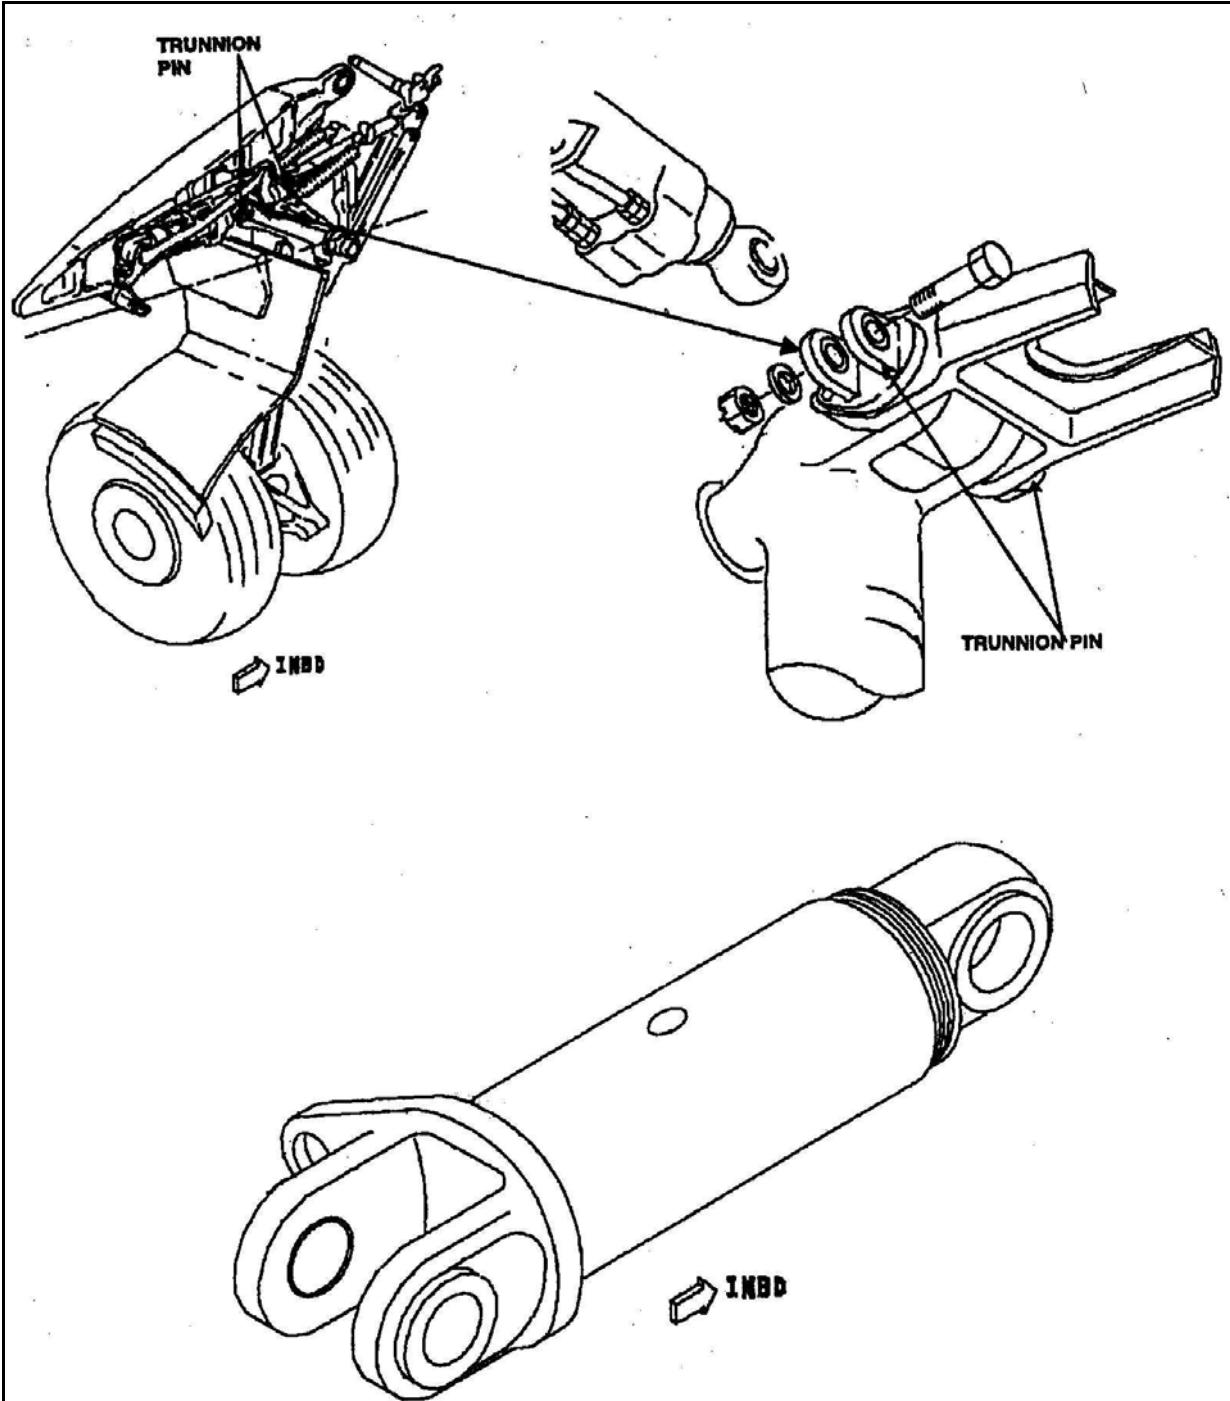
Figure 1. Illustration Showing a Trunnion Pin in the 737 Left Main Landing Gear  
(Right Main Landing Gear Opposite)

The LH MLG trunnion pin Part No. 65-46113-20, Serial No. AT067 failed at the outboard end at the MLG actuator attachment point (**APPENDIX A**).

*The pin was fractured at the transition radius between the shaft and retract flange (APPENDIX A). The surfaces of the pin at and near the fracture were heavily oxidized and corroded and much of the chrome plating in these areas was missing. Due to experience with similar trunnion pin fractures in the past where the corrosion inhibiting compound JC5A has been implicated in accelerating the corrosion process, a chemical analysis was performed on deposits taken from the transition radius as well as nearby locations. There was no indication that JC5A was present.*

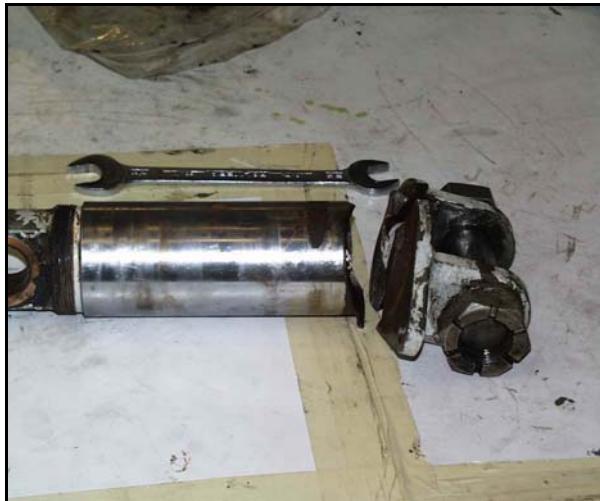
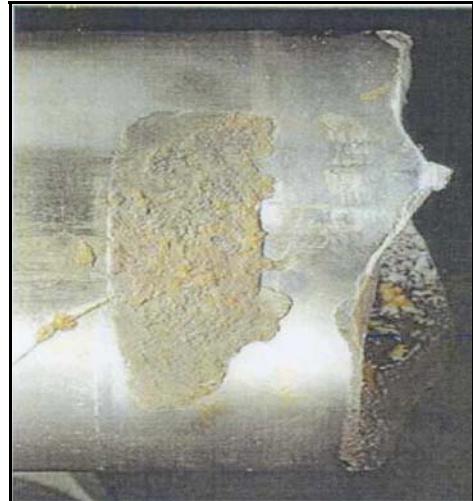
*The primary fracture origin as well as the two other secondary fracture origins are located in or adjacent to the transition radius where much of the chrome plating was missing. The severity and number of through-thickness cracks in the plating (APPENDIX C) indicates poor quality and adhesion characteristics. Additionally, the thickness of the plating is approximately 0.013 inches. Even though the design drawing specification allows for 0.003 inches minimum for the chrome plating, the 0.013 inch layer indicates that the pin might have been reworked or overhauled.*

The above photos show the fractured pin shaft on the left with a detail view of the detached plating on the right.

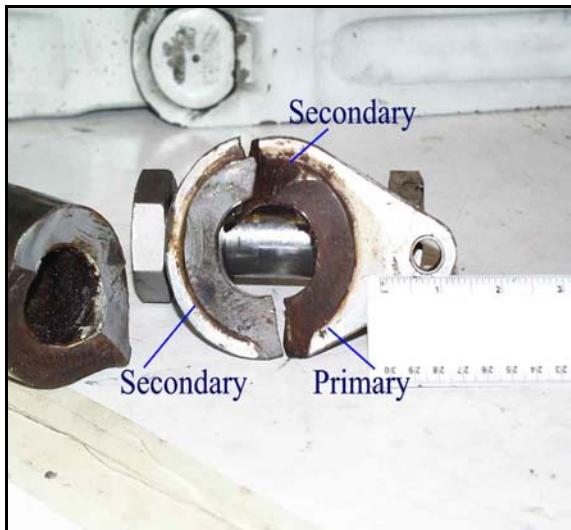
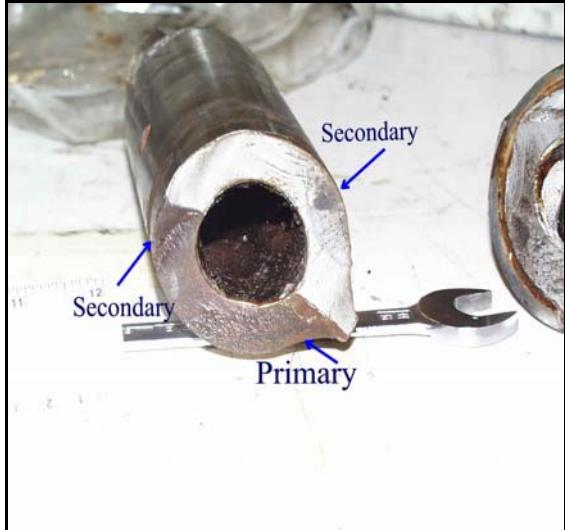
*The fracture surfaces on the separated retract flange section can be seen in (APPENDIX B). The fracture surfaces were cleaned in the laboratory due to the heavy oxidation and corrosion products. The fracture surfaces exhibit three separate planes of fracture propagation, which indicates three separate initiation or origin sites. Each fracture plane exhibits a blocky, rough thumbnail shaped region on the fracture surface emanating from the outer surface of the pin.*

*This surface morphology is consistent with stress corrosion cracking (SCC). All three fracture planes exhibit the flat grainy surface appearance with directional flow lines that are typical of final fracture in high strength steel beyond the SCC regions.*

The photo on the left shows the fracture surfaces on the retract flange sections of the pin. There were three Stress Corrosion Crack (SCC) origins and fields of propagation, which are denoted by the arrows. The photo on the right shows the corresponding fracture surface of the shaft section of the pin.

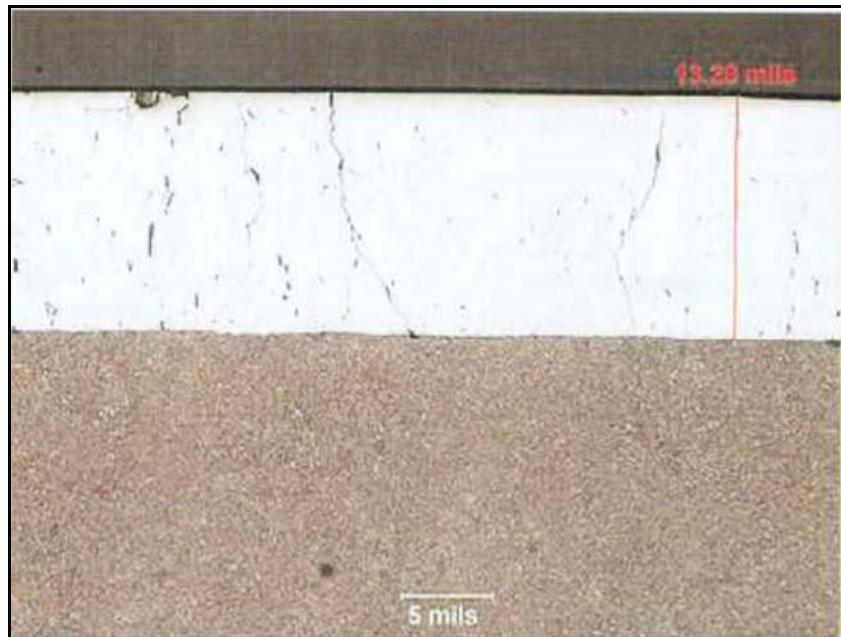
Cross section through the chrome plating showing the through-thickness cracks.  
**(Courtesy of The Boeing Company)**
