# Air Accident Investigation Unit Ireland

**SERIOUS INCIDENT REPORT**  
**Boeing 737-8F2, TC-JGG**  
**Airbus 319, D-AGWJ**  
**Dublin Airport, Co. Dublin**  
**16 October 2010**

AAIU Report No: 2011-019

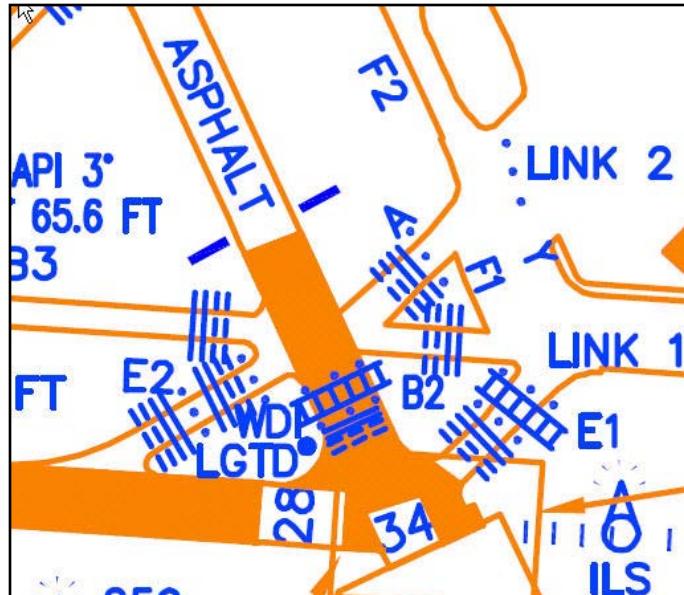
Figure No. 1: Portion of AIP Chart of Incident Area

**Figure No. 1** is an extract from the Aeronautical Information Publication (AIP) Ireland published by the Irish Aviation Authority (IAA), showing the taxiway/runway interface and holding positions at EIDW at the time when the occurrence took place.

It can be seen from **Figure No. 1** that the general layout in proximity to the thresholds of RWY 28 and RWY 34 is complex. It is unusual that a single taxiway (TWY E1) leads to the adjacent thresholds of two divergent runways, and that there is a combined runway-holding position on TWY E1. This combined holding position is noted as an incursion hotspot in AIP Ireland.

In these circumstances, the Investigation considers that the provision of a stopbar facility at the combined holding position of RWY 34 and RWY 28 Cat I on TWY E1 would provide an additional degree of protection against runway incursions at this location. This is in accordance with the guidance provided in ICAO Annex 14. A Safety Recommendation is issued to the DAA, in conjunction with the IAA (as the ATC service provider), in this regard.

The Investigation notes that stopbar lights were introduced into service at the combined holding position of RWY 34 and RWY 28 Cat I on TWY E1, and also at TWY B7 protecting RWY 10, on 25 October 2011. Further information is provided in Section 4 Safety Recommendations.

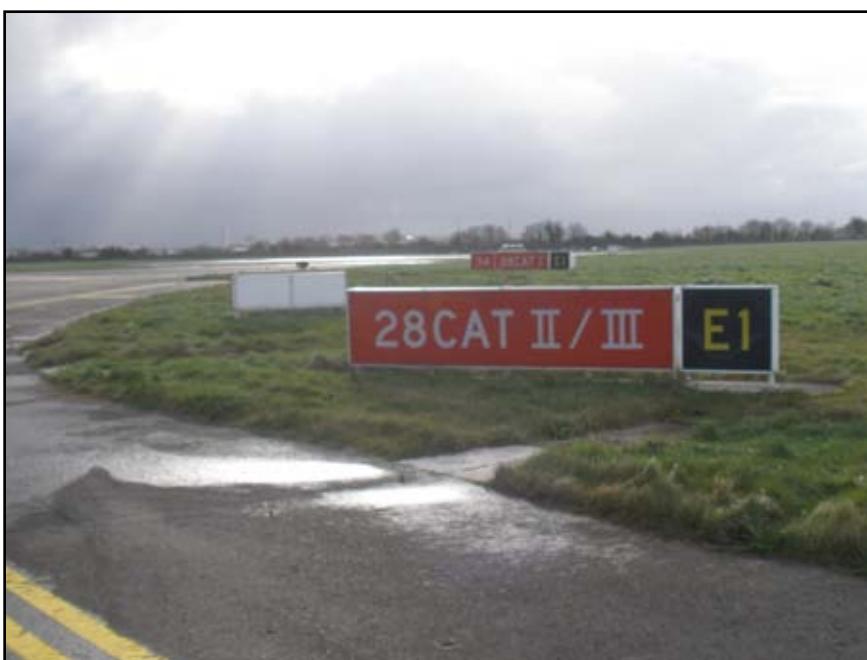
Photo No. 1: TWY E1 Cat II/III Holding Position for RWY 28

As an aircraft taxied along TWY E1 from TWY F1 towards the thresholds of RWY 28 and RWY 34, it first encountered the ILS Cat II/ III holding position for RWY 28. This was marked by runway designation/Cat II/III holding position signage in accordance with the requirements of ICAO Annex 14 - Aerodromes. These signs were located in the grass verges on both sides of TWY E1, and displayed "28 CAT II/III" in white against a red background, **Photo No. 1**. At the same point, there were two large rectangular signs painted on the taxiway surface, one on either side of the centreline, with "34 28" in white against a red background. These were immediately followed, in the direction of taxi, by double yellow lines painted across the taxiway, as per runway-holding position marking "Pattern B", as defined in ICAO Annex 14, see **Appendix C**.

This point was marked by ICAO standard signage on both sides of the taxiway and by painted signage on the taxiway surface. As this holding position was normally only active during low-visibility conditions, it was not in use at the time of the incident. Nevertheless the signage should have alerted the crew to the fact that they were approaching the active RWY 28.

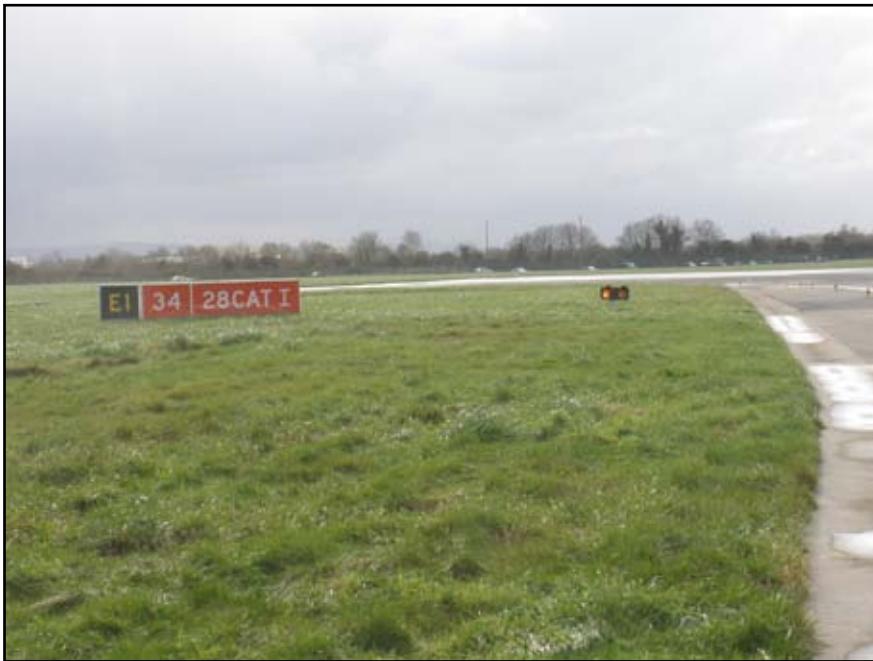
Photo No. 2: TWY E1 Cat I Holding Position RWY 28, Holding Position RWY 34

Approximately 60 m further along TWY E1, a taxiing aircraft encountered the combined holding position signage for RWY 28 ILS Cat I and for RWY 34. These were red and white signs marked "34 28CAT I" accompanied by yellow flashing runway guard lights, mounted in the grass verges on both sides of the taxiway, **Photo No. 2**. At the same point, there were two large rectangular signs painted on the taxiway surface, one on either side of the centreline, with "34 28" in white against a red background. There were also double yellow solid lines and double yellow broken lines painted across the taxiway, as per runway holding position marking "Pattern A", as defined in ICAO Annex 14, see **Appendix C**.

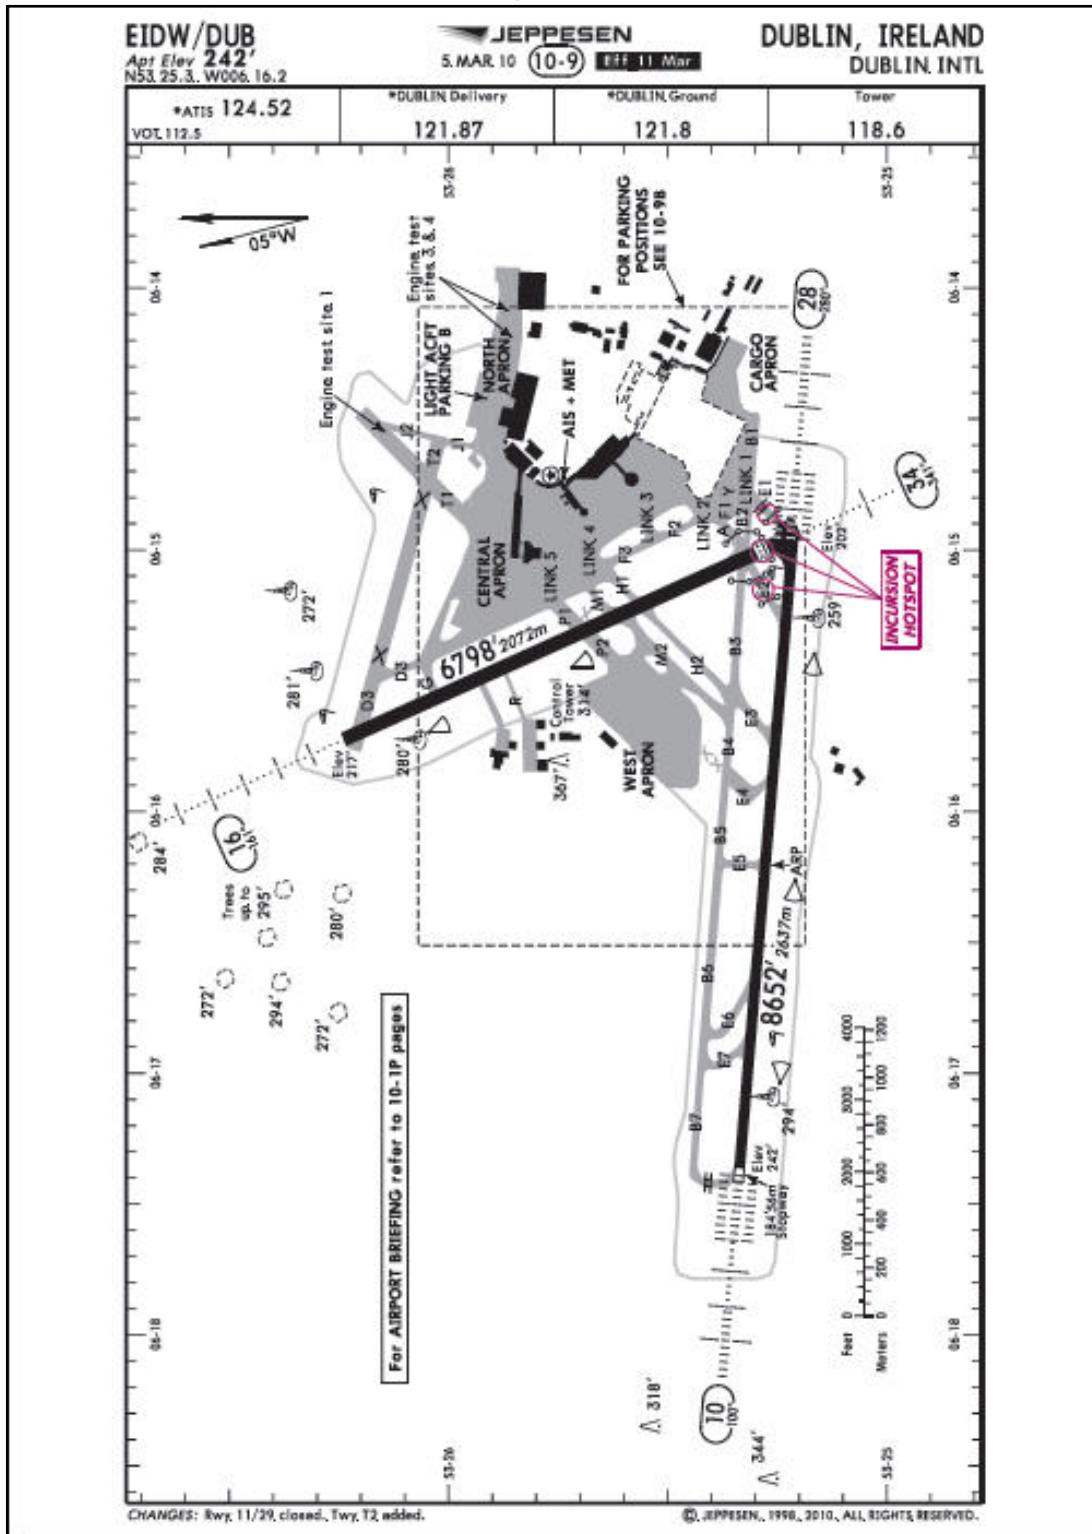
### EIDW Airport Chart 10-9

On EIDW Airport Chart 10-9 (**Appendix A**), the holding position for RWY 28 on TWY E1 was designated as an "Incursion Hotspot". ICAO defines a hot spot as "*a location on an aerodrome movement area with a history or potential risk of collision or runway incursion, and where heightened attention by pilots and drivers is necessary.*"
