FINAL REPORT

AAIU Synoptic Report No: 2006-007

Aircraft Type and Registration:	B737-204ADV, EI-CJC
No. and Type of Engines:	2 x P & W JT8D
Aircraft Serial Number:	22640
Year of Manufacture:	1982
Date and Time (UTC):	8 June 2004 @ 09.45 hrs
Location:	Dublin Airport
Type of Flight:	Commercial
Persons on Board:	Crew - 2 Passengers - 112
Injuries:	Crew - Nil Passengers - Nil
Nature of Damage:	Left Hand main landing gear trunnion pin sheared
Commander's Licence:	Irish Air Transport Pilot Licence
Commander's Details:	Male, aged 46 years
Commander's Flying Experience:	12,000 hours total
Information Source:	Aer Rianta Duty Officer

SYNOPSIS

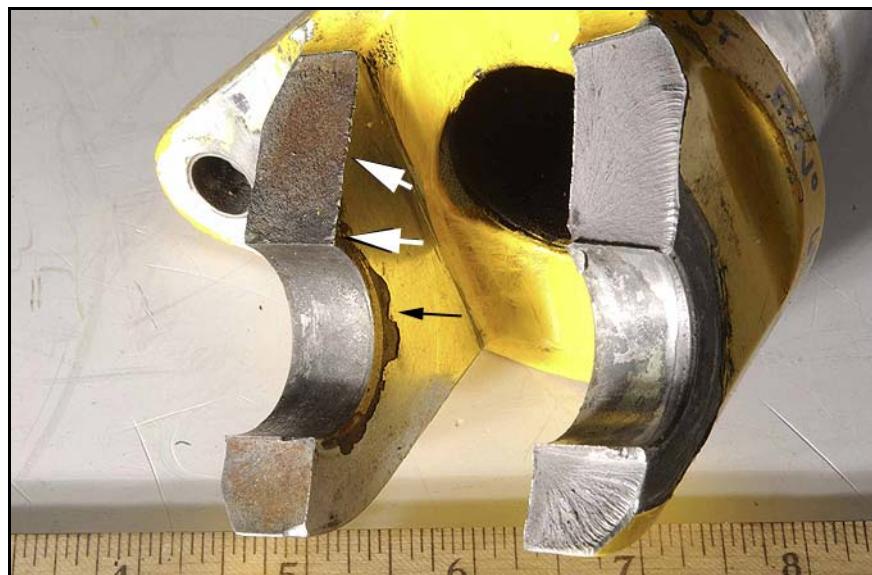
APPENDIX A

The LH main landing gear trunnion pin Part No. 65-46113-16, Serial No. LMC0422 failed at the outboard end at the MLG actuator attachment point (**Appendix A**). This trunnion pin assembly had been fitted, “in overhauled condition”, on another aircraft of the fleet, EI-CKQ (B737-2K2) on 25 June 1999. It was removed from that aircraft as unserviceable on 22 February 2000 during a P12 check in the UK and had 52,887 cycles since new (CSN) and 1511 cycles since last overhaul (CSO) at that stage. The overhaul period for this component is 16,000 cycles and the pin should be scrapped at 75,000 cycles.

1. Fracture of the lugs was due to poor chrome plating and chrome plate grinding damage on the inner face of the lug adjacent to the anti-rotation bolthole flange.

The white arrows denote the fracture origin region of the lug adjacent to the flange, which fractured first. The black arrow shows where chrome plating has flaked off the inner lug face.

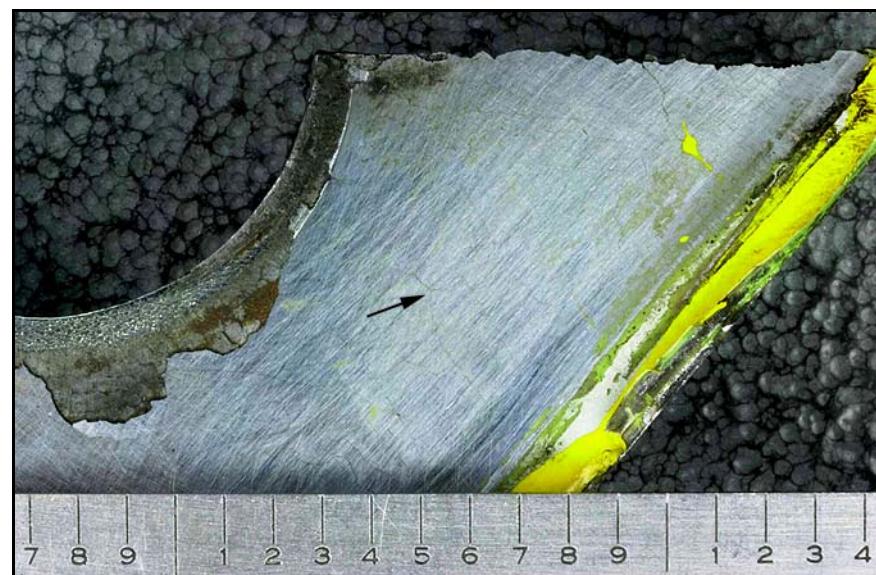
2. The chrome plating exhibited poor adhesion characteristics and numerous through-thickness chicken wire cracks. The severe cracks in the plating are indications of poor plating techniques.
3. The crack propagation mode, which led to the fracture, was due to Stress Corrosion Cracking (SCC). Final fracture occurred in the primary fracture lug as well as in the adjacent lug by ultimate tensile separation.
4. The grinding damage most likely resulted in a thin overtempered martensite layer found beneath the chrome plating on the inner face of the lug. However, the bulk of the trunnion pin material confirmed that the part was fabricated from the drawing specified 4340M alloy steel in the 275-300 ksi heat treat condition.

The chrome plating on the inner surface of the fracture lug exhibits severe through-thickness cracking. The black arrow shows an area of "chicken wire cracking."
