Air Accident Investigation Unit Ireland

**SYNOPTIC REPORT
SERIOUS INCIDENT
Bolkow Bo-209 Monsun, D-EFJG
Navan Airfield, Co. Meath**

14 May 2019

AAIU Report No: 2020 - 010

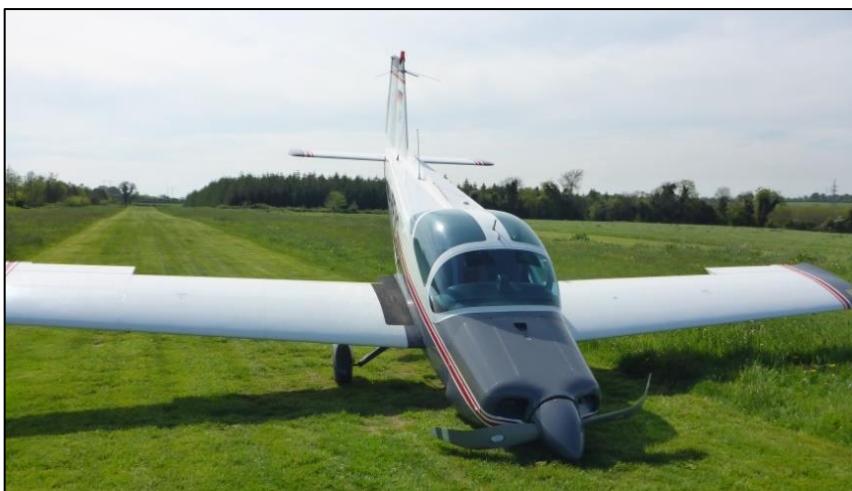
After take-off from Runway (RWY) 09 at EIHH, the Pilot (in command), who was seated in the left-hand seat, selected the nose landing gear to the up position and the aircraft's retractable nose landing gear retracted as commanded. Following the completion of one circuit of the airfield, the Pilot extended the aircraft's trailing edge flaps in preparation for landing back on RWY 09. During the landing roll, the propeller and the lower engine cowling came into contact with the runway surface, as the nose landing gear had not been extended prior to landing. The aircraft came to rest on the runway (**Photo No. 1**). The two occupants were uninjured and exited the aircraft unaided. There was no fire.

Photo No. 1: Final resting position of aircraft

The propeller's two blades sustained bending damage and the engine was shock-loaded. The engine's left and right cowlings and the lower air intake sustained minor damage. Repairs to the aircraft were on going at the time of writing.

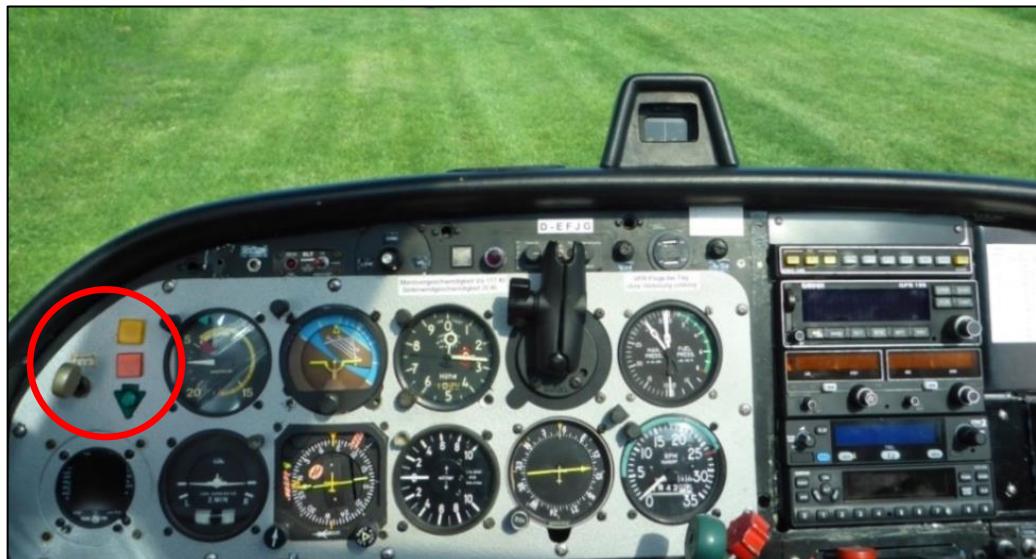
The aircraft's nose landing gear is selected to retract or extend by a wheel-shaped two-position switch located on the left-hand side of the aircraft's main instrument panel. Amber, red and green indication lights are fitted adjacent to the switch (**Photo No. 2**). The nose landing gear is retracted and extended by an electrically powered actuator. It can also be extended manually using a hand crank. According to the Aircraft Manufacturer's '*Technical Description*' document, all three indication lights will be off when the nose gear is retracted; the amber light will flash on the approach to warn the pilot to extend the nose landing gear, and will flash on the ground with the gear extended if the switch is placed in the up position; the green light will illuminate when the gear is down and locked; and the red light will illuminate when the gear is in transit.

Photo No. 2: Nose landing gear extension/retraction switch and indication lights (circled)

According to the '*Technical Description*' document, the amber light is activated by a throttle position switch, which should operate '*as soon as the throttle lever is pulled back to about 1/3 of its travel*'. The '*Technical Description*' document also states that commencing with aircraft serial number (S/N) 131 an aural alert horn is installed in parallel with the amber light. The S/N of the subject aircraft is 129 and the horn was not installed.

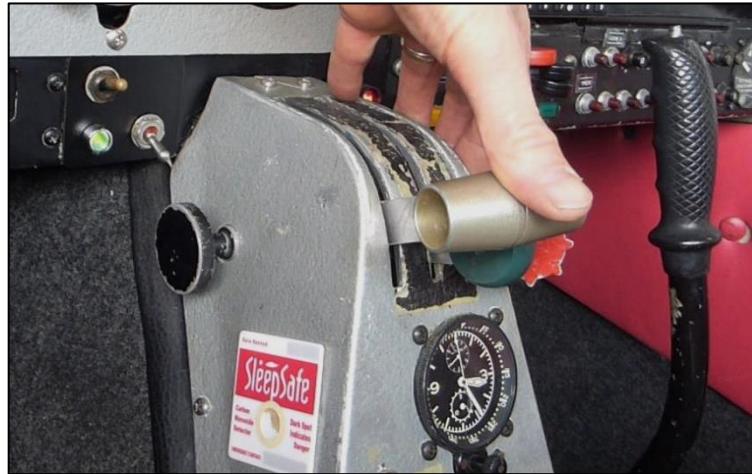
Photo No. 3: Throttle position required to actuate nose landing gear warning switch

The Pilot advised the Investigation that during examination of the landing gear warning system in Germany, it was found that the actuation mechanism for the throttle position switch was worn. This resulted in it not being possible to adjust the warning system to activate earlier than the position shown in **Photo No. 3**. The Pilot said that the subsequent examination also found that a wire had been directly soldered to one of the indication bulbs and that an additional resistor was installed in the circuit. The resistor was secured to the wiring with plastic tape. The Pilot said that this arrangement resulted in a burning smell during system testing. It was also found that a flasher unit was fitted, which was of a different part number to that listed in the Aircraft Manufacturer's parts list obtained by the Investigation. It was not possible to determine when this work was carried out.

According to the aircraft's '*Technical Description*' document, the amber light should flash when the throttle is retarded to about 1/3 of its travel and the nose landing gear is in the retracted position. However, the Investigation's post-occurrence examination of the aircraft found that the light did not activate until the throttle was closer to the idle position. It was also found that once the amber light began to flash, the red light (normally only illuminated when the gear is in transit) also flashed. This may have been due to the condition of the electrical circuit as observed during further examination of the aircraft. In addition, a flap position switch was not installed on the aircraft.

8. Post-occurrence examination by the Investigation also found that the nose landing gear warning system activated at a throttle position that was closer to the idle position than the '*1/3 of its travel*' position described in the aircraft's '*Technical Description*' document.
