Air Accident Investigation Unit Ireland

SYNOPTIC REPORT

INCIDENT Gulfstream G650, EI-JSK Overhead, Co. Waterford

7 July 2019

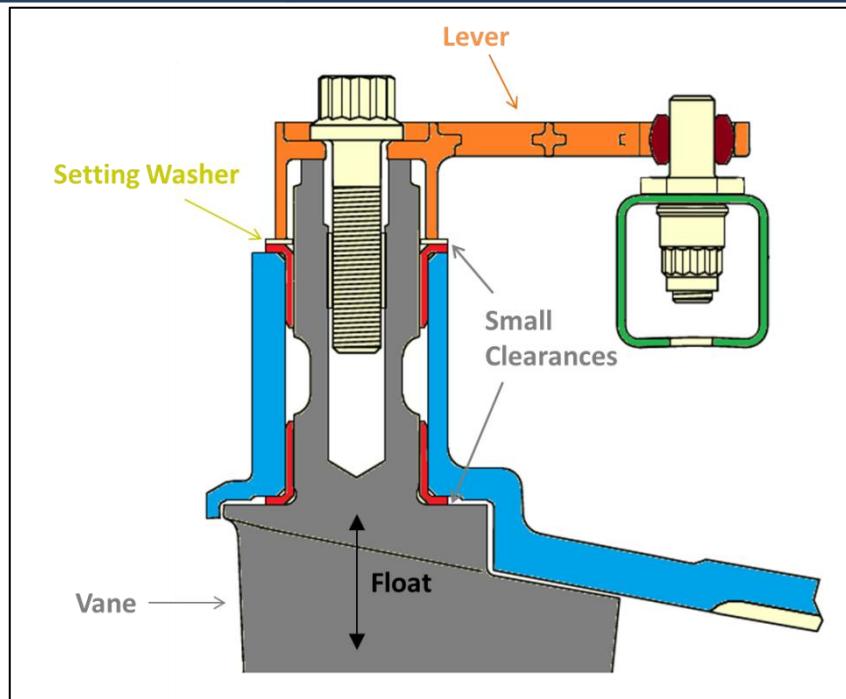
Figure No. 4: Clearance between Vanes and Compressor Casing (*Engine Manufacturer*)

In order to ensure that the vanes do not clamp against the casing during engine operations, a setting washer is installed during assembly (**Figure No. 4**). This ensures the correct clearance or 'float' between the vane and casing. During engine strip, the float on each vane was measured. The results showed that the VIGVs and VSV1s all had a float within or above the clearance set during engine build. However, some of the VSV2 vanes and most of the VSV3 vanes had no float.

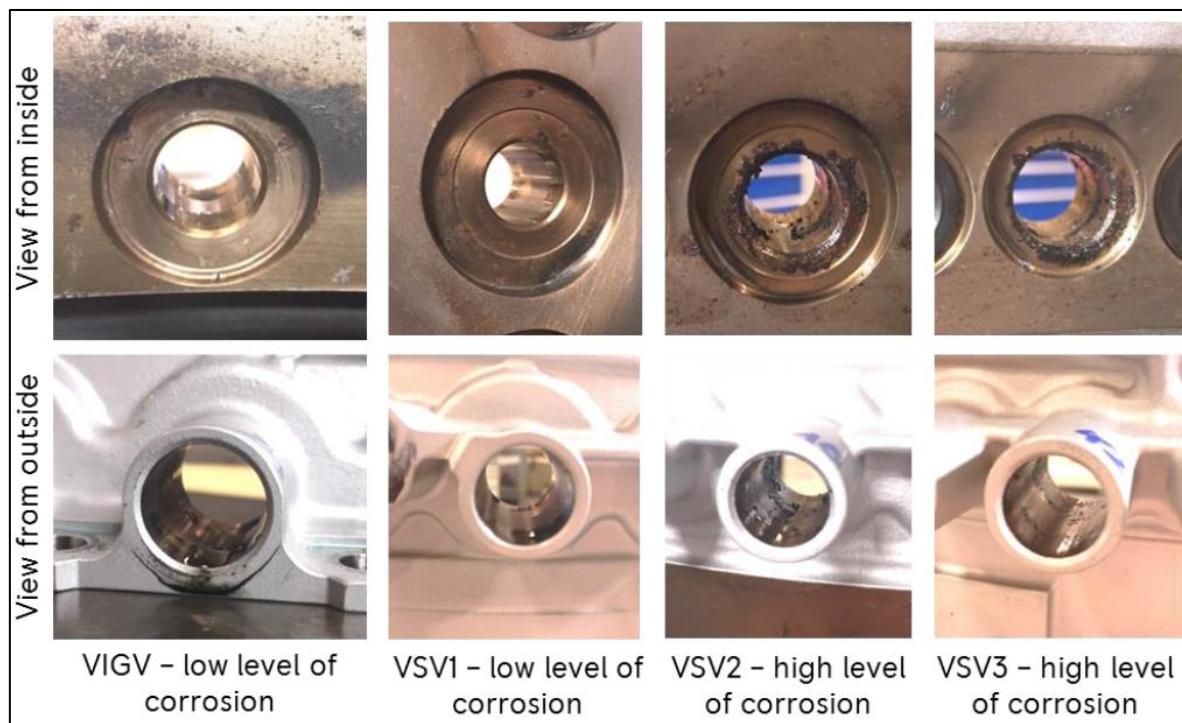
Figure No. 5: Corrosion Levels in Compressor Casing Vane Bores (*Engine Manufacturer*)

Following the individual vane torque measurements, the vane levers were detached and the vanes and bushes were removed from the compressor casing, so that the vane bores in the casing could be inspected. The results of this inspection showed low levels of corrosion on the VIGV and VSV1 bores and high levels of corrosion on the VSV2 and VSV3 bores (**Figure No. 5**).

Corrosion was also observed on other locations in the compressor split casing. The Engine Manufacturer informed the Investigation that corrosion has been found previously at these locations and is in line with service experience on other engines in the BR700 series.

The Engine Manufacturer's report concluded that corrosion products found mainly between the bushes of VSV2 and VSV3 stages and the compressor casing had compressed the bushes, which reduced their diameter and led to an increase in friction between the bushes and the VSV spindles. In addition, the corrosion had eliminated the end float required to maintain gaps between the compressor casing, bushes and vanes. The corrosion was determined to be crevice corrosion which can occur when salt water penetrates small gaps in the engine assembly. The Engine Manufacturer noted that the progressive worsening of corrosion from VIGV to VSV3 stages could have been caused by a number of factors:

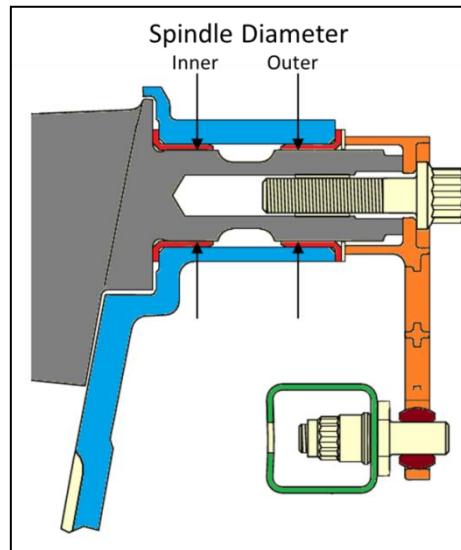
Figure No. 6: Vane Spindle Diameter (*Engine Manufacturer*)

The diameter of the vane spindle at the inner and outer positions (Figure No. 6) on a sample of vanes from each stage was measured. This showed that the majority of the vanes were within the Engine Manufacturer's specified tolerance. A small number were slightly outside the specified tolerance, but the Engine Manufacturer did not consider the discrepancy to be large enough to have affected the actuation of the VSV system.

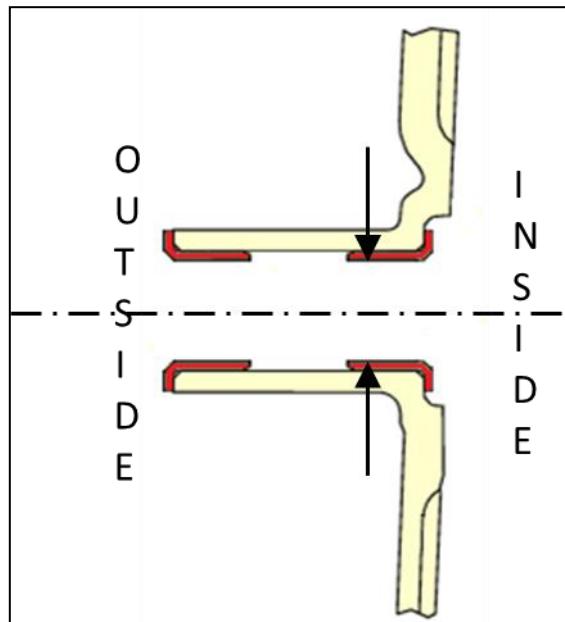
Figure No. 7: Bush Internal Diameter (Engine Manufacturer)

While the bushes were still installed on the compressor casing, the internal diameter of the bush at the inner end of the casing bore (**Figure No. 7**) was measured. This showed that the majority of the VIGV and VSV1 bushes were within the expected tolerance range, whilst all of the VSV2 and VSV3 bushes were below. The majority of the VSV2 and VSV3 bushes were close to the diameter of the spindle.

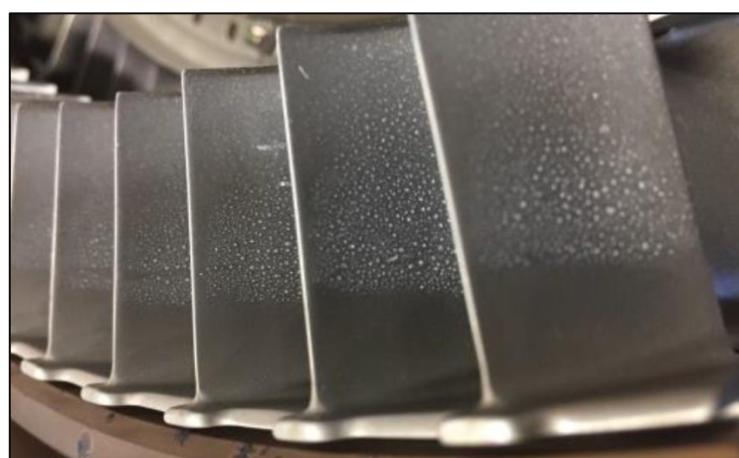
During the engine examination, deposits were observed on the nose cone, the fan blades, the stator vanes immediately downstream of the fan at the entry to the engine core, and in the compressor. In particular, the Stage 4 stator vanes located just downstream of the VSV3 vanes showed clear evidence of a white crystalline deposit (**Photo No. 1**). One of the Stage 4 stator vanes was removed and analysed using a Scanning Electron Microscope (SEM). This determined that the deposits were largely composed of sodium chloride, sodium sulphate and sodium nitrate, i.e. environmental salts.

Photo No. 1: White Crystalline Deposits on Stage 4 Stator Vanes (Engine Manufacturer)
