Air Accident Investigation Unit Ireland

FACTUAL REPORT

ACCIDENT
ICP Ventura, EI-GHS
Tubrude Airfield, Co. Meath

20 July 2019

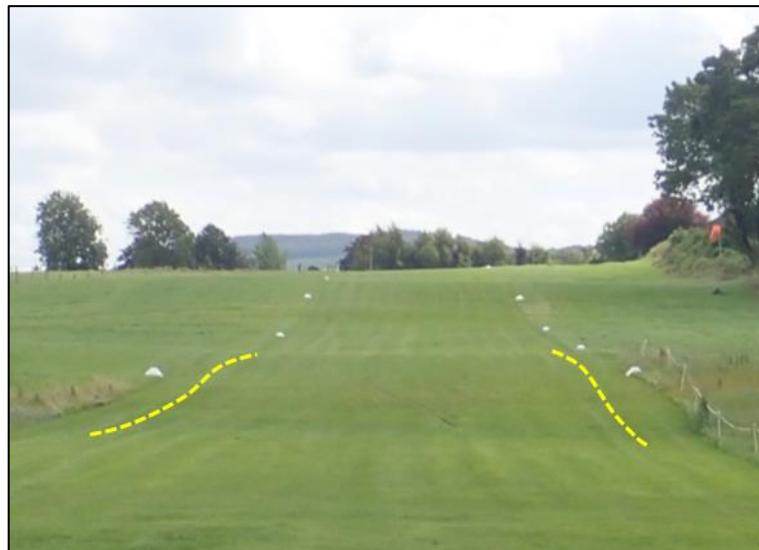
The runway was prepared across two adjacent fields that were once separated by a ditch. The significant and prominent hillock within the runway is indicated by the yellow dashed lines in **Photo No. 1**. This hillock is coincident with where the runway crosses the previous ditch boundary.

Photo No. 1: Touchdown area on RWY 09 (facing east). Yellow lines added

The effects of windshear during flaring for a landing can be challenging for a pilot. In this accident, the challenge for the Pilot in correcting for the effects of possible windshear was likely exacerbated by the overall gradient of the runway and the significant and prominent hillock with which the dropping left wing impacted.

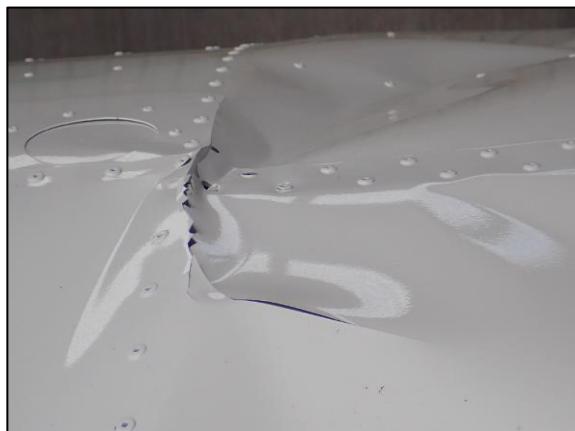
After the accident, the aircraft was recovered by the Pilot to the hangar at the airfield and placed on a temporary support. As a result of the accident, significant damage was evident on the left wing, which showed compression at its mid-span with associated buckling of the wing skins (**Photo No. 2** and **Photo No. 3**). The right wing tip also showed minor contact damage.

Photo No. 2: Left wing upper surface

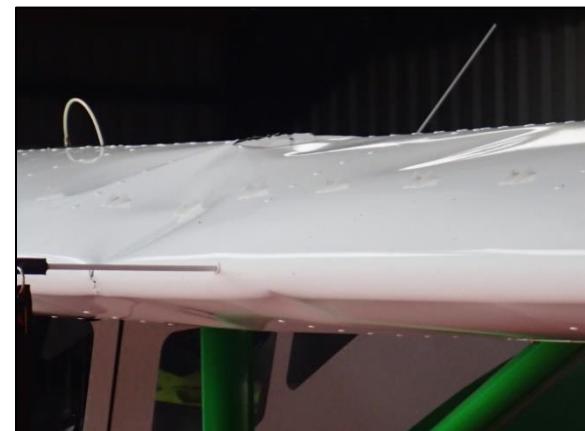
Photo No. 3: Evidence of buckling (left wing)

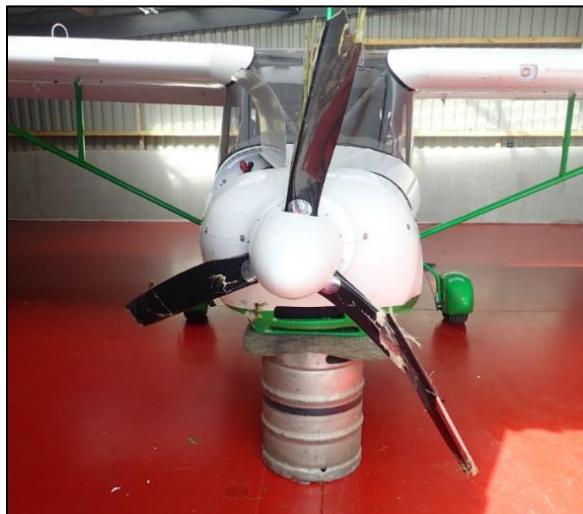
During the impact sequence, the nose landing gear detached from the aircraft, resulting in damage to the nose landing gear assembly and the surrounding engine and fuselage cowlings. All three propeller blades impacted the runway and were destroyed (**Photo No. 4**). The main landing gear fairings and associated fittings also exhibited impact damage (**Photo No. 5**).

Photo No. 4: Damage to propellers

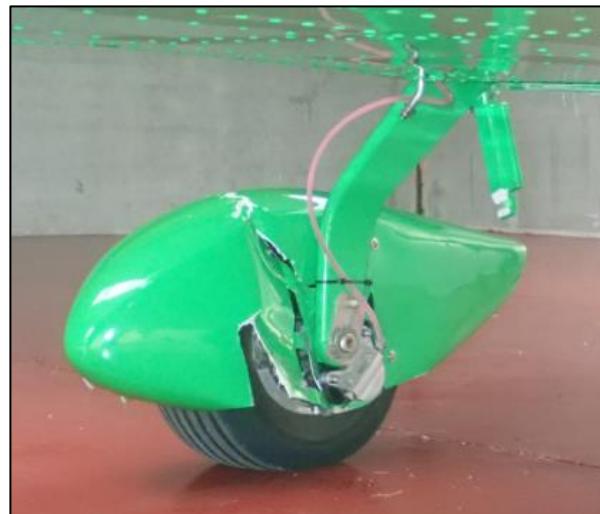
Photo No. 5: Right main landing gear

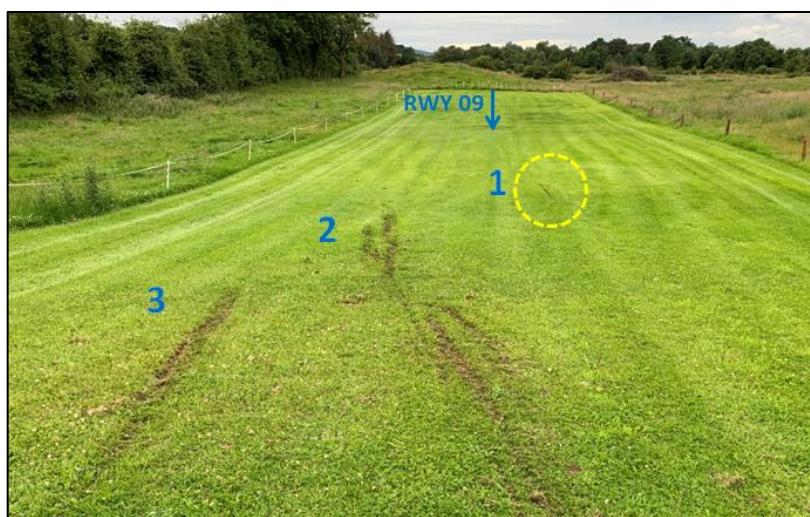
Minor impact marks to the runway surface were evident as shown in **Photo No. 6**.

Photo No. 6: Impact marks on RWY 09 (facing west)

The impact marks observed in **Photo No. 6** indicate that at 73.5 m from the threshold (Point 1 circled in yellow) the left wing impacted the ground first. The next witness mark noted on the runway (Point 2) at 78.5 m from the threshold corresponds to a heavy nose impact, which is likely when the nose landing gear detached. This was followed approximately 3.5 m later by a series of propeller marks in the ground. At a distance of 85 m from the threshold, a ground impression, corresponding to the right main wheel (Point 3) commenced and continued for a distance of 34 m. The nose wheel assembly was reported to have been recovered to the right of this track marking.
