Air Accident Investigation Unit Ireland

FACTUAL REPORT
ACCIDENT
ICP Srl Savannah S, EI-GEO
Navan Airfield, Co. Meath

2 October 2019

AAIU Report No: 2020-017

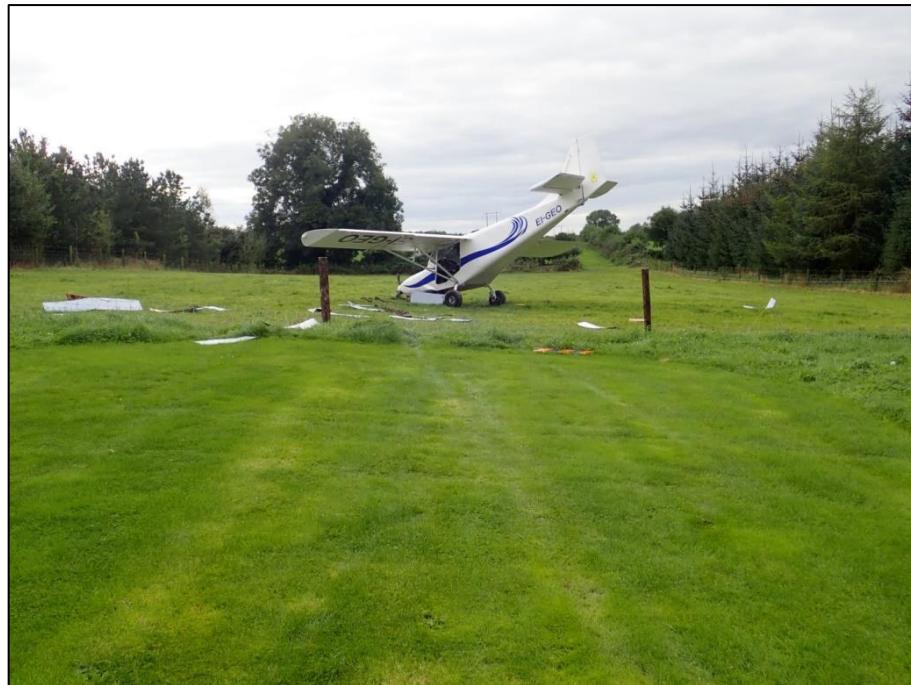
The right wing tip contacted the ground and the right main tyre partially detached from the wheel hub before the aircraft came to a stop, nine metres beyond the fence (**Photo No. 1**). There was no fire, and the Pilot exited the aircraft without assistance.

Photo No. 1: Final resting position of EI-GEO

The wire fence at the end of the runway was detached from the poles, and the orange and black warning boards were displaced and damaged. The debris from the warning boards can be seen in **Photo No. 1** and **Photo No. 3**.

The ground marks and damage to the aircraft were consistent with entanglement in the wire fence causing the nose landing gear to fold under the fuselage, leading to the propeller and lower cowling contacting the ground. The entanglement also pulled the aircraft's nose to the left of the direction of travel inducing a short skid that briefly rolled the aircraft to the right causing the right wingtip to impact the ground, causing crush damage to the wing tip and outer leading edge. The weight of the fuselage resting on the nose gear leg caused further damage to the fuselage. The aircraft avoided contact with the large fence poles at the end of the runway because it was a high-wing design. The poles are not highlighted in the airfield information as presented on the airfield operator's website. An aircraft impacting with such poles could suffer more serious damage with the potential for injury to the occupants.

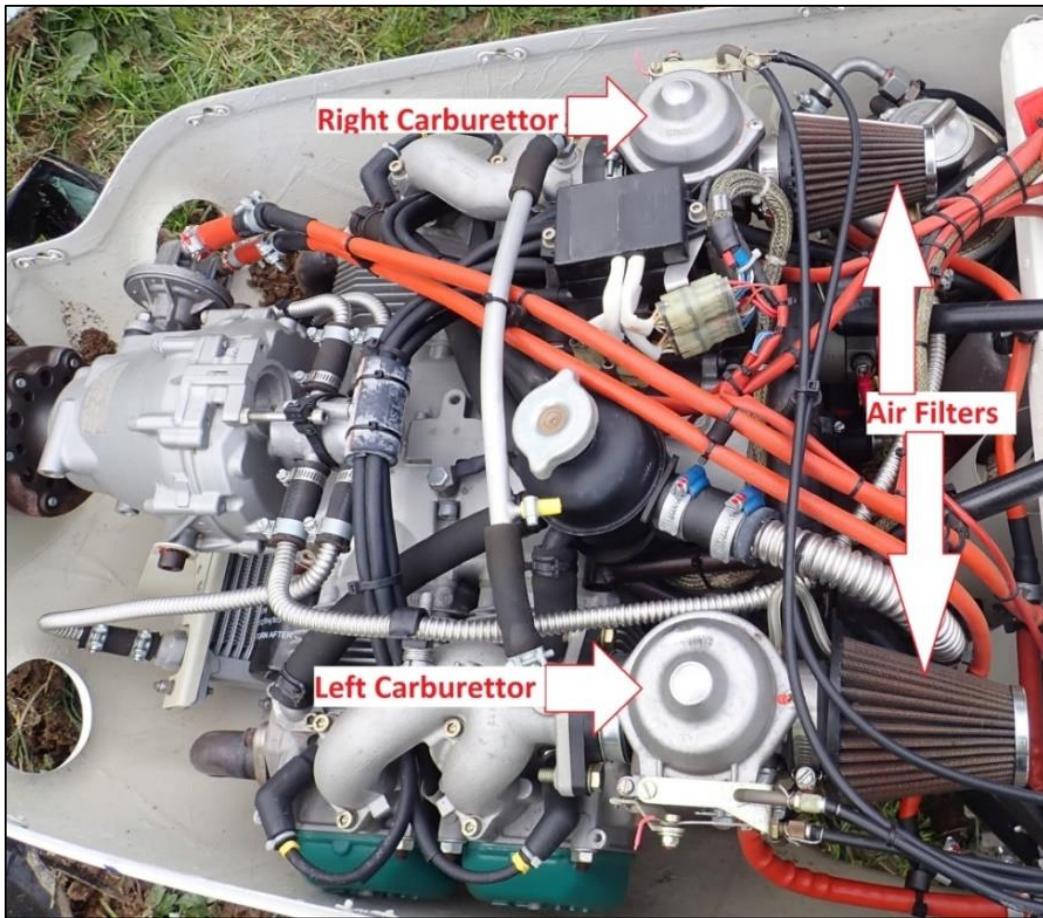
The engine was equipped with two float-type carburettors to supply the appropriate fuel/air mixture to the cylinders during operation (**Photo No. 2**). The left carburettor supplied cylinders No. 2 and No. 4, while the right carburettor supplied cylinders No. 1 and No. 3. Each carburettor was fitted with an individual air filter. When checked by the Investigation, the fuel in both carburettor bowls was free from contamination and the floats were in good condition. On the subject aircraft, the means to prevent and eliminate engine induction icing (carburettor icing) relied on air entering the two air intakes within the engine compartment, being warmed by engine operation.

Photo No. 2: BRP-Rotax 912 ULS engine installation in EI-GEO

The subject engine installation relied on the location of the carburettors and air intake filters within the engine compartment and the increased ambient air temperature within the engine compartment while the engine was operating, as the means of preventing carburettor icing. It is probable that, prior to take-off, the temperature of the air within the engine compartment had not reached a temperature that would have precluded the formation of carburettor ice, or to remove any that had already formed, due to the prevailing conditions existing on the airfield at that time.

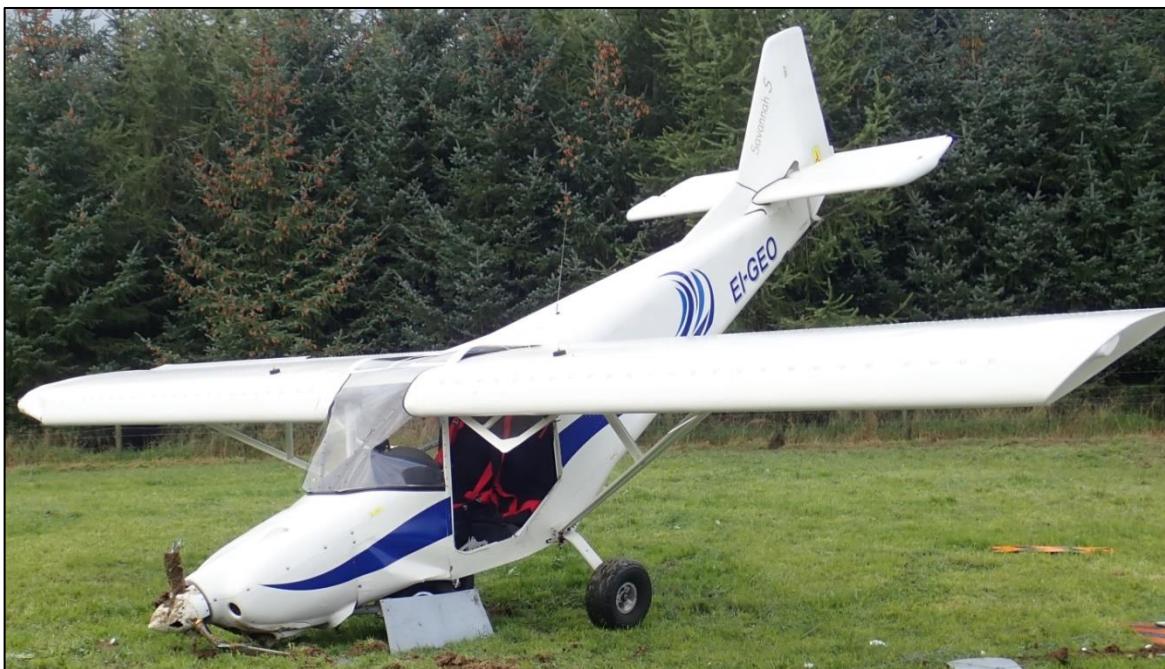
The three propeller blades were broken, and the propeller spinner was cracked. The nose landing gear had collapsed, and the lower engine cowling was damaged. The fuselage below the cockpit was distorted, the structure above the cockpit ruptured, the fuselage on both sides forward of the cockpit doors creased and the windscreens were cracked. The outermost part of the right wing leading edge and wingtip was dented and contained soil. The right main undercarriage tyre had partially detached from the wheel hub. **Photo No. 3** shows some of the damage sustained during the accident. Post-accident examination of the engine by a Rotax Engineer did not reveal any defects that may have caused the reduction in power reported by the Pilot. No other defects were reported to the Investigation after repairs to the aircraft were completed.

Photo No. 3: Some of the damage to EI-GEO

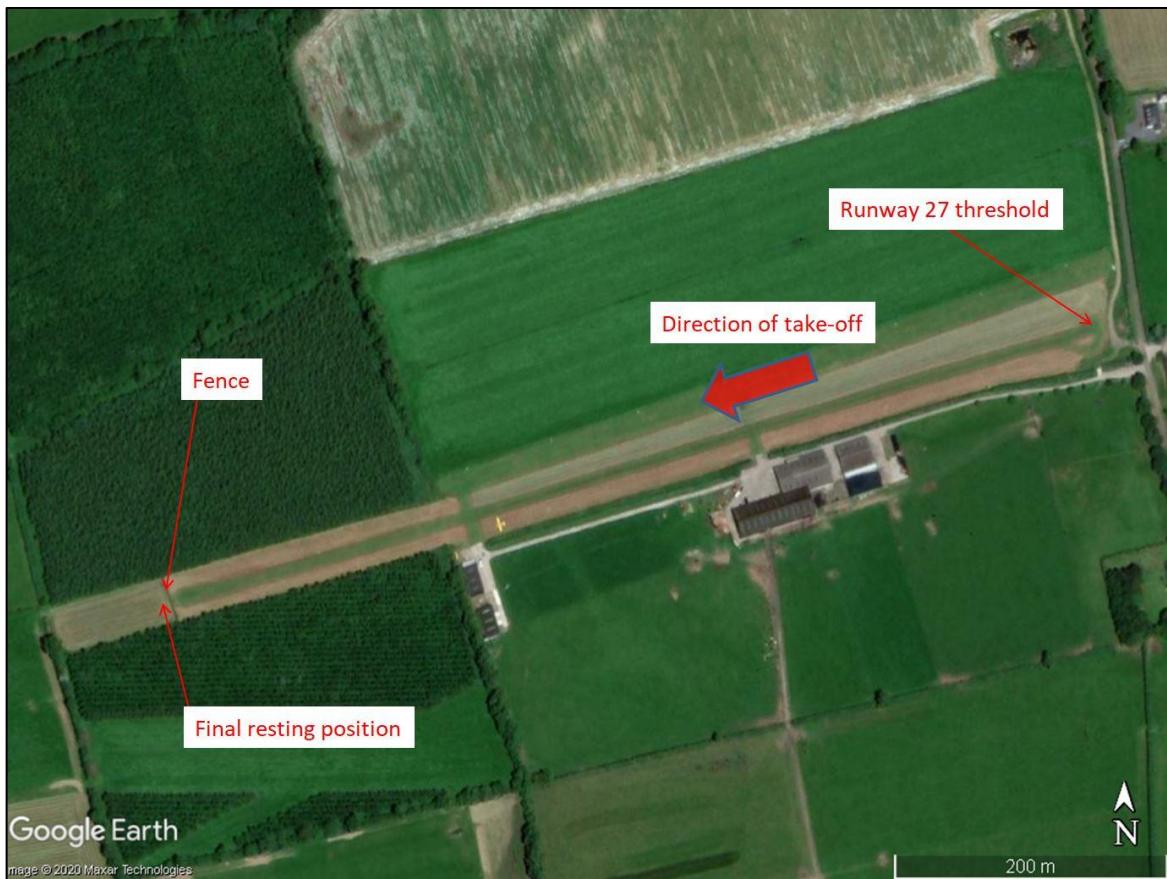
Navan Airfield is a private unlicensed grass airfield located three nautical miles north-east of Navan, County Meath, at an elevation of 250 feet above mean sea level. **Figure No. 1** shows the general layout of the airfield. According to the airfield website, the take-off run available on RWY 27 was 700 m. There was a fence at the end of the runway. The fence consisted of a number of large vertical wooden poles set in the ground and spaced across the end of the runway. Fencing wire was attached to the poles and carried orange and black coloured boards to highlight the presence of the fence. The poles are not highlighted in the airfield information as presented on the airfield operator's website.

Figure No. 1: Navan Airfield (Google Earth)

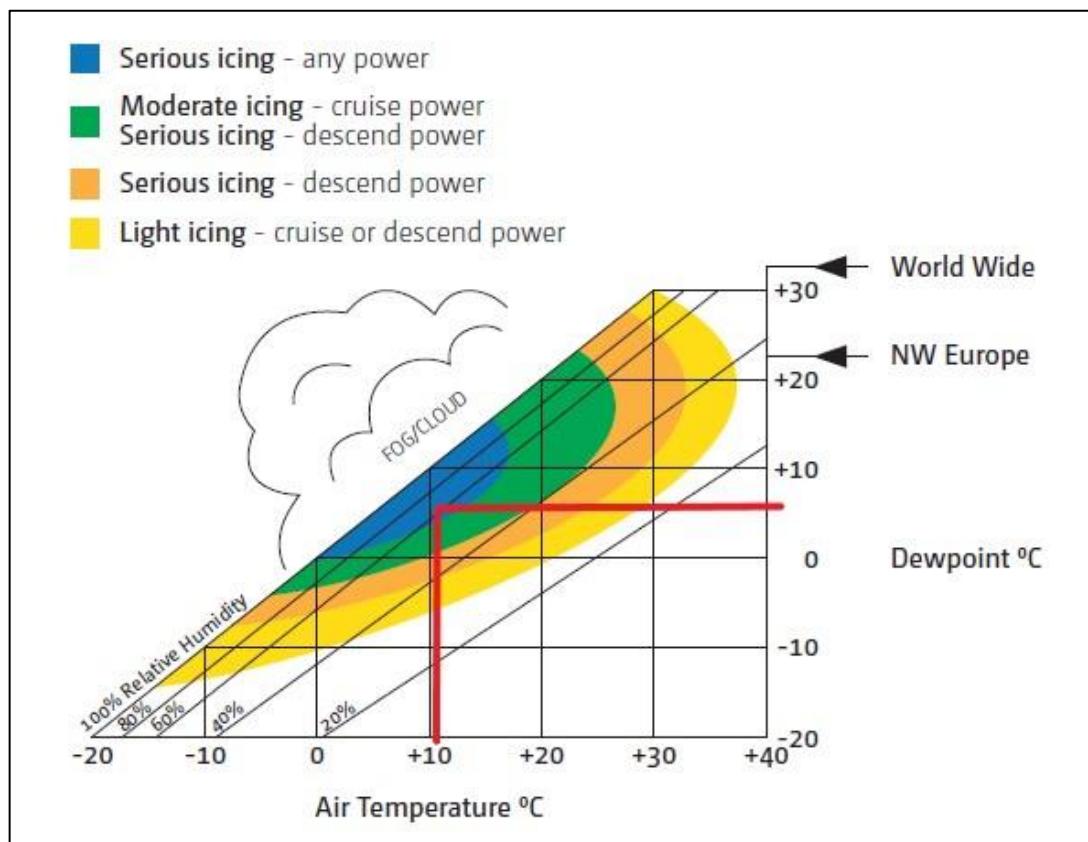
The EGAST GA 5 safety leaflet includes an illustration of the probability of '*Carburettor Icing*' at various combinations of temperature, dewpoint and engine power setting (**Figure No. 2**). The temperature and dewpoint provided by *Met Éireann* for the time of the accident is highlighted in red.

Figure No. 2: Atmospheric conditions for carburettor icing

Figure No. 2 is based on the use of aviation gasoline (avgas). GA 5 states that '*Carburettor icing is more likely when MOGAS is used, because of its volatility and water content*'. Therefore, the risk areas in **Figure No. 2** will be larger when the fuel used is Mogas.

The Pilot reported that he had observed heavy dew on the grass of the airfield. Based on the atmospheric conditions for carburettor icing chart as published by EGAST in their GA 5 safety leaflet (June 2013), and the environmental conditions prevailing at the time of the occurrence, there was a serious risk of carburettor icing. The inherent characteristics of Mogas further increased the icing risk.
