## FINAL REPORT

**AAIU Synoptic Report No: 2008-001**  
**AAIU File No: 2007/0078**  
**Published: 21/01/08**

<b>Aircraft Type and Registration:</b>	Urban-Air UFM10 Samba, EI-DRM	
<b>No. and Type of Engines:</b>	1x Jabiru 22A	
<b>Aircraft Serial Number:</b>	3/10	
<b>Year of Manufacture:</b>	2000	
<b>Date and Time (UTC):</b>	7 September 2007 @ 12.30 hrs	
<b>Location:</b>	Abbeysrule, Co. Longford (EIAB)	
<b>Type of Flight:</b>	Training	
<b>Persons on Board:</b>	Crew - 2	Passengers - Nil
<b>Injuries:</b>	Crew - Nil	Passengers - Nil
<b>Nature of Damage:</b>	Minor damage to nose gear and propeller	
<b>Commander's Licence:</b>	PPL/A (IRL)	
<b>Commander's Details:</b>	Male, aged 44 years	
<b>Commander's Flying Experience:</b>	1,496 hrs, of which 1,340 were on type.	
<b>Notification Source:</b>	AAIU Report Form submitted by Pilot.	
<b>Information Source:</b>	Aircraft's Irish Agent

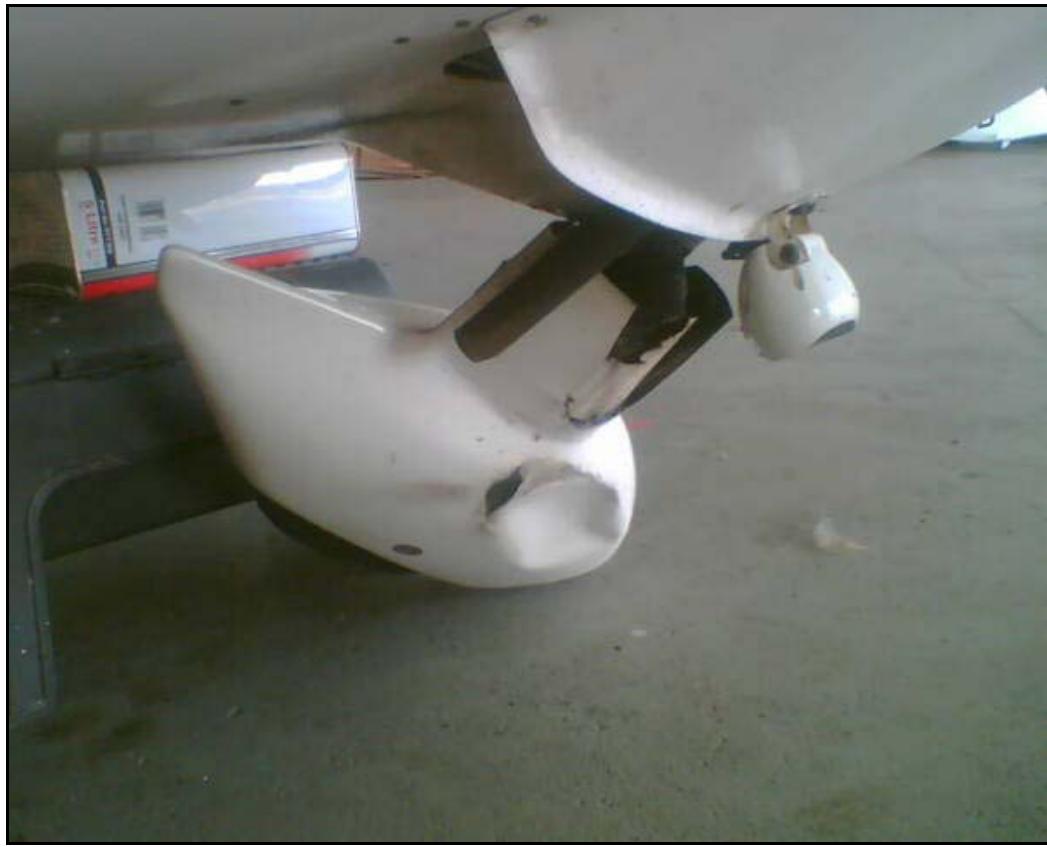
The aircraft suffered minor damage. Both propeller blade tips were damaged up to 3 cm from the tip. An examination of the nose undercarriage revealed that the strut had partly collapsed at its weakest point but had not broken off. (see **Appendix B**). There was no damage to other property.

When the rubber shock absorber was removed from the strut the mode of failure was evident. The strut had only partly broken at the plug welds, bent backwards and to the side. There was some corrosion and evidence of weld slag at the plug welds. When the aircraft ran along the runway the bent strut impacted the ground and was scored adjacent to the shock absorber. Failure of the steering tube, on heavy impact of the nose wheel, is designed to fracture where the two internal tubes meet. This point is about 20mm upwards from the plug welds.

The weakest point of the fork/steering tube attachment in this incident was 2 cm below that point, along the circumference of the tube, where the three plug welds are located. This fracture may also have been assisted by a degree of internal corrosion.

**Photo No.1:** The bent nose undercarriage following the incident.

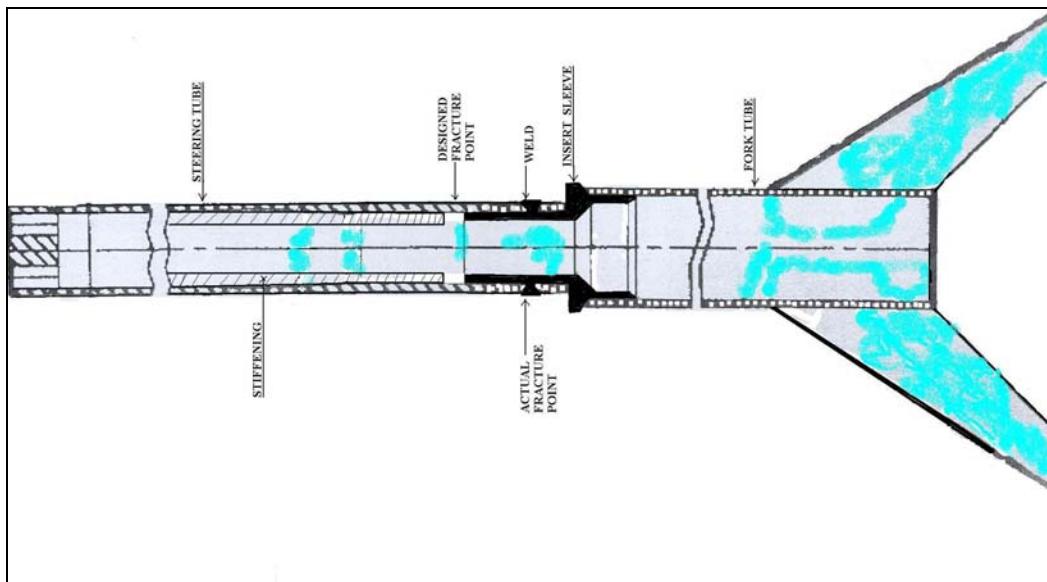
The nose wheel is held in a fork unit, similar to that on a bicycle (**Appendix B**). The fork tube is attached to the steering tube through a short internal 35 mm long sleeve, which is plug welded to the steering tube at three circumferential locations. A second internal tube held in place with adhesive extends up the steering tube about 100mm. The fork unit is formed from steel tube and includes a rubber shock absorber. The steerable nose wheel is connected to the rudder controls. Main wheels are mounted on a spring axle and are equipped with hydraulic brakes. A single brake lever mounted on the pilot's control column operates these and thus differential braking is not available.

The designed weak point appears to be where the 35 mm internal sleeve meets the 100 mm internal stiffening tube. This construction facilitates fracture at this location, in the event of possible overload, in order to reduce damage to the front structure and composite skin.

**Photo No.2:** Schematic cross-section drawing of nose strut found on EI-DRM.
