FINAL REPORT

AAIU Synoptic Report No: 2008-002
AAIU File No: 2007/0060
Published: 29/01/2008

Aircraft Type and Registration:	ATR 72-202, EI-REE
No. and Type of Engines:	2 x Pratt and Whitney PW124B
Aircraft Serial Number:	342
Year of Manufacture:	1992
Date and Time (UTC):	4 July 2007 @ 08.10 hrs
Location:	Dublin Airport, Stand 9
Type of Flight:	Public Transport Scheduled
Persons on Board:	Crew - 4 Passengers - 36
Injuries:	Crew - 1 Passengers - Nil
Nature of Damage:	None
Commander's Licence:	IRL/ATPL
Commander's Details:	Male, aged 32 years
Commander's Flying Experience:	3,800 hours, of which 3,685 were on type
Notification Source:	Operator
Information Source:	Operator AAIU Investigation

SYNOPSIS

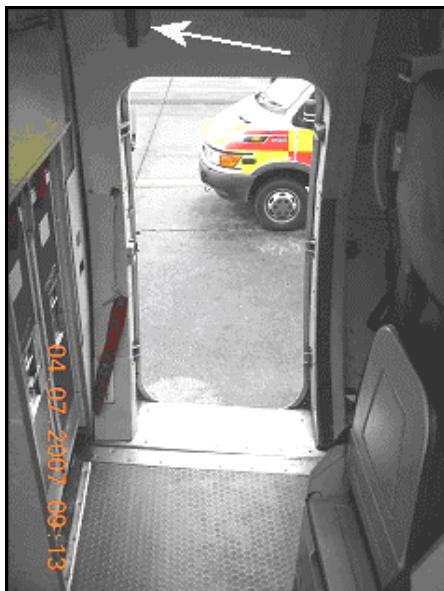
Photo No. 1

Passenger baggage is loaded via the aft service door into the cargo containment area (to the right in **Photo No. 1**). Thus, the aft service door is normally left open until all baggage is loaded. The baggage handlers then close the door. The door is about 4 ft from the ground and is not equipped with a slide. The door itself is small and of a low height.

The door jam is equipped with a grab handle, over the door on the left side (marked with a white arrow in **Photo No. 1** above. The floor area is tressed leading to a metal boundary strip that abuts the stainless steel doorsill.

As it was raining at the time it is probable that the stainless steel doorstep was wet and consequently slippery. Due to the low height of the door, the CCM would have had to bend down to look out for the loaders. In this crouching position, holding on to the assist handle with her left hand, she stated her right foot slipped. This caused her to loose her balance and would have rotated her to the left causing the injury to her right side when she fell through the door, hit the trolley and subsequently the ground. Due to the size of the door, safety straps are not considered necessary. In addition, such a strap on a small door would impede loading baggage and would therefore not be practical.

The Operator conducted an investigation of this incident and is installing anti-slip strips on the metal sills of the aft cabin doors.

The incident was reported to the manufacturer who liaised with the European Aviation Safety Agency. Although this was the first reported case of a CCM being injured following a slip, the manufacturer has nevertheless opened a design change (Modification No 05873) that will incorporate an anti-slip strip on its production aircraft. In addition, Service Bulletins (SB ATR42-53-0132 and ATR72-53-1088) are being developed and will be available to operators of in-service aircraft. The Service Bulletins will be available in the first quarter of 2008.

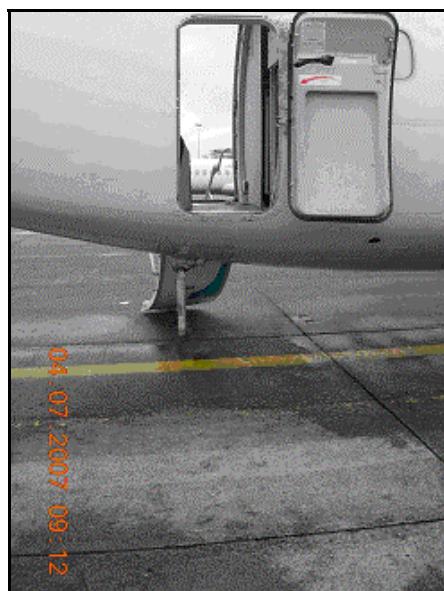
Photo No. 2

Aft Service door – (Photographs supplied by Operator's Air Safety Office)

The weather report (METAR) for Dublin Airport at time 08.00 hrs was wind velocity 240/16 kts, visibility greater than 10km, some cloud at 700 ft, broken cloud layers at 1,000 ft and 1,500 ft, temperature 14°C, dew point 12°C and a QNH of 1000 hPa. The maximum gust recorded between 08.00 - 09.00 hrs was 28 kts. As can be seen from **Photo No. 1** and **No. 2** above, taken shortly after the incident, the ground was wet except where the baggage trolley was parked.
