FINAL REPORT

AAIU Synoptic Report No: 2008-003
AAIU File No: 2007/0050
Published: 08/02/2008

Aircraft Type and Registration:	Kolb Twinstar Mk. IIIA, G-BUZT
No. and Type of Engines:	1 x ROTAX 582
Aircraft Serial Number:	PFA 205-12367
Year of Manufacture:	2001
Date and Time (UTC):	4 June 2007 @ 16.13 hrs
Location:	Killoughrum, near Enniscorthy, Co. Wexford
Type of Flight:	Private
Persons on Board:	Crew – 1 Passengers – Nil
Injuries:	Crew – 1 (Serious)
Nature of Damage:	Damaged beyond economic repair
Commander's Licence:	JAA Private Pilot's Licence (UK)
Commander's Details:	Male, aged 60 years
Commander's Flying Experience:	105 hours, of which 6 were on type
Notification:	Shannon ATC Watch Manager
Information Source:	AAIU Field investigation

SYNOPSIS

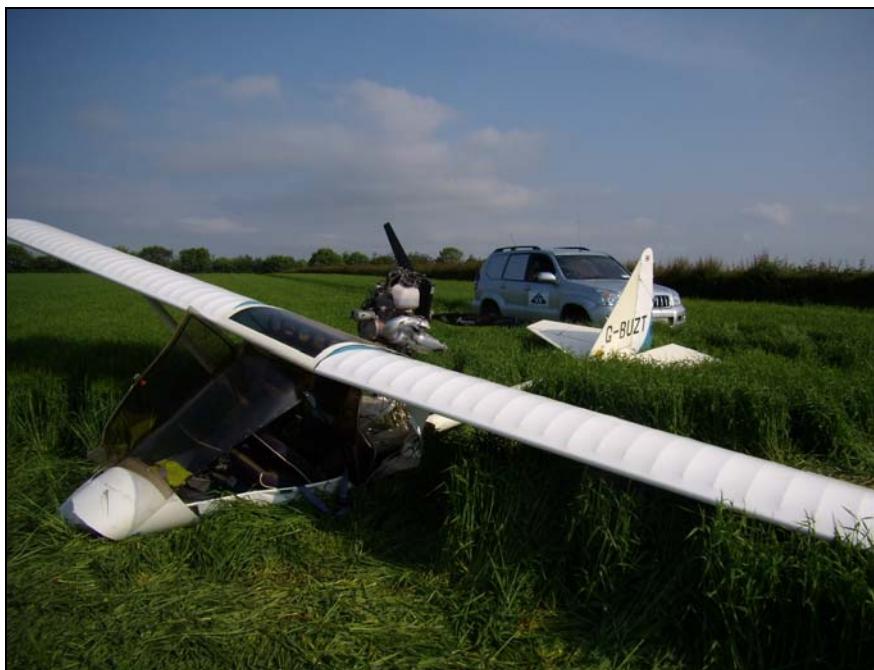
Photo No. 1: Final position of G-BUZT

The impact severely distorted the main undercarriage and lower fuselage around the cockpit area. Substantial deceleration forces were experienced by the pilot who suffered serious injuries as a result. Two witnesses were quickly on the scene; they rendered assistance to the pilot and called the emergency services. The scene was secured by An Garda Síochána.

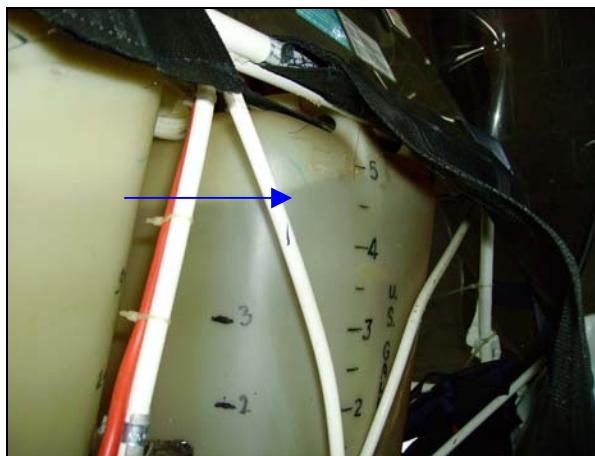
The left fuel tank contained 4½ US Gallons of fuel, while the right tank contained only a small quantity of unusable fuel (**Photo No. 2** and **Photo No. 3**). There was no evidence of any fuel leakage from the fuel tanks or lines. Aft of the cockpit, the fuel line was opened for inspection at the in-line fuel filter coupling and revealed only a trace amount of fuel. The fuel filter itself was found to be clean and free of debris.

Photo No. 2: Left Tank – approx. 4 ½ USG

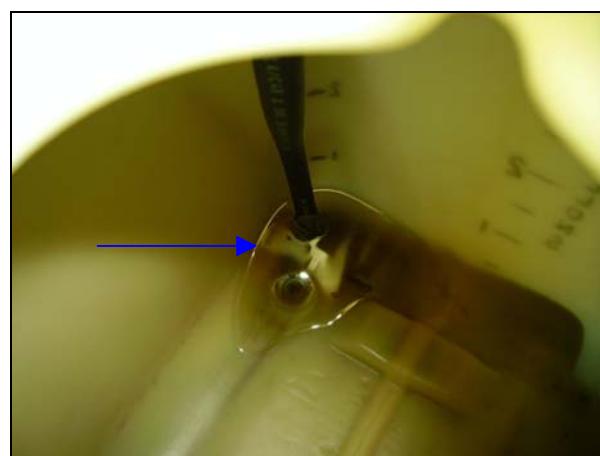
Photo No. 3: Right Tank – unusable fuel

The engine stoppage was as a direct result of the exhaustion of useable fuel in the right fuel tank. At some point in time prior to the accident flight, the fuel selector was rotated in the wrong direction against the stop while being positioned to 'OFF'. An individual, not familiar with the operation of the fuel selector, aligned the *selector handle* (not the *selector pointer*) with the 'OFF' placard, leaving the selector lever 180 degrees out of proper alignment. The loose collar stop adjustment allowed rotation of the lever beyond the stop. Following this, with the selector handle 180 degrees out of position, selection of either tank would appear to be indicated by the selector handle position and not by the pointer.

The pilot accepted that he had misunderstood the operation of the fuel selector. On the day of the accident flight the pilot believed he was drawing fuel from the left tank. In actual fact fuel was being drawn from the right tank, which at that point, contained less fuel. The engine stopped when the usable fuel level in the right tank became exhausted. By switching tanks after the stoppage, a re-start should have been possible as fuel was available from the left tank. But as no fuel remained in the fuel line, the only way to prime the line and carburettor bowls was to crank the engine using the starter, as the priming bulbs are not accessible in flight. As there was little time to accomplish this, a re-start of the engine in the circumstances would have been unlikely.

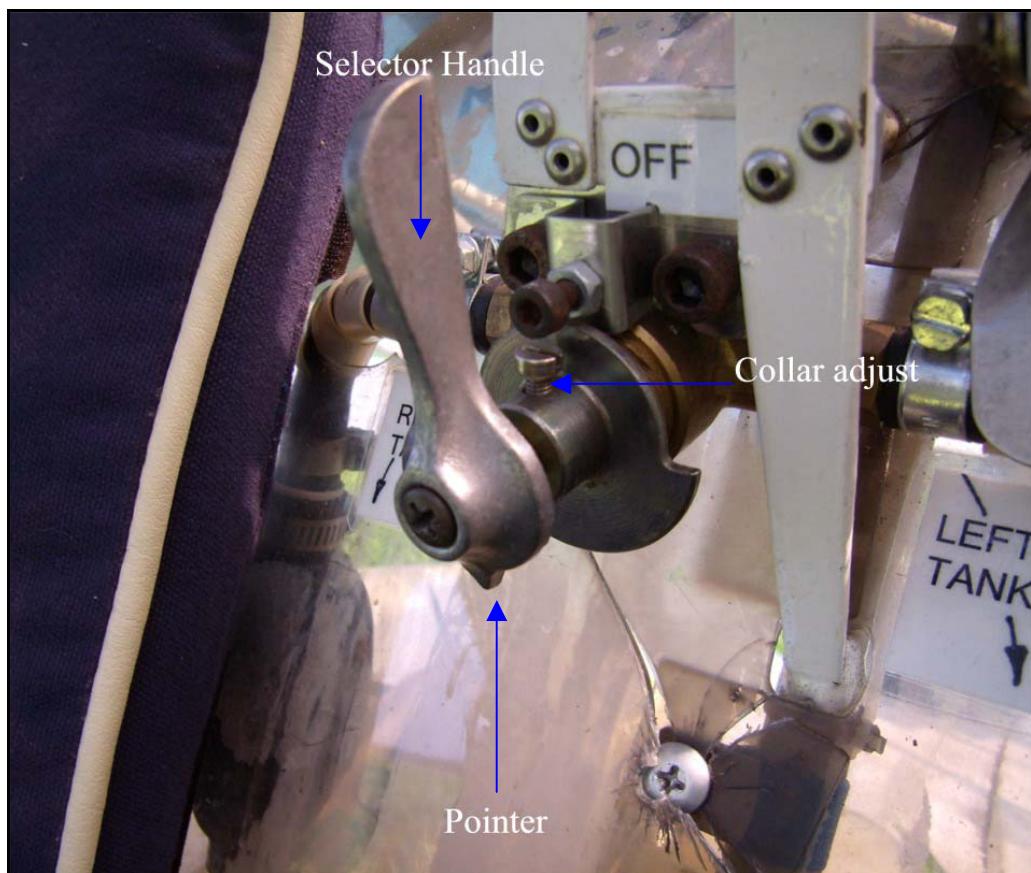
Examination of the fuel selector revealed the selector lever to be 180 degrees out of correct position. As can be seen in **Photo No. 4**, the handle of the selector lever is aligned with the 'OFF' placard instead of the pointer. It was possible to rotate the selector lever through a full 360 degrees as the collar stop adjustment screw was not tightened sufficiently to restrict lever travel.

Photo No. 4: Fuel Selector

8. Permission was not obtained from the IAA to operate the aircraft in Ireland on a *Permit to Fly* issued in the United Kingdom.
9. The collar stop on the fuel selector was found sufficiently loose to allow full 360-degree rotation of the fuel selector lever.

10. The fuel selector was found 180 degrees out of proper alignment.
11. The left fuel tank contained approx. 4 ½ US Gallons of fuel; the right fuel tank contained only a small quantity of unusable fuel.

Mismanagement of the fuel system, due to the fuel selector lever being 180 degrees out of proper alignment, led to exhaustion of the useable fuel in the right tank and stoppage of the engine.
