FINAL REPORT

AAIU Synoptic Report No: 2008-007
AAIU File No: 2007/0075
Published: 09/05/2008

Aircraft Type and Registration:	Hughes H369HS, N239MW	
No. and Type of Engines:	1 x Allison T63-A-5A	
Aircraft Serial Number:	110288-S	
Year of Manufacture:	See Section 1.5	
Date and Time (UTC):	07 July 2007 @ 12.30 hrs UTC	
Location:	Athlone, Co. Westmeath.	
Type of Flight:	Private	
Persons on Board:	Crew - 1	Passengers - 1
Injuries:	Crew - Nil	Passengers - Nil Other - 1 (Minor)
Nature of Damage:	Nil	
Commander's Licence:	PPL(H), issued by FAA	
Commander's Details:	Male, aged 48 years	
Commander's Flying Experience:	See Section 1.4	
Notification Source:	Irish Aviation Authority (IAA)	
Information Source:	AAIU Field Investigation

SYNOPSIS

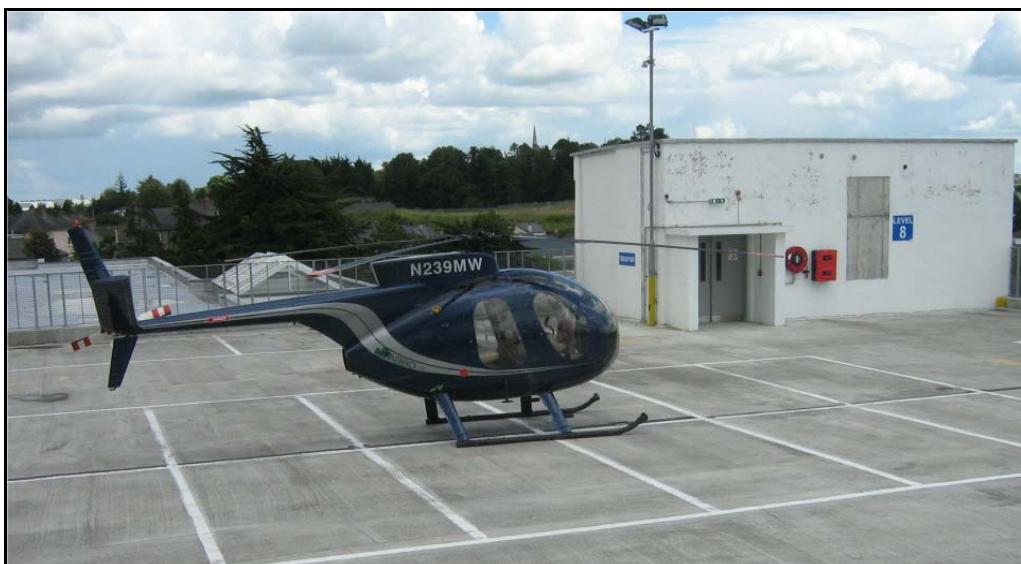
Photo No. 1: Supplied by Car Park Manager

The photograph above was taken from the upper section and faces east. To the right is the entrance and doors to the stairwell where the attendant stated he took refuge. Behind the tail of the helicopter (out of view) is the spire of a local church. The roof of the shopping centre and its 'A' framed glass skylights can be seen over the tail boom of the aircraft. The car park was formerly owned by the owner of the shopping centre, who sold it on to a car parking company. It was not an IAA approved heliport.

Despite the appearance of **Photo No: 1** of open space the area is quite congested as it is in the central shopping area of Athlone, a large town. It is unclear to the Investigation where the helicopter could have been safely force landed in the event of an engine failure during landing or take off. It is also probable that the approach was made over the unstressed roof of the shopping centre due to the location of the church to the north of the landing site. The shopping centre was open for business at the time, and for obvious safety reasons, the area should have been completely avoided. In landing at such a site the pilot displayed poor airmanship.
