AAIU Synoptic Report No: 2008-008
State File No: 900951
AAIU File No: 2007/0086
Published: 23/05/2008

Aircraft Type and Registration:	Robinson R44 EI-TOY
No. and Type of Engines:	1 x Lycoming O-540-F185
Aircraft Serial Number:	1294
Year of Manufacture:	2003
Date and Time (UTC):	23 Sept 2007 @ 11.27 hrs
Location:	UCD Belfield, Dublin
Type of Flight:	Private
Persons on Board:	Crew - 1 Passengers - 0
Injuries:	Crew - Nil Passengers - Nil
Nature of Damage:	None
Commander's Licence:	CPL (H)
Commander's Details:	Male, aged 41 years
Commander's Flying Experience:	1,600 hours, of which 650 hours were on type
Notification Source:	Dublin ATC Watch Manager
Information Source:	AAIU Field Investigation

SYNOPSIS

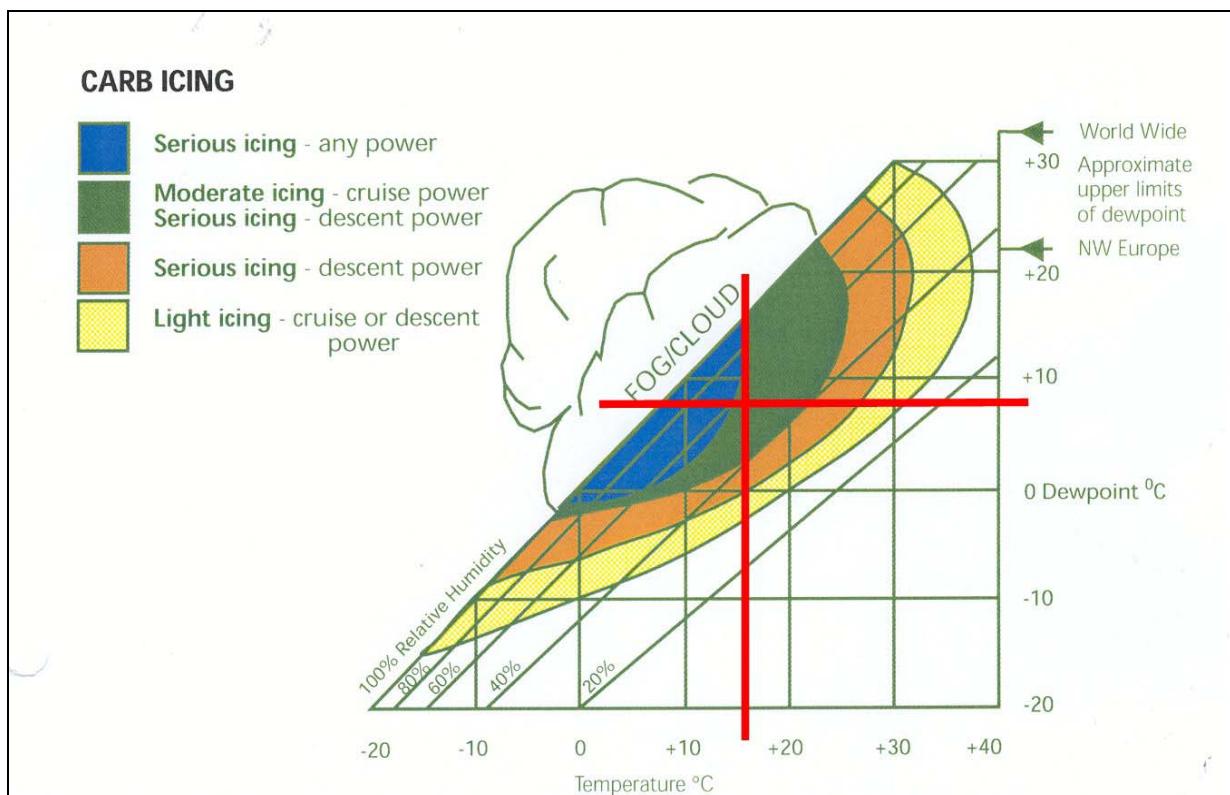
Figure 1

2.1 The Investigation plotted the ambient temperature and humidity for the day of the incident, using the Met Éireann data, on the standard carburettor-icing diagram, as shown on Figure 1. This shows that the temperature/dew point conditions were such that the helicopter was operating in the zone where moderate carburettor icing could be expected at cruise power or severe icing at descent power, and very close to the zone where serious icing could be expected at any power setting. The fact that the helicopter was operating in a light configuration with only one pilot and approximately 60% of fuel capacity, would have meant that a relatively low power setting would be required in the cruise, thereby further increasing the susceptibility to carburettor icing. Furthermore the presence of mountain wave, and its associated large vertical movements in the local air mass, could have produced localised conditions which may have moved the local environment into the Serious Icing - At Any Power Setting - zone.

This figure shows the plot of the temperature and dew point in the Belfield area, at 1,000 ft, at the time of the incident, superimposed on the standard chart for carburettor icing. The data indicates that the helicopter was operating in the Moderate Icing – at cruise power - Zone and close to the boundary of the Serious Icing - at any power setting – Zone.
