FINAL REPORT

AAIU Synoptic Report No: 2008-009

AAIU File No: 2008/0008

Aircraft Type and Registration:	Piper PA34-200 Seneca II, G-EZYU	
No. and Type of Engines:	2 x Lycoming IO-360-CIE6	
Aircraft Serial Number:	34-7450110	
Year of Manufacture:	1974	
Date and Time (UTC):	16 February 2008 @ 16.46 hrs	
Location:	Galway Airport	
Type of Flight:	Private	
Persons on Board:	Crew - One	Passengers - One
Injuries:	Crew - Nil	Passengers - Nil
Nature of Damage:	Substantial	
Commander's Licence:	UK PPL (A)	
Commander's Details:	Male, aged 47 years	
Commander's Flying Experience:	310 hours, of which 21 hours were on twin-engine aircraft.	
Notification Source:	Manager, Galway Airport	
Information Source:	AAIU Field Investigation. AAIU Accident Report Form submitted by the Pilot.

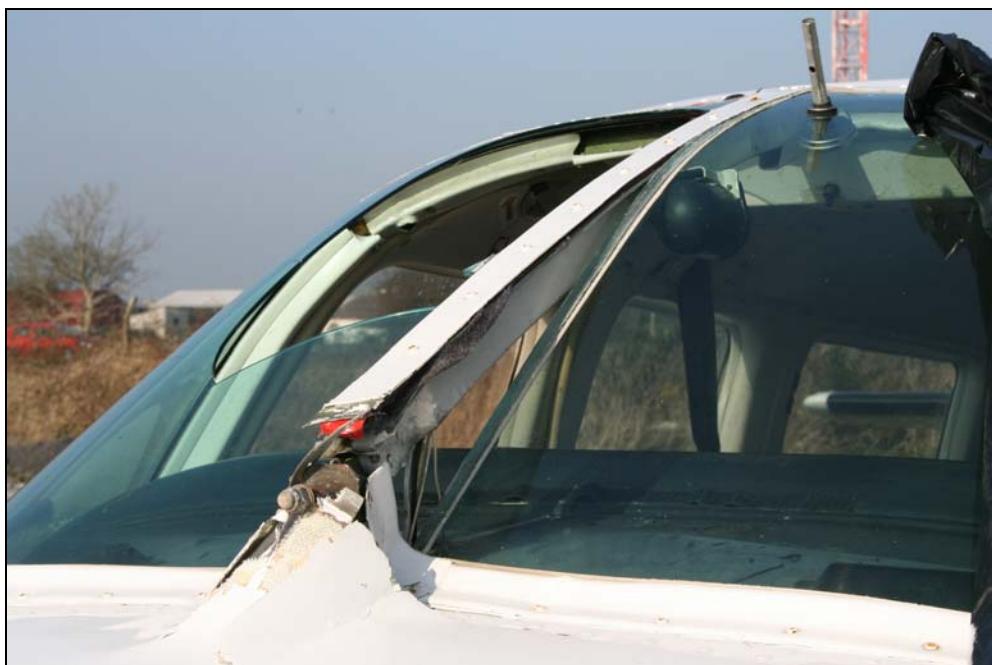
Fuselage and Wings: The complete nose gear and its attaching frame were found pushed upwards by the heavy landing. The main 'A' frame holding the windscreen centre support penetrated the fibreglass nose of the aircraft and jutted about 4" above that surface (**Photo No. 1 and Figure No. 1**). The right hand windscreen was cracked and broken. There were crease marks on the underwing panel behind the port engine.

Photo No. 1: Showing apex of 'A' frame protruding 4 inches above fuselage nose and the severed windscreen support.
