FINAL REPORT

AAIU Synoptic Report No: 2008-010

Aircraft Types and Registrations:	(1) Bombardier BD-700-1A10, N20EG (2) Bombardier BD-700-1A10, N6VB
No. and Type of Engines:	(1) 2 x Rolls Royce - BR 700 (2) 2 x Rolls Royce - BR 700
Aircraft Serial Numbers:	(1) 9038 (2) 9144
Years of Manufacture:	(1) 1999 (2) 2004
Date and Time (UTC):	04 July 2007 @ 14.54 hrs
Location:	Dublin Airport (EIDW)
Type of Flight:	Not Applicable
Persons on Board:	Crew - Nil Passengers - Nil
Injuries:	Crew - Nil Passengers - Nil
Nature of Damage:	(1) Radome and radome bulkhead (2) Wing tip and winglet
Information Source:	AAIU Investigation
Notification Source:	Duty Manager, Dublin Airport Authority

SYNOPSIS

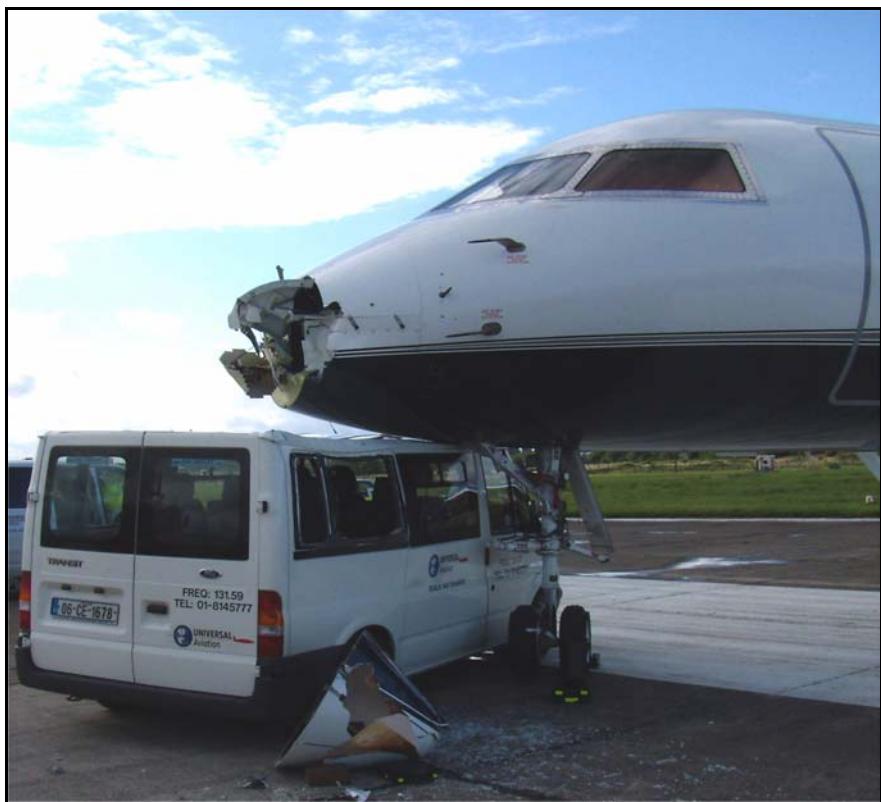
Photo No. 1: Damage to N20EG and Marshaller's van

The parked aircraft, N20EG, was correctly positioned behind the red boundary line. Its nose was substantially damaged. It had slewed to starboard and mounted the roof of a crew van that had been parked close by. The nose oleo strut was fully extended with the nose wheel 5 cm off the ground.

The radome of N20EG had detached and was lying on the ground. The radar antenna was damaged. The bulkhead on which the antenna was mounted had opened on the port side and pulled away from the stringers, some of which were visible. The nose of N20EG was resting on the roof of the van, which was carrying the weight of the front of the aircraft. The nose gear was fully extended with the tyres about 5 cm off the ground and nose steering link was disconnected. That area of the aircraft nose in contact with the roof of the van appeared indented (**Photo No. 1**).

The roof of the van was depressed with the rear windows broken. Though damage was significant the van was subsequently repaired.

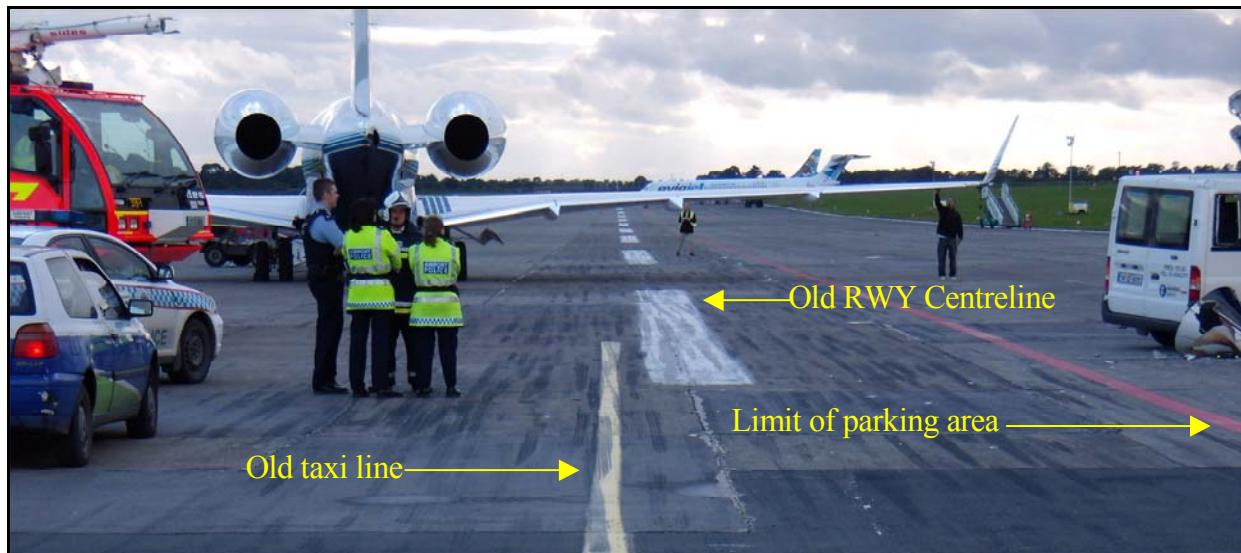
Photo No. 2: Starboard wing of towed N6VB, facing west on RWY 11/29

The towed aircraft, N6VB, was a little further up the runway still attached to the tug. Its right hand wing projected over the red boundary line into the parking area. The wingtip, winglet and navigation light assembly were damaged (**Photo No. 2**).

The damage to N6VB appeared relatively minor being confined to the wingtip and winglet base with the starboard light assembly destroyed.

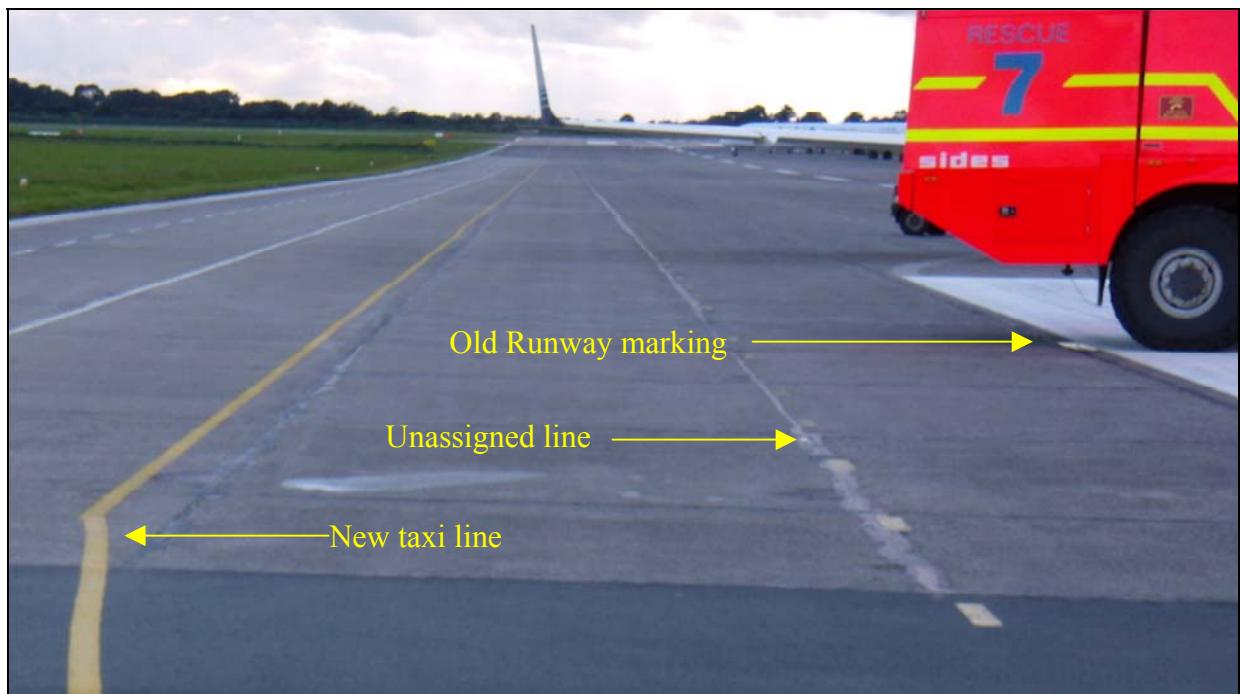
Photo No. 3: Port wing of the towed N6VB, facing west on RWY 11/29

In addition, the Investigation observed a significant number of lines or markings on the disused runway. These included old runway markings, roadway markings on the southern edge, old taxiway lines and new taxi lines associated with a new Aerodrome directive (**Photo Nos. 2 & 3**).

- (1) A thin broken yellow line (new taxiway line), leading to a solid line (**Photo No. 4**) that he was already on, and if followed would have led to the left hand side of RWY 11/29 (**Photo No. 3**).
- (2) A normal width solid taxiway line (old taxiway line) that lead straight ahead to the centreline of the old RWY 11/29 (**Photo No. 4**).

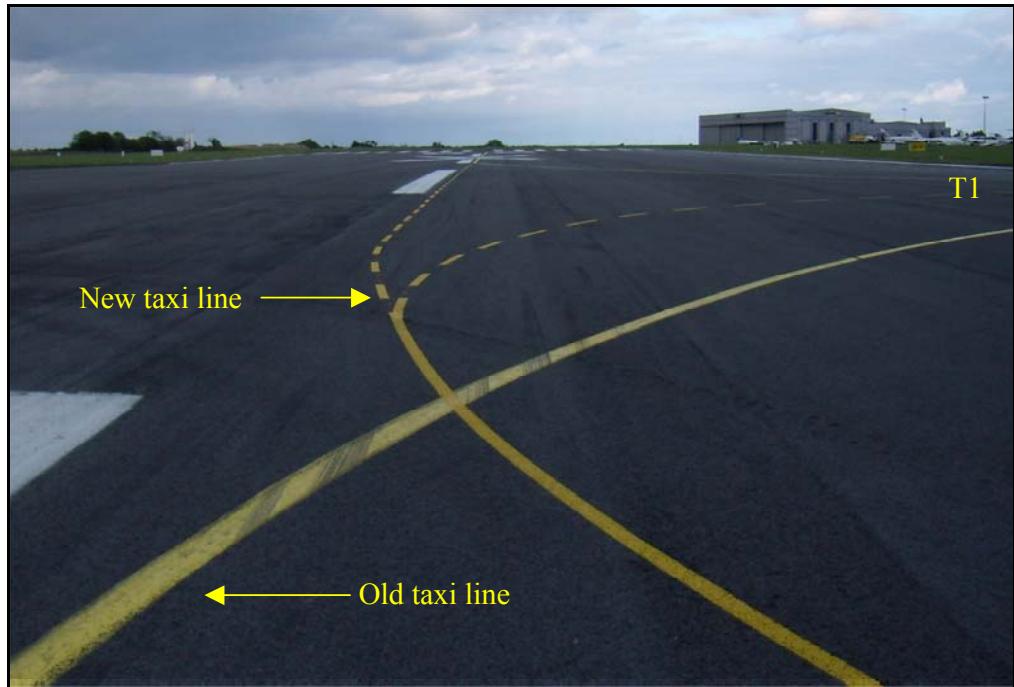
Photo No. 4: Facing east along RWY 11/29
The direction from which the tow would have come.

The Investigation also observed two crossing taxi lines leading towards the temporary parking area. The new taxi line was narrower and irregular compared to the older. It was also discontinuous to the east in the vicinity of taxiway intersection T1 (**Photo No. 4**).

Although the new taxi line marking was yellow, this was narrower than usual and discontinuous at the intersections. In addition, some changes in direction were angular and not the smooth curves associated with a taxi line. It is possible that these properties influenced the driver and caused him to feel that the line looked more like a roadway edge line than a taxi line. The Investigation notes that the old taxi line was later erased and that the new taxi line is regular and continuous. Thus, this possible cause of confusion has been removed.

1. The Dublin Airport Authority should ensure that its taxiways are adequately marked before unescorted, towed aircraft uses them. [\(SR 06 of 2008\)](#)
2. That the handling agency makes its tug drivers aware that they should not operate equipment in an unserviceable condition. [\(SR 07 of 2008\)](#)

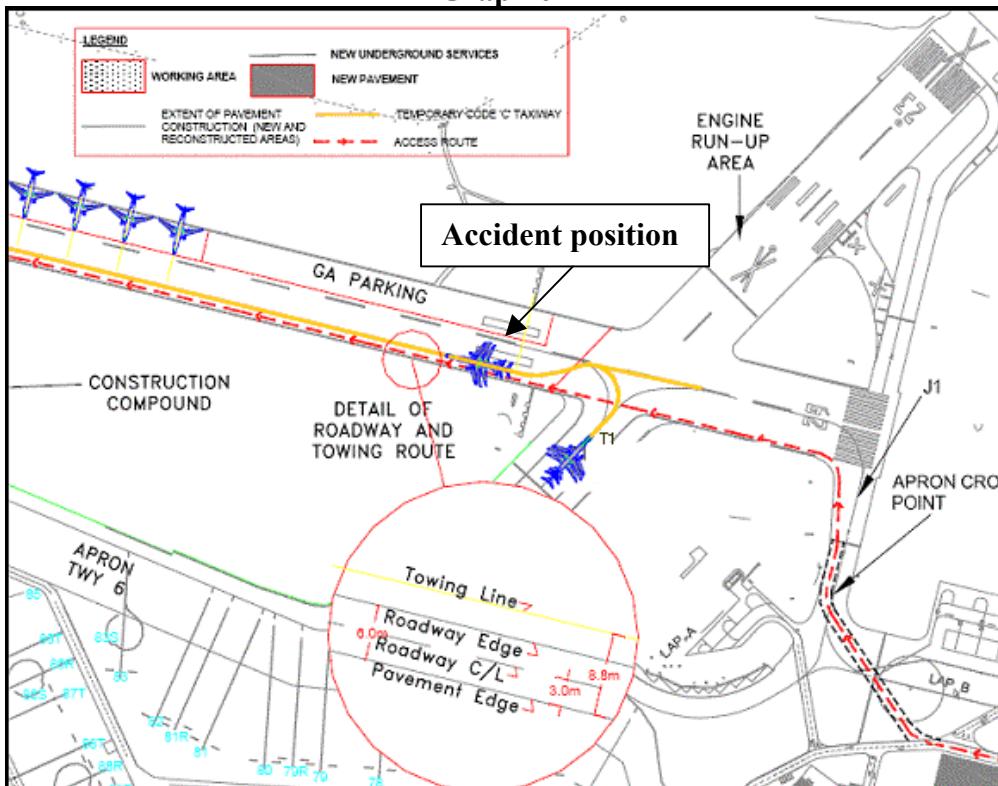
Graphic 1

Extract from Aerodrome Directive 21B/2007

The markings on the surface of the disused RWY did not conform to the drawing details in AN 21B/2007. The Investigation notes that a previous accident involving a taxiing aircraft the AAIU commented on disused taxiway lines, which had not been removed. Although in this case the AN specified the maximum size of aircraft, the old yellow taxi line had not been removed and thus the potential for confusion existed.
