FINAL REPORT

AAIU Synoptic Report No: 2008-011

Aircraft Type and Registration:	Cessna 206, G-SKYE
No. and Type of Engines:	1 x Continental TSIO-520-M
Aircraft Serial Number:	TU206G-04568
Year of Manufacture:	1978
Date and Time (UTC):	21 April 2007 @ 13.16 hrs
Location:	Hacketstown (EIHN), Co. Carlow
Type of Flight:	Aerial work
Persons on Board:	Crew – 1 Passengers – 5
Injuries:	Crew – Nil Passengers – 2 (Serious)
Nature of Damage:	None to aircraft
Commander's Licence:	UK PPL
Tandem Master Licence:	Parachute Association of Ireland (PAI) Licence No. 470
Tandem Master Total Jumps:	1,920
Notification Source:	Member of the public
Information Source:	AAIU Field investigation

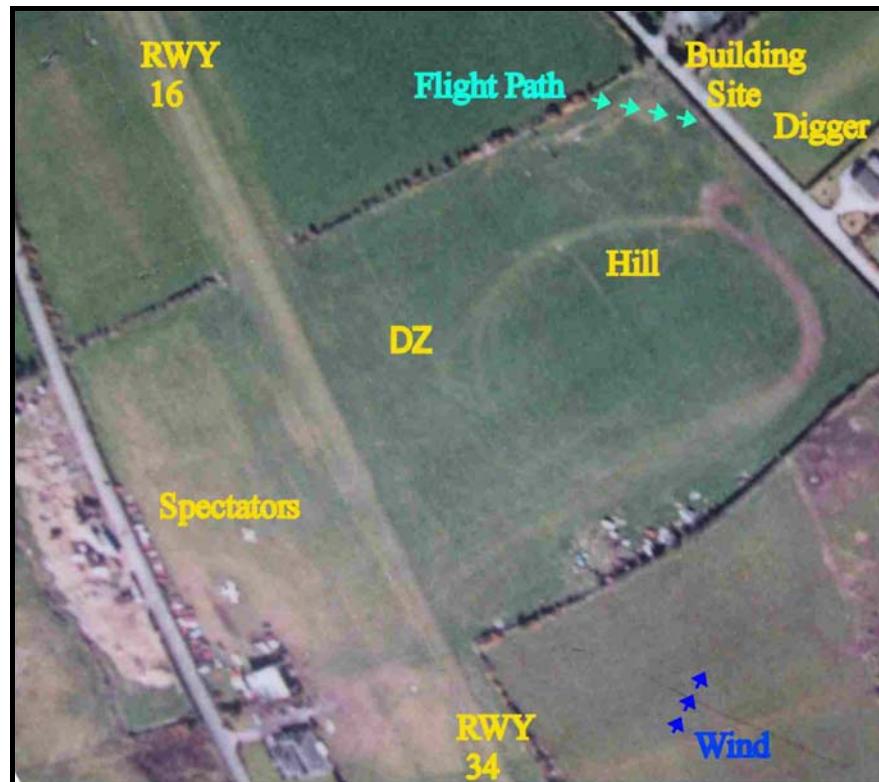
Photo No. 1: EIHN – Aerial view supplied by Parachute Club

A short time later, the tandem pair was found under the cab and between the tracks of a mechanical digger that was facing in the direction of the airfield and located in a field close to the DZ (**Appendix 2, Photo No.1**).

It is noted from **Appendix 2** that there are three sets of electric cables between the landing area and the accident site. These cables comprise both power and telephone lines, the power lines being the nearer to the DZ. Thus, when the TM found he was being driven towards the electric cable his decision to try to avoid them was understandable.
