FINAL REPORT

AAIU Formal Report No: 2008-013
AAIU File No: 2006/0040
Published: 08/07/2008

Operator: National Flight Centre
Manufacturer: Cessna
Model: 150 M
Nationality: Irish
Registration: EI-CHM
Location: Raharney, Co. Westmeath, Ireland
Date/Time (UTC): 25 May 2006 @ approximately 08.59 hrs UTC ¹

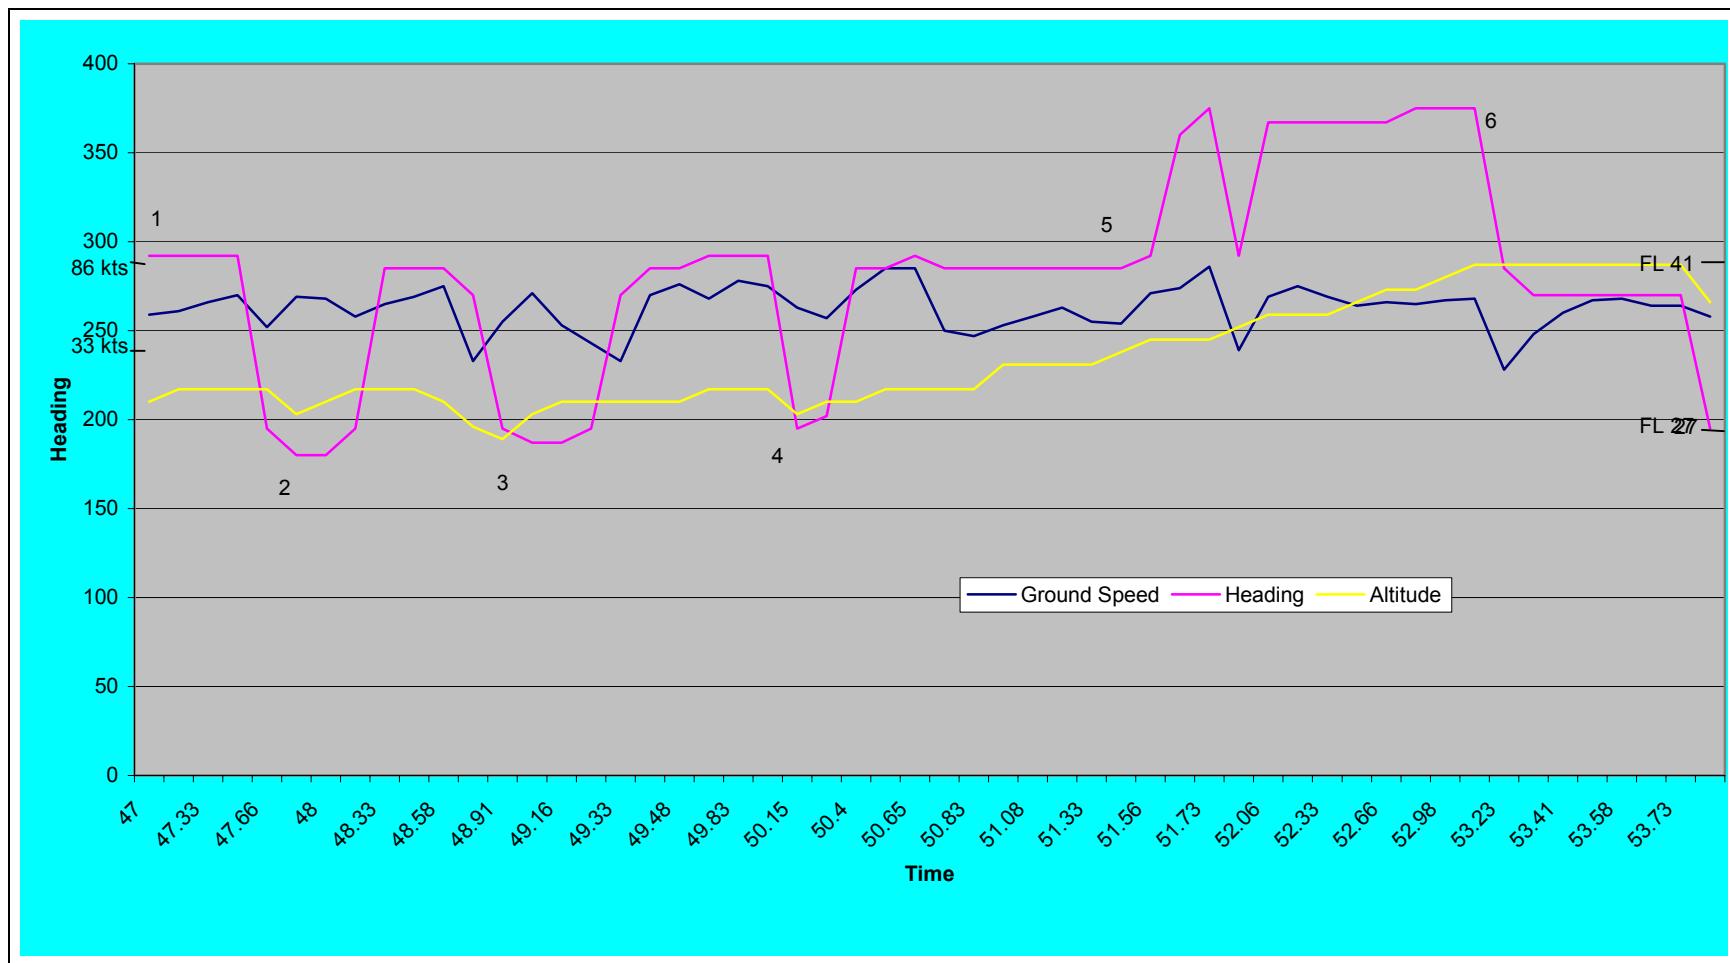
Appendix B

The ARTAS tapes were replayed on the ATC playback machine and flight parameters of time, aircraft position, ground speed, flight level, and heading for intervening positions of the target were manually noted. These are reproduced in graphical form, along with aircraft track, starting from 08.47 hrs (**Appendix B**). It should be noted that the ground speed is that interpreted by the ground radar. The radar interprets the speed as a differentiation of the target distance from the radar head with respect to time. Also, that target positions recorded by the Investigation are at various points in the track and independent of radar signal intervals.

Bar Chart recording heading, groundspeed and altitude prior to loss of radar contact

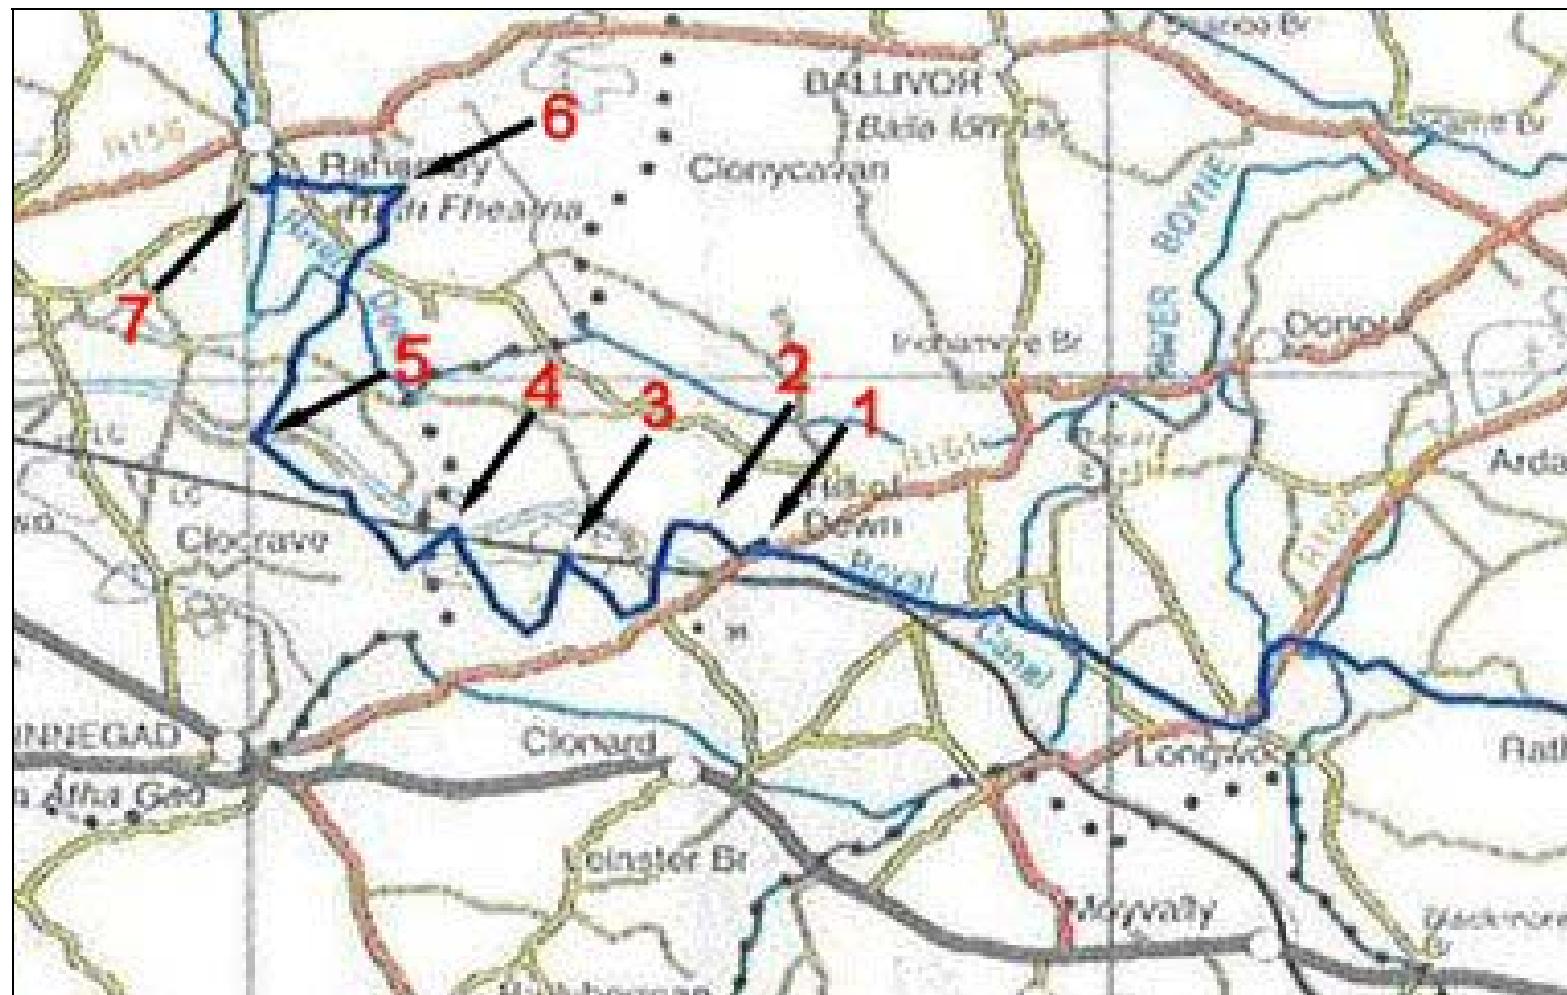
Appendix C

Map overlay of track made good prior to loss of radar contact

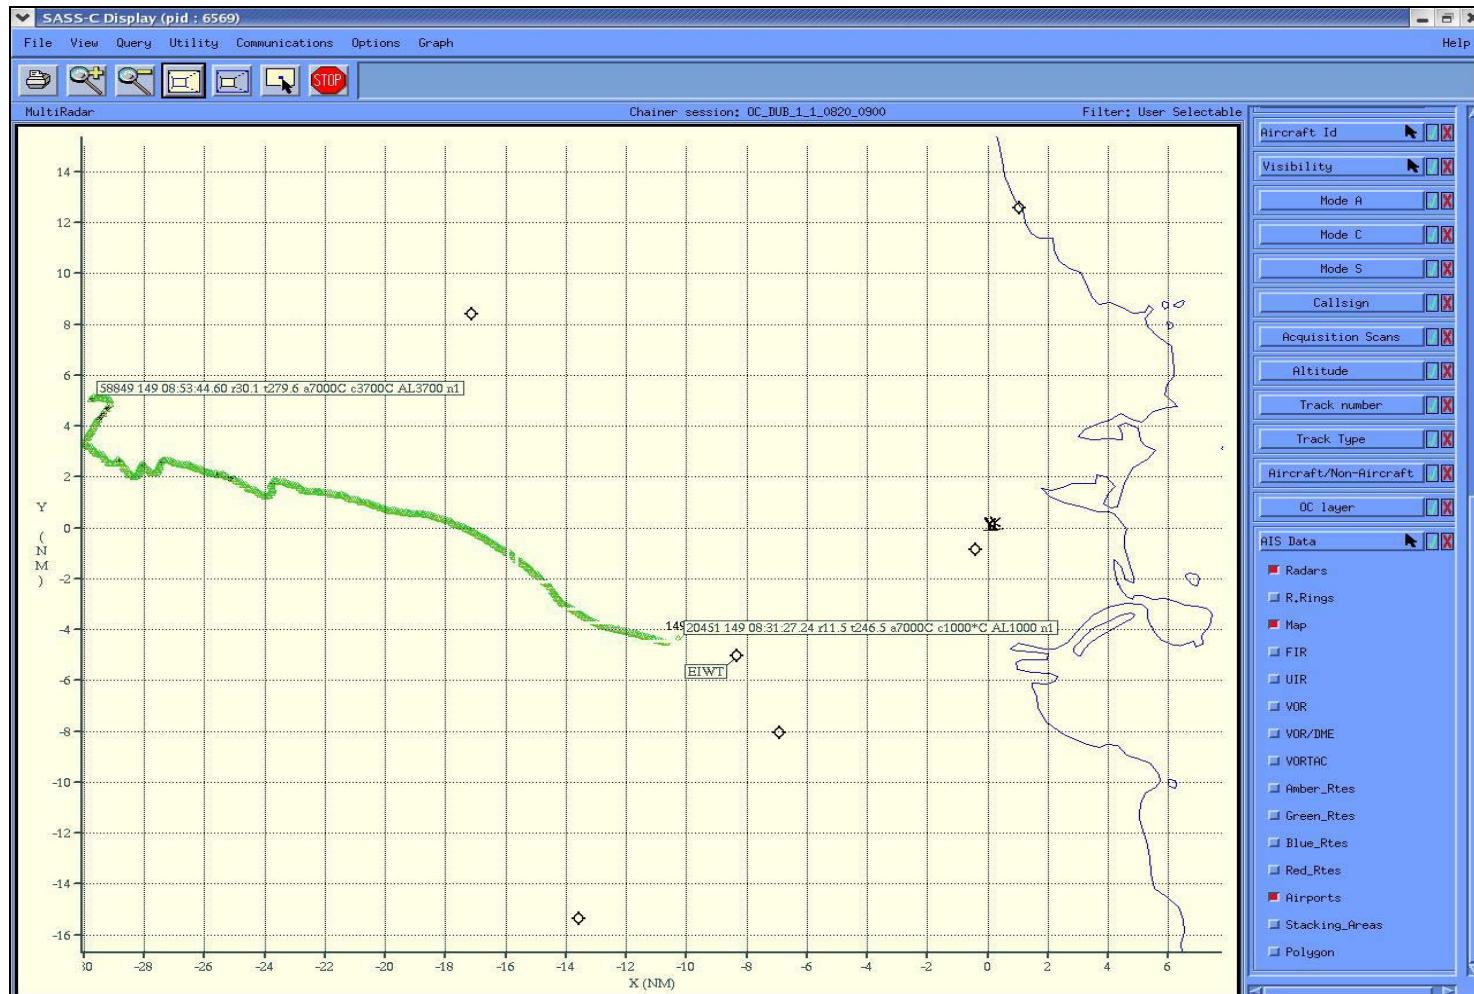
Appendix D

Screen Shot from Dublin Radar 1

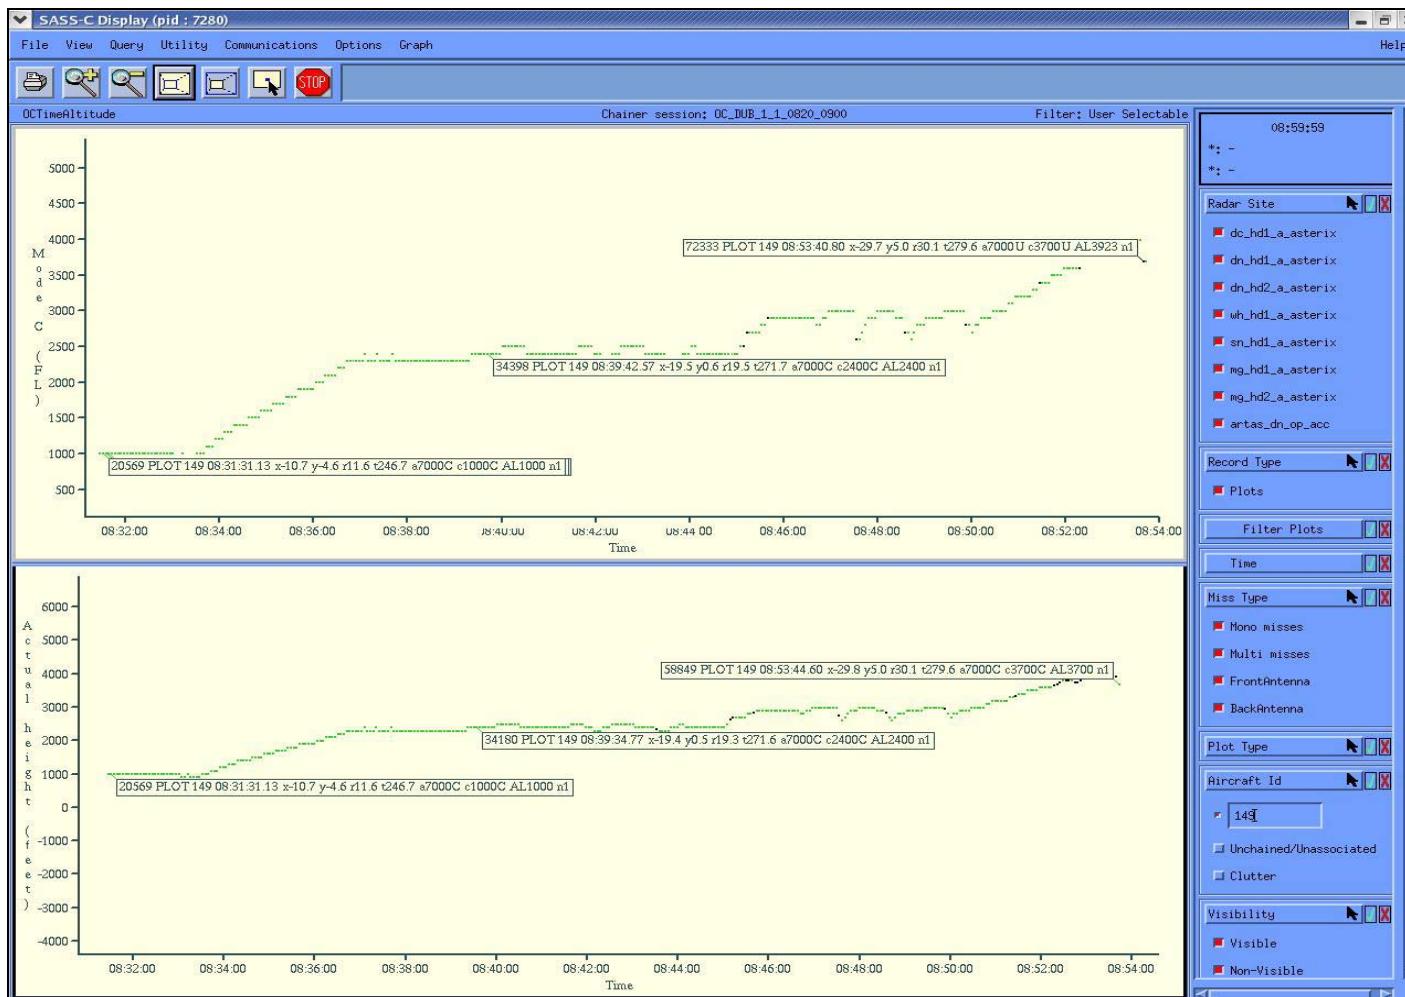
Appendix E

Screen shot showing Mode C Flight Level and Actual Height Vs Time

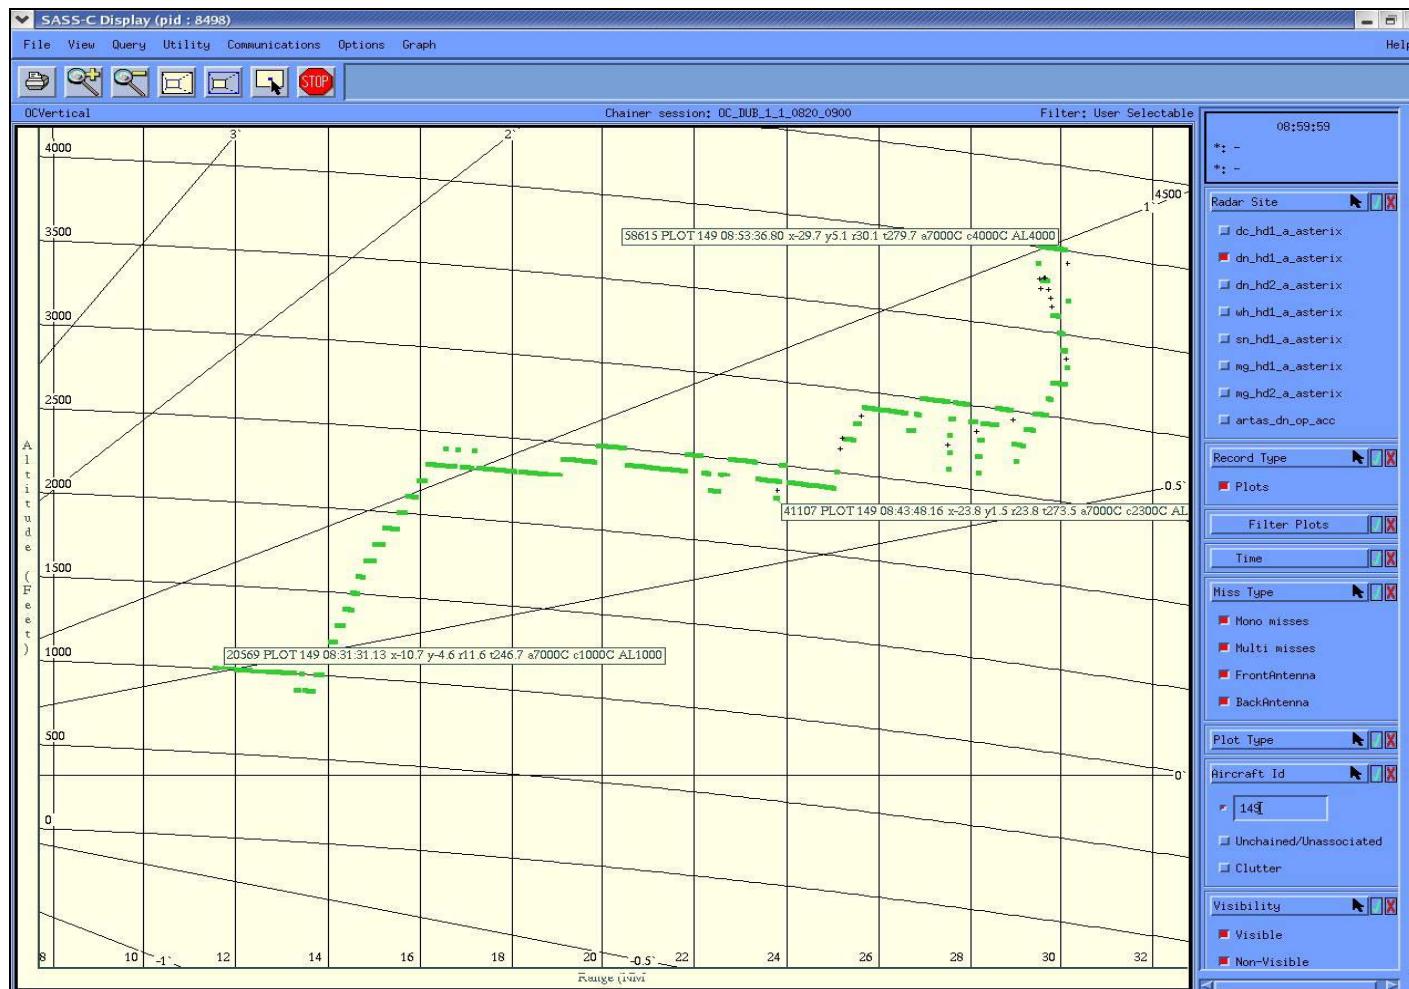
Appendix F

The screen dump at **Appendix F** shows the SASS system height (feet) v Range (NM). The range and bearing details displayed here are relative to Dublin Radar No.1 and are seen on the attached labels in terms of r (NM) and t (degrees). The height variations can be seen and also the secondary plots (green squares) are shown interspersed with return misses (black crosses). This is clearer here than in the previous screen dumps. One possible cause for these misses is probably due to the manoeuvring of the aircraft about its axes during flight at that time.

Screen Shot of Altitude (feet) Vs Range (NM)

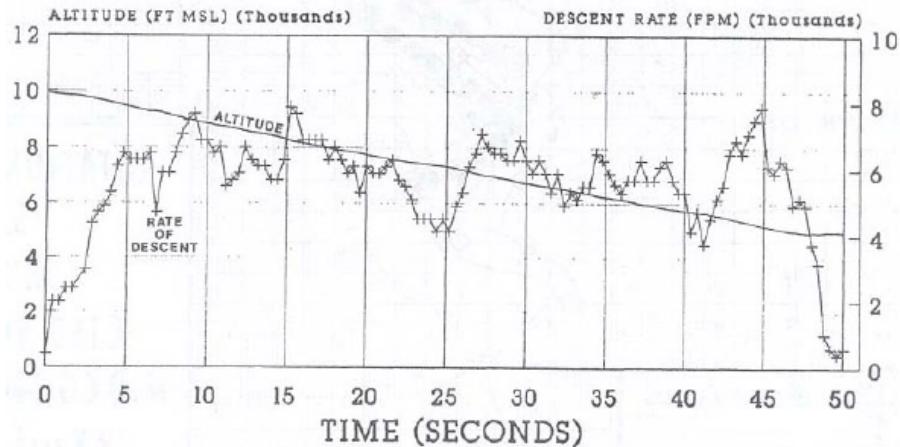
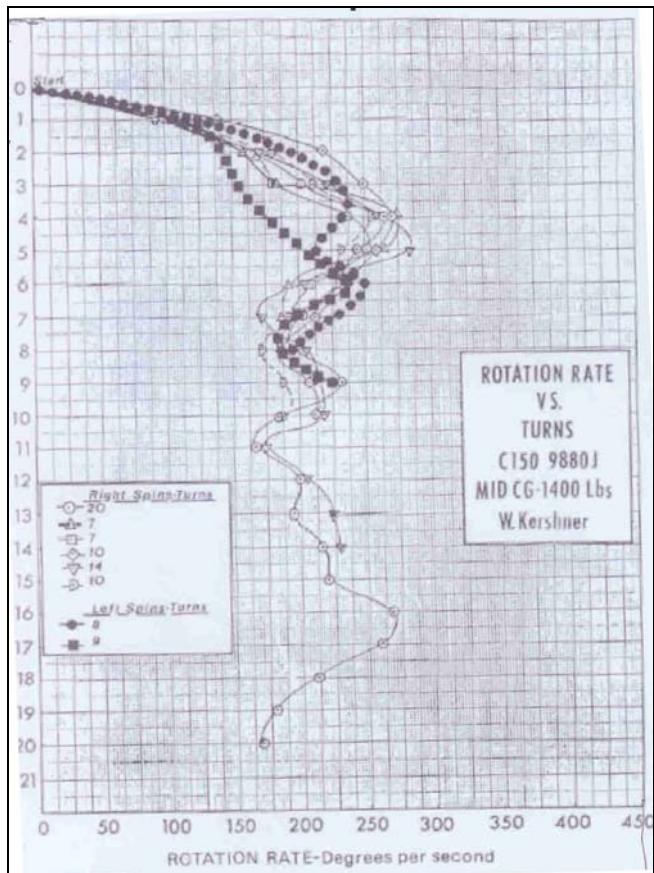
Appendix G

It should be noted (**Appendix G**) that both entry and exit from a spin will result in an accelerated height loss and therefore the average rate of descent will increase. However, the height from which the exercise commenced, the nature of the pre-test flight, the evidence of Witness No. 2 and No. 4 and the time discrepancy militates against this scenario. In addition, no Mayday call was made and giving consideration for the level of experience onboard the aircraft, the Investigation is of the opinion that a re-entered spin is unlikely to have happened. The fact that no Mayday call was made indicates that whatever occurred did so very suddenly.

Descent rates of up to 8000 fpm (80 kts)
achieved for C150 Aerobat.

The above charts of Descent Rate versus Time and Turns versus Turn Rate are reproduced from the published works of W. Kershner, former head of flight testing at Piper Aircraft, and an authority on aircraft spinning, in particular the Cessna 150 series.

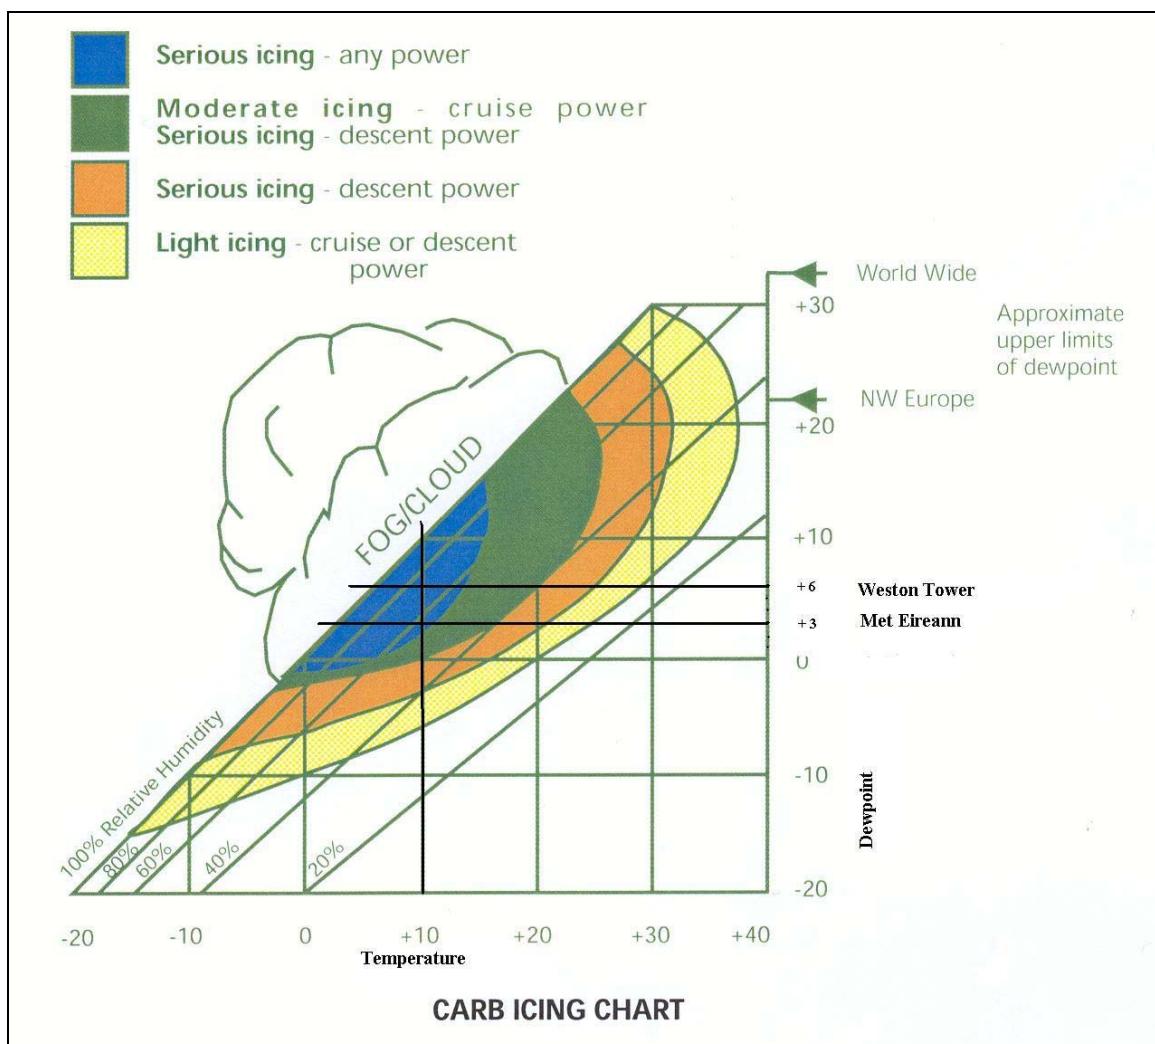
Appendix H

Chart indicates risk of serious icing at +3° and +6° respectively
