AAIU Synoptic Report No: 2008-014
AAIU File No: 2008/0039
Published: 11/07/2008

PRELIMINARY ACCIDENT REPORT

| Model: | BE77 Skipper |
| Registration: | EI-BHT |

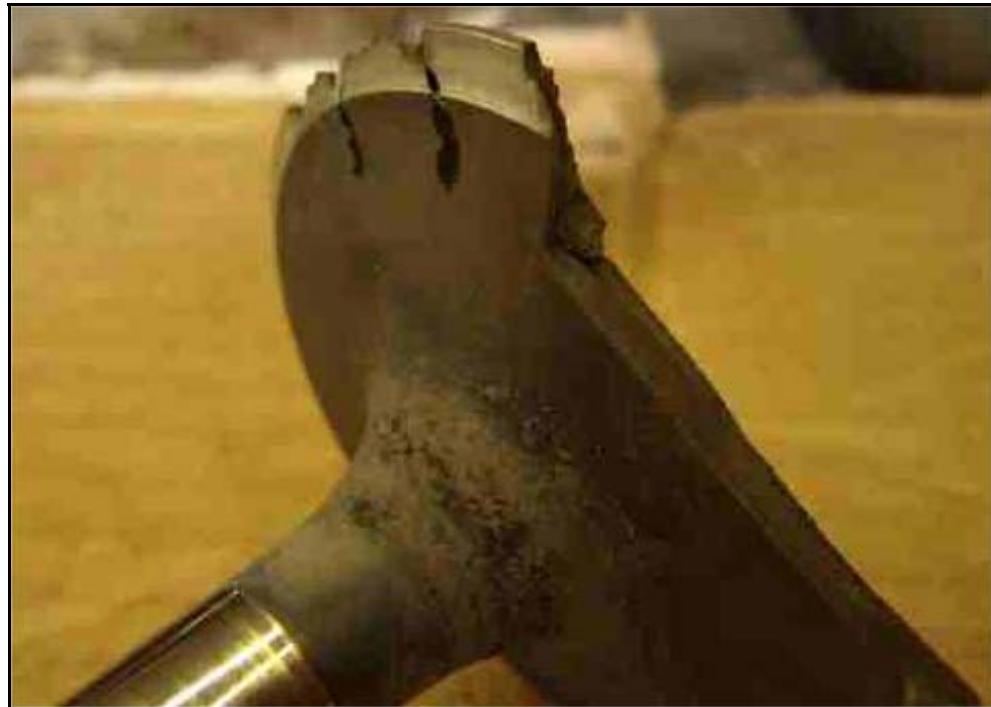
Inlet valve Cylinder No. 2

A strip examination of the engine was later conducted at the AAIU facility at Gormanston, Co. Meath, under the supervision of an AAIU Inspector. This examination determined that the inlet valves in Cylinder No. 2 and No. 3 were damaged with radial cracking extending from the valve seat towards the stem (**Appendix A**). A segment of the inlet valve in Cylinder No. 2 had separated and was found in Cylinder No. 4.

The cause of this radial cracking has yet to be determined and further research is required.
