FINAL REPORT

AAIU Synoptic Report No: 2008-018
State File No. IRL00900962
AAIU File No: 2007/0097
Published: 6/08/08

Aircraft Type and Registration:	Piper PA-34-200T, EI-CMT	
No. and Type of Engines:	2 x Continental TSIO-360E	
Aircraft Serial Number:	34-787-0088	
Year of Manufacture:	1978	
Date and Time (UTC):	7 November 2007 @ 09.33 hrs	
Location:	Co. Kerry, (Shannon CTA)	
Type of Flight:	Private	
Persons on Board:	Crew - 1	Passengers - 4
Injuries:	Crew - Nil	Passengers - Nil
Commander's Licence:	JAR CPL	
Commander's Details:	Male, aged 39 years	
Commander's Flying Experience:	1,900 hours, of which 250 were on type	
Notification Source:	Cork Airport ATC	
Information Source:	AAIU Pilot Report Form submitted by Pilot, AAIU Field Inspection

SYNOPSIS

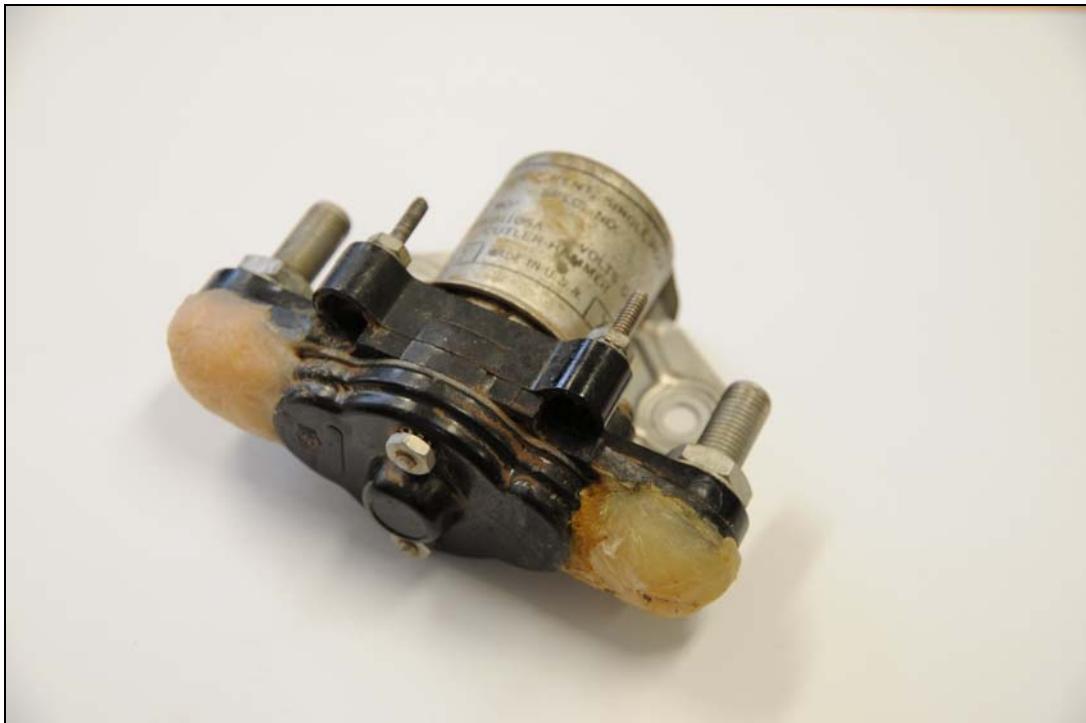
Appendix A

This aircraft is normally parked outdoors on the aircraft ramp. For the following tests, however, the aircraft was removed to an adjacent hangar. The aircraft was placed on aircraft jacks and the wiring in the nose bay inspected by the Operator's Contractor. The pilot's undercarriage control was set to the "UP" position but the electric motor/hydraulic pack had insufficient battery voltage in order to operate the hydraulic pump satisfactorily. The battery was removed from the forward nose compartment for charging. The master relay adjacent to the battery, Cutler-Hammer No. 604IH105A, was removed. It was noted that the relay had been modified during its service life. A form of epoxy (twin-pack) hard adhesive was found adhered to the rear of the main terminals probably as a form of corrosion protection. The relay was replaced along with its diode assembly.

Thus, the master relay appeared to function normally although the contact resistance seemed high.

The loss of all aircraft electrics during an IFR flight is considered very serious. The Investigation is of the opinion that the master relay had not been replaced during the 30-year life of the aircraft. However, at some stage it had been modified in a way which was not recommended by the manufacturer. Because of the location of the master relay in the exposed front of the fuselage and its importance in the electrical circuitry the Investigation is now of the opinion that the part should have been replaced at that time.

1. There was insufficient battery voltage to excite the field alternator windings. The poor condition of the master relay combined with a heavy electrical load following take off, could have been a contributory factor.

The Battery Master Relay (4.5 X 3 inches) installed in the nose of the aircraft showing the epoxy adhesive modification to main terminals.
