FINAL REPORT

AAIU Synoptic Report No: 2008-019
State File No: IRL00908040
AAIU File No: 2008/0040
Published: 14/08/08

Aircraft Type and Registration:	Piper PA44-180, EI-SKR
No. and Type of Engines:	2 x Lycoming 0-360-EIA6D
Aircraft Serial Number:	44-7995008
Year of Manufacture:	1979
Date and Time (UTC):	15 May 2008 @ 09.23 hrs
Location:	Waterford Airport (EIWF)
Type of Flight:	Training
Persons on Board:	Crew - 2
Injuries:	Crew - Nil
Nature of Damage:	Substantial
Commander's Licence:	CPL
Commander's Details:	Male, aged 53 years
Commander's Flying Experience:	1,560 hours, of which 285 were on type
Notification Source:	ATC Waterford Airport
Information Source:	AAIU Accident Report Form submitted by Pilot. AAIU Field Investigation

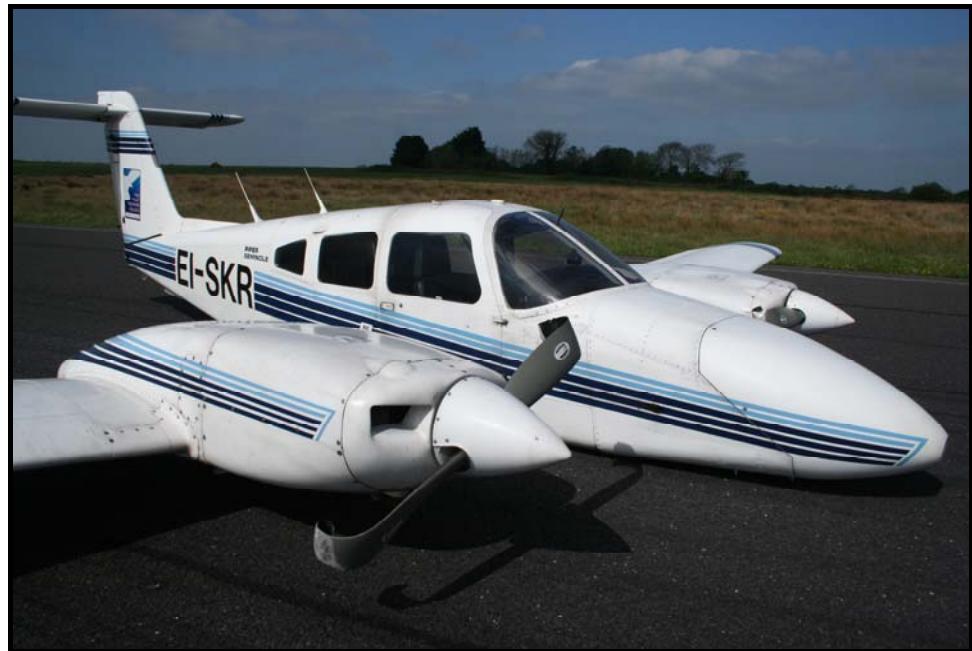
There was serious ground impact damage to the aircraft, including both propellers damaged beyond repair; both engines suffered shock loading and both flaps damaged beyond repair. In addition, various antennae and aircraft under surfaces were damaged due to the aircraft’s sliding action on the ground.

Photo No.1: Showing aircraft on RWY 03 (Waterford ATC photo)
