FINAL REPORT

AAIU Synoptic Report No: 2008-020
State File No: IRL00908047
AAIU File No: 2008/0047
Published: 18/08/08

| Aircraft Type and Registration: | UFM 10 XXL, OK-MUA 78 |

OK-MUA 78, a SAMBA microlight, struck the airfield boundary wire fence following an attempted go-around. Both Pilot and Passenger exited the aircraft safely.

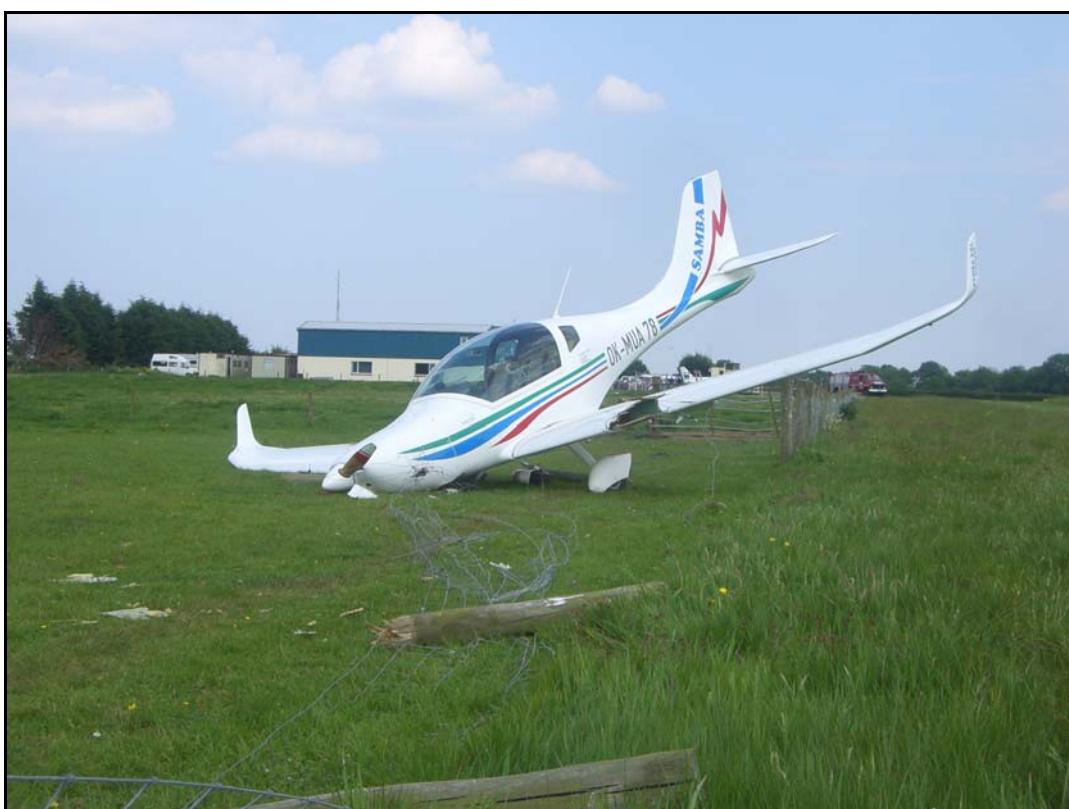
There was serious impact damage to the aircraft, including the front nose wheel, propeller, righthand main gear, wing and lefthand wing.

Photo No. 1: Impacted airfield boundary wire fence and broken posts.
