## FINAL REPORT

**AAIU Synoptic Report No: 2008-022**  
**State File No: 00908056**  
**AAIU File No: 2008/0056**  
**Published: 27/08/08**

<b>Aircraft Type and Registration:</b>	Samba XXL, OK-KUA 26
<b>No. and Type of Engines:</b>	1 x Jabiru 2200 A
<b>Aircraft Serial Number:</b>	SA-XL-28
<b>Year of Manufacture:</b>	2005
<b>Date and Time (UTC):</b>	28 July 2008 @ 20.05 hrs
<b>Location:</b>	RWY 27 - Kilkenny Airfield (EIKL)
<b>Type of Flight:</b>	Private
<b>Persons on Board:</b>	Crew - 1
<b>Injuries:</b>	Crew - Nil
<b>Nature of Damage:</b>	Substantial
<b>Commander's Licence:</b>	Student Pilots Licence (SPL)
<b>Commander's Details:</b>	Male, aged 69 years
<b>Commander's Flying Experience:</b>	59.14 hours, of which 59.14 were on type
<b>Notification Source:</b>	Duty Flying Instructor, Kilkenny Airfield
<b>Information Source:</b>	AAIU Pilot Report Form submitted by Pilot.

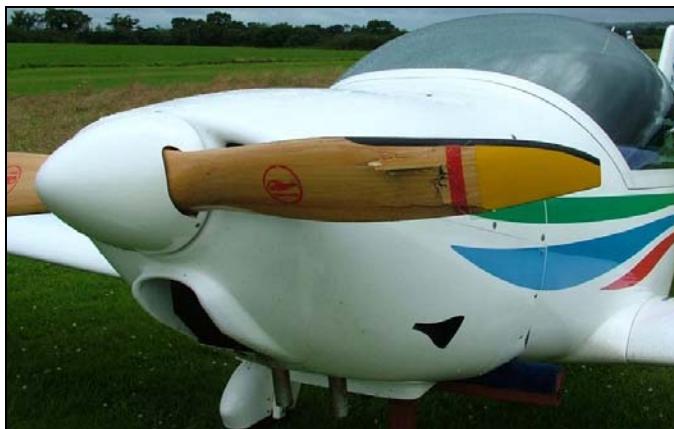
The nose wheel was severed and the wooden propeller suffered impact damage as did the underside of the fuselage (**Photo's No. 1 & 2**).

In a frank comment the Student Pilot considered the cause of the accident was due to him not holding the nose wheel of the tricycle undercarriage off sufficiently during the landing phase.

A mitigating factor may have been the downhill slope of RWY 27, which made the landing judgement that more difficult for the Student Pilot.

**Photo No. 1:** Propeller damage

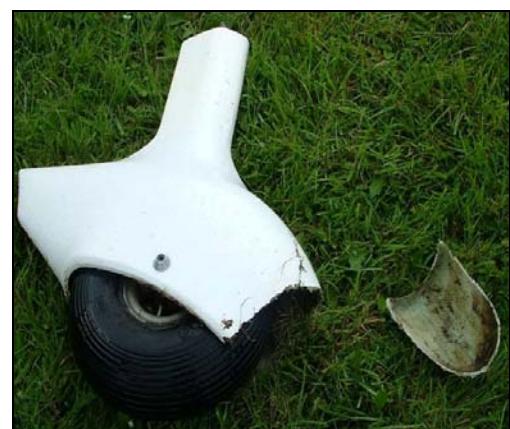
**Photo No. 2:** Severed nose wheel strut
