FINAL REPORT

AAIU Formal Report No: 2008-023

Operator:	Aer Lingus
Manufacturer:	Airbus
Model:	A330-301
Nationality:	Ireland
Registration:	EI-DUB
Location:	Approach to Runway (RWY) 22R, Chicago O'Hare Airport (KORD), USA
Date/Time (UTC):	16 September 2006 @ 21.45 hrs UTC

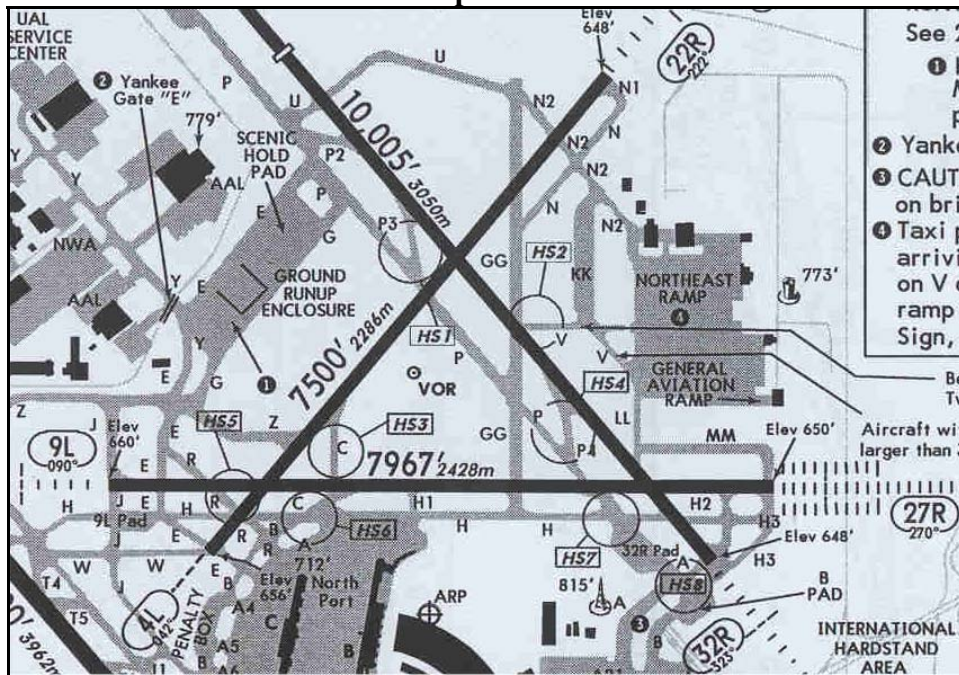
Graphic 1

Part of KORD Jeppesen Chart 10-9

Following a landing on 22R, an aircraft may exit the runway via taxiway C - the shortest distance to the International Hardstand Area at lower right where it will park. However, exiting by taxiway C is not always achievable, especially by heavier aircraft, and later exits to the left may have to be used. It was therefore important for the crew to prepare carefully for after-landing instructions.

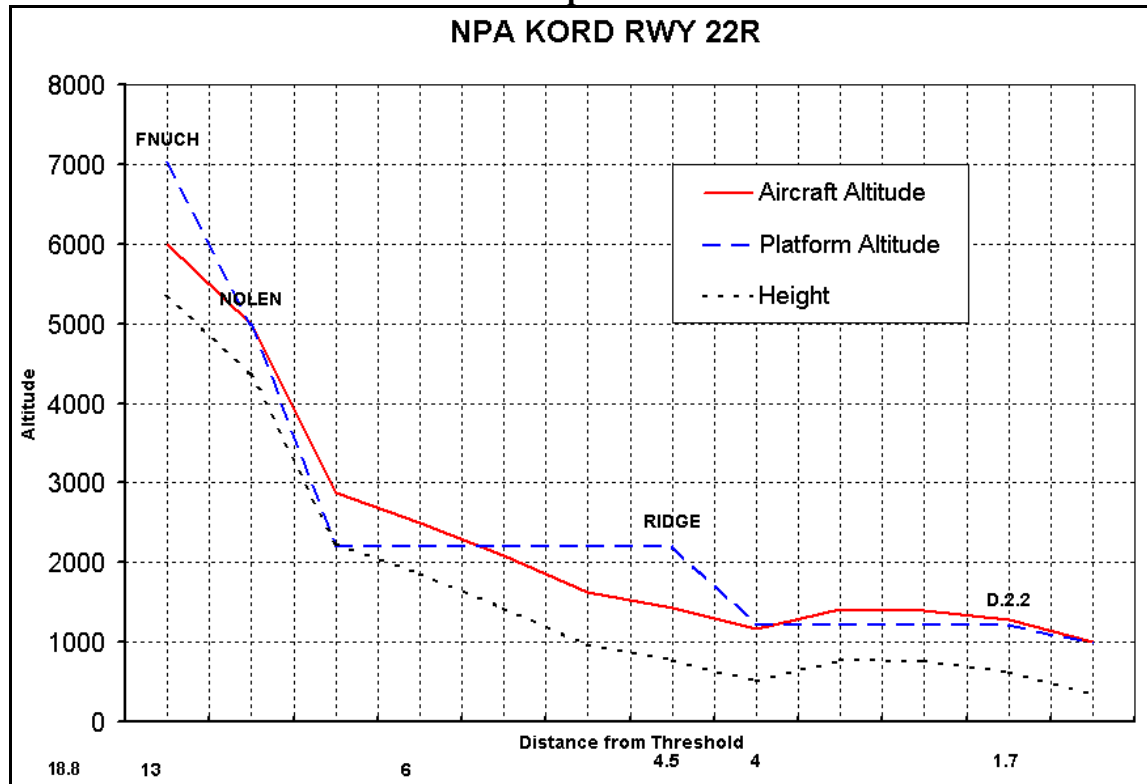
Graphic 2

The data showed the flight crossing waypoint FNUCH at 6,000 ft or 1,000 ft lower than the published approach height. This is a common ATC procedure. Passing NOLEN the aircraft was correctly positioned on the vertical profile. At 6 nm from the runway, it had descended 120 ft below platform. It continued the descent and reached its maximum deviation (774 ft) at RIDGE, 4.5 nm from the runway threshold.

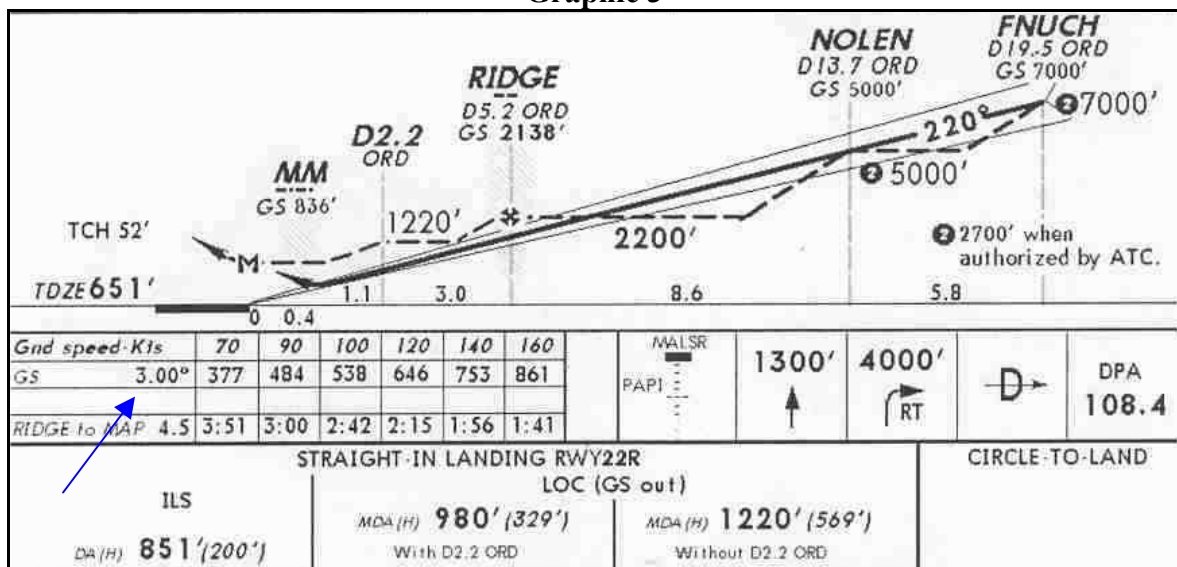
Graphic 3

This Graphic depicts the glide slope/glidepath⁸ of the published ILS RWY 22R at KORD and is an extract from Jeppesen Chart 21.8 of 10 MAR 06, **Appendix A, Chart 1.**

Glide Path ILS 22R KORD –

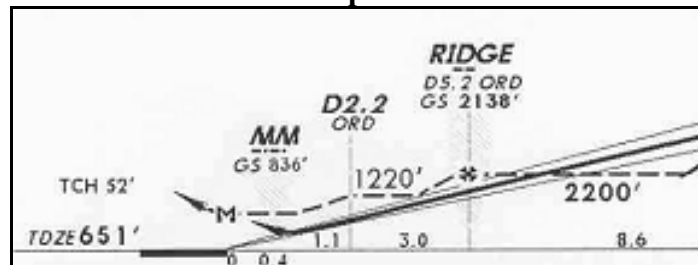
Graphic 5

The *G/P Angle* column identifies the descent angle of the platform heights for the published non-precision localiser approach to RWY 22R at KORD. Although the published glide slope angle is 3°, and that is the only vertical profile angle information available to the pilot, calculation shows that at the Final Approach Fix RIDGE the glidepath is 3.27° and at D2.2 it is 3.57°. This is reflected by platform heights on the Jeppesen approach chart showing above the glide slope, at RIDGE, at D2.2 and at Minima on the approach chart. In addition, the inter-fix angles confirm that picture. It is noted that there is no visual depiction of an NPA flight path on the AIP chart.

As the FPA selector of the aircraft is calibrated to a tenth of a degree and aircraft can fly to that level of accuracy, the Investigation is of the view that the published final glide slope angle should reflect reality. As the approach procedure has been constructed in accordance with TERPS and, as all the fixes are movable reference positions, the Investigation is unaware of any reason why the approach cannot be designed to provide a singular flight path angle and so facilitate stabilised approaches. The Investigation therefore believes that the FAA should review the KORD RWY 22R published glide slope and glidepath design.

The visual picture presented on the approach chart is quite distracting and confusing to a pilot unsure of his vertical flight path. In examining the approach chart non-precision vertical profile, the aircraft is depicted as high at both RIDGE and D2.2, if it maintains platform heights. This visual depiction is correct, as was borne out by the analysis of the flight path. However it is confusing, especially to a pilot who intends to perform a stabilised 3° glide path, in accordance with his SOPs. At a quick glance all he knows is that if he follows the platform altitudes he will be high, and that is not a good option when faced with a short runway. It is possible that this confusion contributed to the pilot's decision to ignore the platform height at RIDGE and concentrate on his height/distance profile, which he had incorrectly calculated.

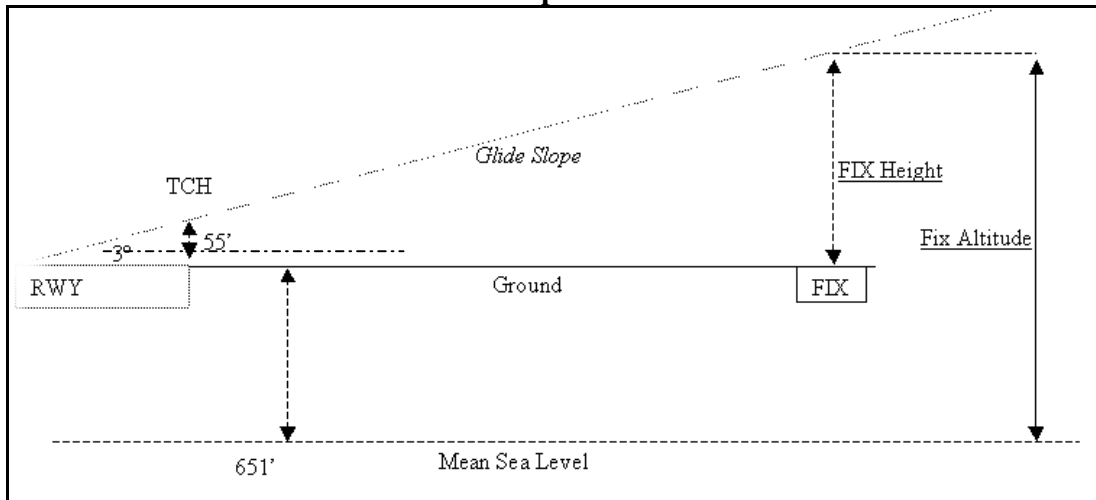
Graphic 5

A 3° angle was assumed to commence at 55 ft over the runway threshold, which is the Threshold Crossing Height (TCH) identified in the FAA TERPS manual for larger air transport Group 4 aircraft.

The Haversine formula, which is sufficiently accurate for this analysis, was used to determine inter-fix distances from their geographic co-ordinates, this when summed resulted in distances to the runway threshold. These international nautical mile distances were converted to feet.

The elevations at the various fix distances were then calculated (distance x tangent 3°). The TCH and RWY 22R altitude (55 + 651 = 706) were then added to give the *Theoretical 3° Platform Altitudes* at the fix positions.
