FINAL REPORT

AAIU Synoptic Report No: 2008-024
State File No. 900662
AAIU File No: 2004/0042
Published: 22/09/08

Aircraft Type and Registration:	Grob 115A, EI-CAC
No. and Type of Engines:	1 x Lycoming O-235-H2C
Aircraft Serial Number:	8092
Year of Manufacture:	1989
Date and Time (UTC):	17 May 2004 @ 12.00 hrs
Location:	Kilrush Airfield
Type of Flight:	Private
Persons on Board:	Crew - 1 Passengers - Nil
Injuries:	Crew - Nil Passengers – Nil
Nature of Damage:	None
Commander's Licence:	Student Pilots Licence (SPL)
Commander's Details:	Male, aged 44 years
Commander's Flying Experience:	40 hours of which 35 hours were on type
Notification Source:	Aircraft Operator
Information Source:	Aircraft Operator

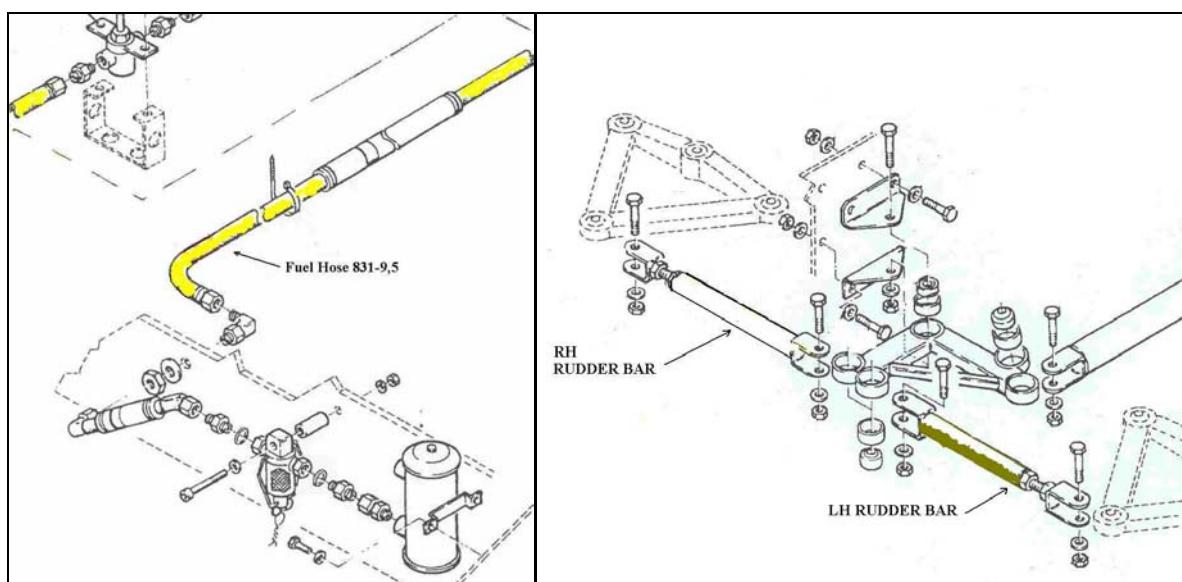
Appendix A

Upon examination of the cockpit area by the Operator, it was found that the smell was due to a leak in the feed hose from the fuel selector valve to the back of the firewall. The hose had been rubbing against the rudder pedal crossbar (the adjoining bar that links both rudder pedal units – see **Appendix A**), for what must have been a reasonably long period of time. The hose in question was removed and in due course a length of this hose was forwarded to the AAIU.

The Operator then checked a third aircraft, G-BYFD (Serial 8100) and this again had the same problem. In all three cases, the length of hose in question was replaced. It would appear that the original hose units were marginally too short causing them to be in the way of the rudder crossbar. The Operator checked the fourth Grob G115A of the fleet and the hose did not appear to be impinging upon the rudder mechanism, and did not have any wear marks on it.

The hose was overdue replacement as per the aircraft Manufacturer's requirements.

The fuel hose (831-9,5), which rubbed against the LH rudder pedal crossbar

The Operator replaced all the affected units with 20 mm longer hoses. The Manufacturer did specify an exact length for the hose in question (1,120 mm), but the Operator found that in using this specified hose, it impinged upon the rudder control linkage.

All fuel hoses are subject to exchange every 5 years, unless maintenance-free fuel pipes (steel) are installed. As a precautionary measure a one-time inspection of the fuel hoses is required to preclude possible similar maintenance shortfalls. Defective fuel hoses must be exchanged against maintenance-free fuel pipes immediately.
