FINAL REPORT

AAIU Synoptic Report No: 2008-030
AAIU File No: 2007/0102
State File No: IRL00900967
Published: 5/12/08

Aircraft Type and Registration:	APEX DR400/140B, EI-SKL	
No. and Type of Engines:	1 x Thielert TAE 125-01 (Centurion 1.7)	
Aircraft Serial Number:	2611	
Year of Manufacture:	2006	
Date and Time (UTC):	23 November 2007 @ 12.25 hrs	
Location:	Weston Airport, Co. Kildare	
Type of Flight:	Training	
Persons on Board:	Crew - Two	Passengers - Nil
Injuries:	Crew - Nil	Passengers - Nil
Nature of Damage:	None	
Commander's Licence:	Commercial Pilot's Licence (CPL)	
Commander's Details:	Male, aged 31 years	
Commander's Flying Experience:	500 hours, of which 79 were on type	
Notification:	Weston Airport MOR (Mandatory Occurrence Reporting) Form	
Information Source:	AAIU Pilot Report Form submitted by Pilot, AAIU Field Inspection

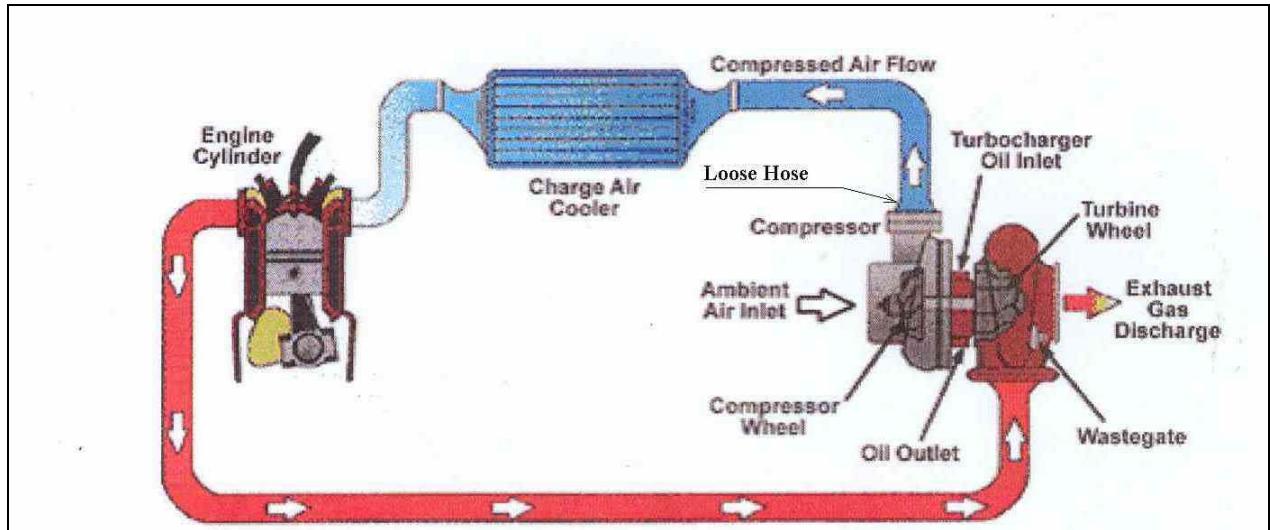
APPENDIX A

An inspection of the engine following the incident revealed that the silicone hose from the turbocharger to the intercooler had become loose at the turbocharger outlet thus allowing ambient air to enter the engine intake instead of the normal compressed air flow. A Wiggins clamp (Jubilee clip), which secures the end of the hose to the turbocharger outlet was found tightly clamped in situ on the displaced hose. The hose was replaced on to the turbocharger outlet and re-clamped in situ (**Appendix A**). The aircraft was then released to service.

The turbocharger consists of a radial compressor and a centripetal turbine, which are connected with a common shaft. The exhaust gases of the engine drive the turbine. Position of loose hose is shown. *(Sketch, courtesy manufacturer's Repair Manual).*

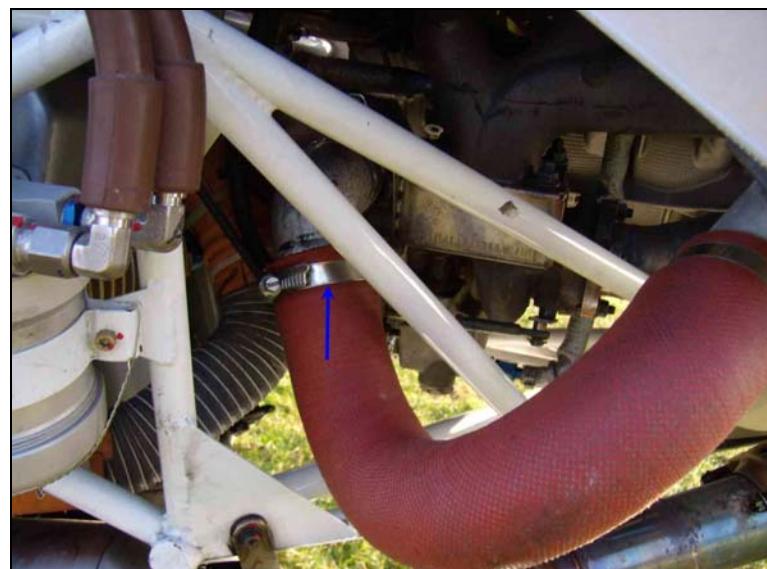
The air connection from the turbocharger to the intercooler failed when the adjoining hose slipped off.

Blue arrow indicates the single clamp, which became loose, leading to a rapid deterioration of engine power.

The engine manufacturer should re-examine the turbocharger pipe/hose connection design in order to improve its security. **(SR 25 of 2008)**

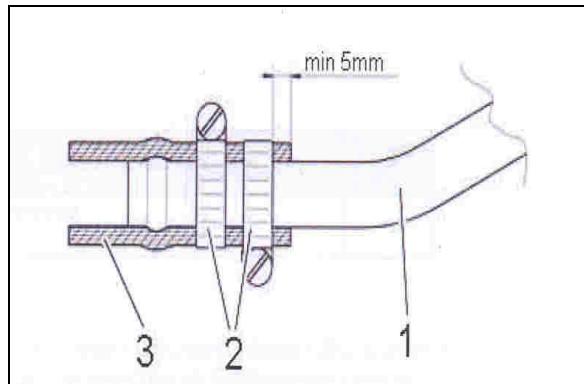
APPENDIX B

This SB issued instructions for the installation of two clamps at the turbocharger pressure pipe, two clamps at the intercooler, another two clamps on the intake manifold and one clamp only at the outlet of the intercooler (total 7 clamps).

1 - Pressure pipe, 2 - Clamp, 3 - Hose.
SB (No. TM TAE 671-0001) initial issue requiring two clamps.

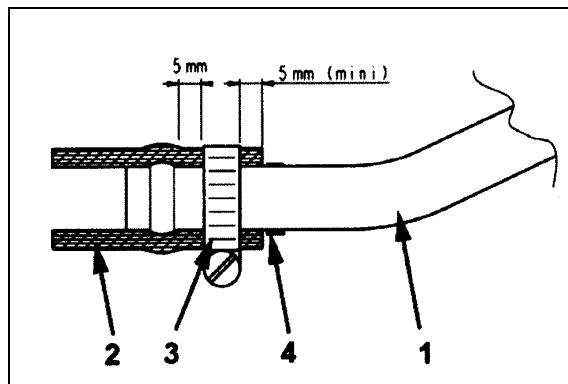
In June 2007, only 3 months later, the engine manufacturers re-issued the Service Bulletin for the DR400/140B (No. TM TAE 671-0001 Revision 1) The re-issued SB gave instructions for the removal of the double clamps and reinstallation of a single clamp at the turbocharger pressure pipe and at the intercooler (**Appendix B**). It included the final tightening of the clamps to a specified torque, application of sealant to all clamps and the marking of a slip line at the end of each hose for a later slip check. The torque and slip marks were to be checked between 3 and 6 flight hours after the incorporation of the Service Bulletin, with torque values and slip marks checked every 25 flight hours thereafter. Part B of this SB referred to the replacement of the intercooler at the next maintenance check or within the next 100 flight hours, whichever occurs soonest. On EI-SKL, Part A was carried out on 18/06/07, 29/06/07 and on 09/07/07 with Part B installed on 06/07/07.

1 - Pressure pipe, 2 - Hose, 3 - Clamp, 4 -Slip Mark.
SB (No. TM TAE 671-0001 Revision 1) requiring only one clamp and a slipmark.
