FINAL REPORT

AAIU Synoptic Report No: 2008-031
State File No: IRL00908036
Published: 10/12/08

Aircraft Type and Registration:	Pilatus PC-6/B2-H4, EI-IAN
No. and Type of Engines:	1 x Pratt & Whitney PT6A-27
Aircraft Serial Number:	810
Year of Manufacture:	1981
Date and Time (UTC):	4 May 2008 @ 17.00 hrs
Location:	Clonbullogue Airfield, Co. Offaly (EICL)
Type of Flight:	Aerial Work
Persons on Board:	Crew - 1 Passengers – Nil
Injuries:	None
Nature of Damage:	Substantial
Commander's Licence:	Private Pilot's Licence (Aeroplanes)
Commander's Details:	Male aged 64 years
Commander's Flying Experience:	3,500 hours, of which 500 were on type
Notification Source:	Pilot-In-Command
Information Source:	AAIU Field Inspection

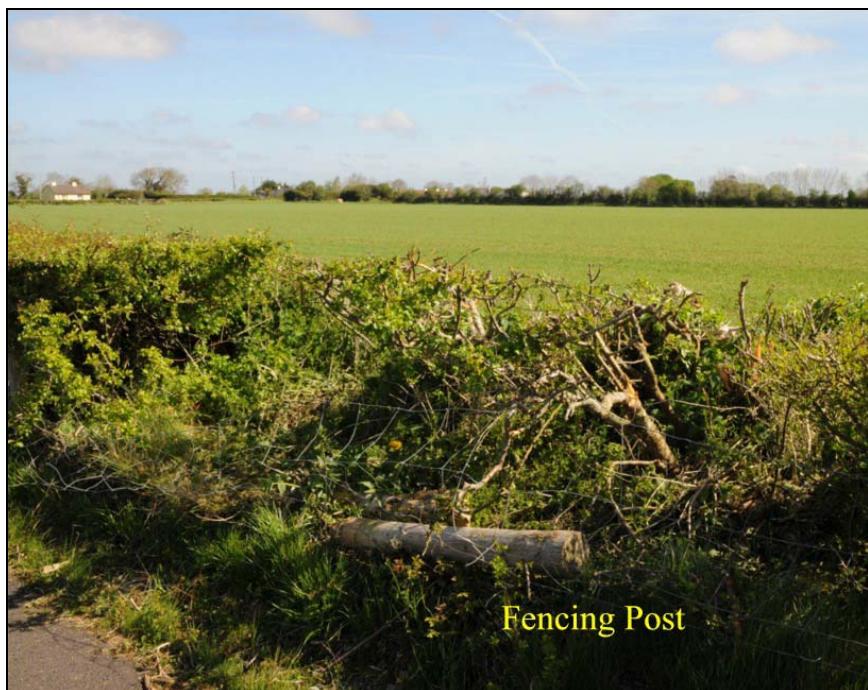
Photo No. 1: Hedgerow with embedded fencing posts

A low fence post embedded in the hedge caused substantial damage to the underside of the fuselage. The aircraft continued its landing run without further incident. The Pilot was informed on the airfield frequency that he appeared to have struck the boundary hedge on landing. On inspection the extent of the damage was revealed.

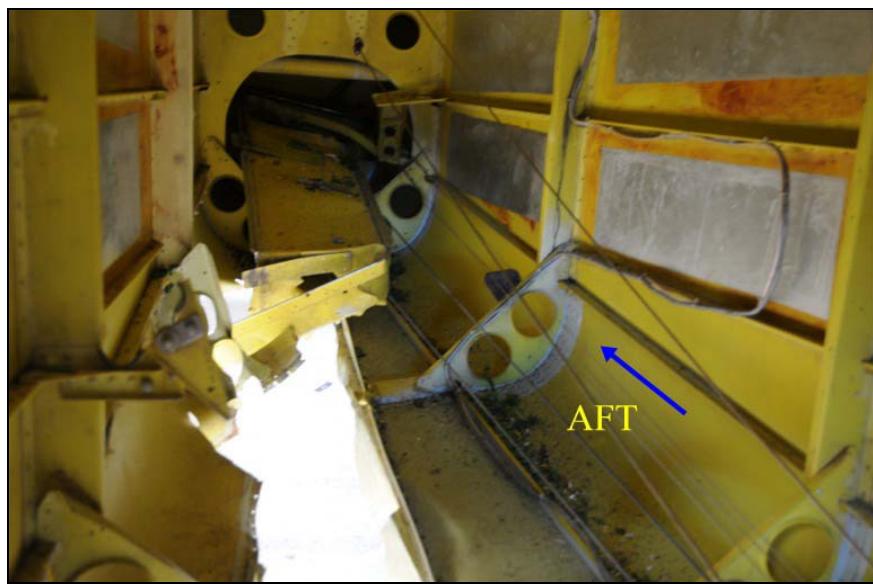
The AAIU were informed of the accident by the Pilot shortly after the event. The following morning an Inspector of Air Accidents travelled to Clonbullogue and commenced an Investigation. The aircraft was inspected and was found to have substantial damage to the underside of the rear fuselage (**Photo No. 2**).

Photo No. 2: Damage to fuselage

The area under the right tailplane showed signs of buckling due to compression. The controls and associated control runs were free and remained undamaged. The approach to RWY 27 is made over a large grass field with no obstacles in the direct flight path until the boundary.
