FINAL REPORT

AAIU Synoptic Report No: 2009-001
State File No. IRL 00900748
AAIU File No: 2005/0061
Published: 05/01/09

Aircraft Type and Registration:	Piper PA 28-181, EI-DDZ	
No. and Type of Engines:	1 x Avco Lycoming O-360-A4M	
Aircraft Serial Number:	28-7690211	
Year of Manufacture:	1976	
Date and Time (UTC):	1 October 2005 @ 17.05 hrs	
Location:	Navan Airfield	
Type of Flight:	Private	
Persons on Board:	Crew – 1	Passengers – 1
Injuries:	Crew – 1 (Minor)	Passenger – Nil
Nature of Damage:	Substantial	
Commander's Licence:	Private Pilot's Licence (Aeroplanes)	
Commander's Details:	Male, aged 41 years	
Commander's Flying Experience:	177 hours, of which 97 were on type	
Notification Source:	Airfield owner	
Information Source:	AAIU Field investigation

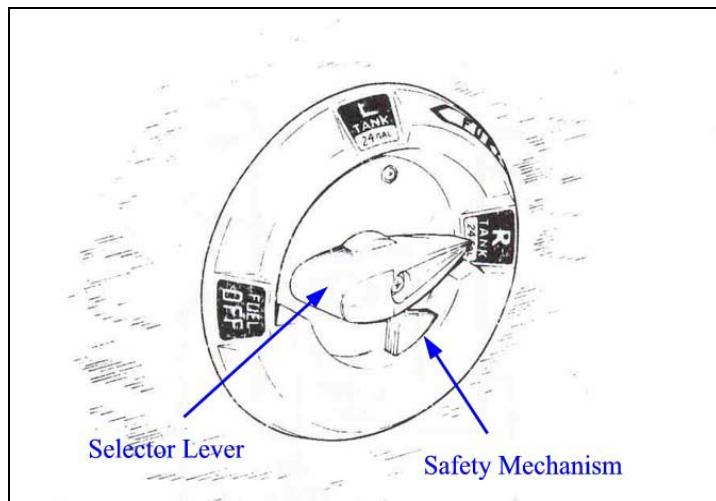
Diagram No. 1: Fuel Selector

A fuel tank selector control is located on the left side panel forward of the pilot's seat, which controls the position of the fuel tank selector valve. A safety mechanism comprising of a button on the selector cover must be depressed and held while the selector is moved to the 'FUEL OFF' position. The mechanism releases automatically when the selector is moved back to the 'L TANK' or 'R TANK' position (**Diagram No. 1**).
