FINAL REPORT

AAIU Synoptic Report No: 2009-002
State File No. IRL 00908035
AAIU File No: 2008/0035
Published: 08/01/09

Aircraft Type and Registration:	TECNAM Srl P2002-JF, EI-LFC
No. and Type of Engines:	1 x ROTAX 912-S2
Aircraft Serial Number:	63
Year of Manufacture:	2007
Date and Time (UTC):	4 May 2008 @ 15.50 hrs
Location:	Coonagh Airfield, Co. Limerick
Type of Flight:	Private
Persons on Board:	Crew – 1 Passengers – 1
Injuries:	None
Nature of Damage:	Substantial
Commander's Licence:	Private Pilot's Licence (Aeroplanes)
Commander's Details:	Male, aged 46 years
Commander's Flying Experience:	1,393 hours, of which 26 were on type
Notification Source:	Limerick Flying Club
Information Source:	AAIU Field investigation

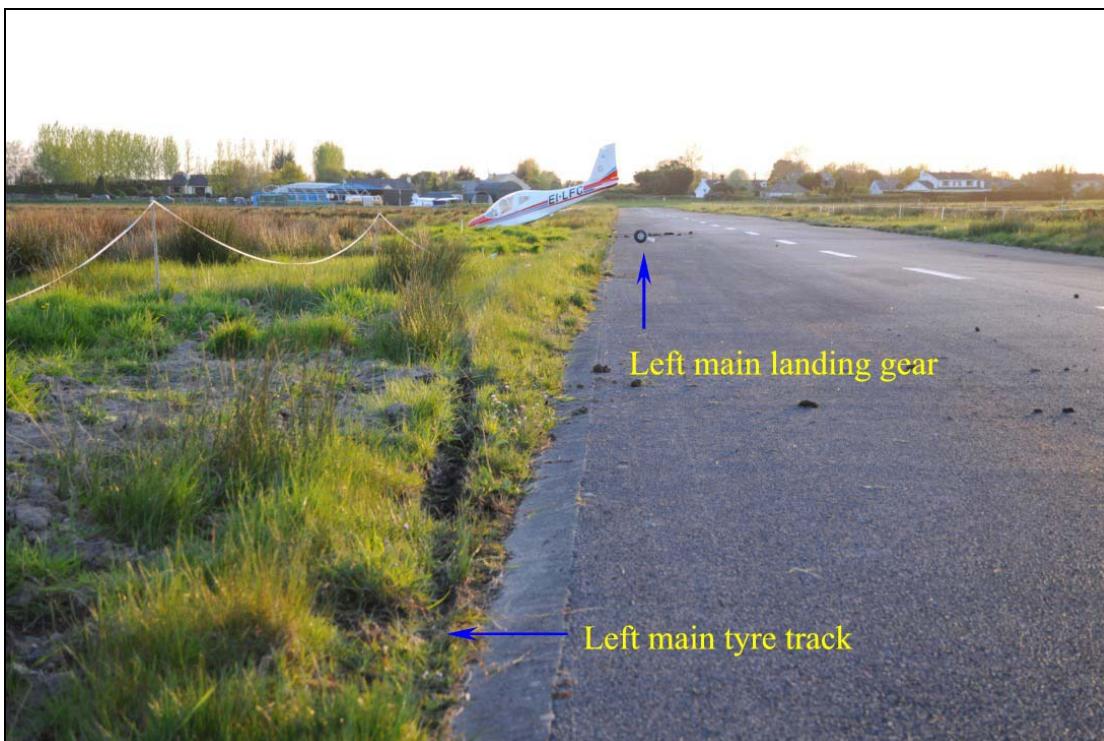
The Pilot's intention was to conduct a local flight from Coonagh Airfield with a friend. The weather was good on the day, but with a strong crosswind from the left. External checks were completed and start up made at 15.45 hrs on the ramp. After a short taxi out and when power checks were completed the aircraft taxied to the departure end of the active runway (RWY) 28. On lining up the Pilot assessed the wind as being from 200 degrees at 10 kts from the airfield windsock. The take-off roll commenced at 15.50 hrs. As the indicated air speed reached 45-50 kts the aircraft veered to the left with the left main landing gear and nose gear departing the paved surface (**Photo No. 1**).

Photo No. 1: General view

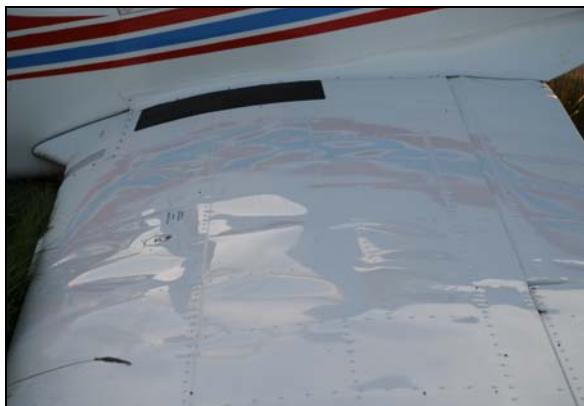
The aircraft incurred significant damage to the left wing as evidenced by buckling of the wing skin on the upper surface due to contact with the ground (**Photo No. 2**). The left wing flap mechanism was also damaged. The engine was displaced and the propeller broken. The left stabilator showed a significant impact on the leading edge as a result of being struck by the detached main landing gear leg (**Photo No. 3**). The rear fuselage showed evidence of a tail strike with the runway during the event.

Photo No. 2: Damage to left wing

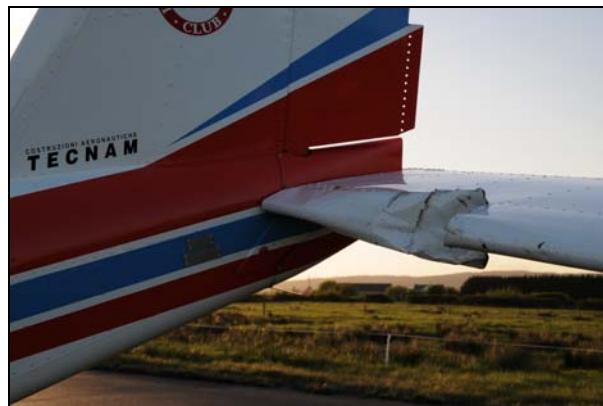
Application of full right rudder brought the aircraft back towards the runway centreline but as flying speed was reached the Pilot heard a loud 'thud' as the left main landing gear leg detached and struck the horizontal tailplane (stabilator¹). The Pilot rejected the take-off and closed the throttle, keeping the nose up by application of aft control stick.

Photo No. 3: Damage to left stabilator
