FINAL REPORT

AAIU Synoptic Report No: 2009-004
State File No: IRL00900971
AAIU File No. 2007-0106
Published: 04/02/09

Types and Registrations:	(1) AGUSTA WESTLAND - A109, N449J (2) LEARJET – 31A, EI-MAX
Nos. and Types of Engines:	(1) 2 x Pratt and Whitney 206C (2) 2 x Garret AIRESEARCH - TFE 731
Aircraft Serial Numbers:	(1) 11056 (2) 233
Year of Manufacture:	(1) 2000 (2) 2002
Date and Time (UTC):	17 December 2007 @ 08.43 hrs
Location:	Dublin Airport (EIDW), Runway (RWY) 10
Types of Flight:	Private
Persons on Board:	(1) Crew – 1 Passengers – Nil (2) Crew – 2 Passengers – 2
Injuries:	Crew – Nil Passengers – Nil
Nature of Damage:	None
Commanders' Licences:	(1) FAA Commercial Pilot Rotorcraft- Helicopter (2) JAR Airline Transport Pilot Licence
Commanders' Details:	(1) Male, aged 39 years (2) Male, aged 52 years
Aircraft Commanders' Flying Experience:	(1) 2,350 hours, of which 200 were on type (2) 14,400 hours, of which 805 were on type
Notification Source:	ATC Watch Manager EIDW
Information Source:	AAIU Field Investigation

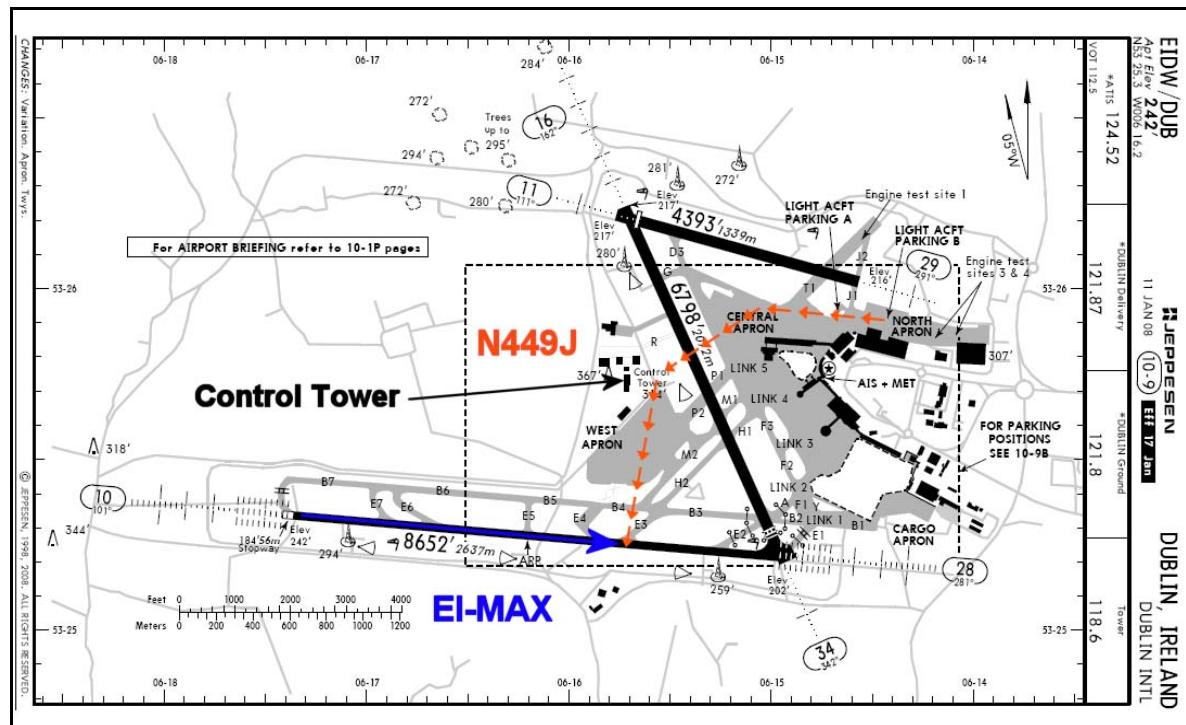
Graphic No. 1: 1Jeppesen plate EIDW 10-9 showing the track of both aircraft.

EI-MAX was then cleared to take-off following which the ATC Controller asked the Pilot of N449J if he had the traffic rolling off RWY 10 in sight. He confirmed that he had and was issued with a conditional clearance by the Controller to pass behind that aircraft. However, he crossed in front of it.
