# FINAL REPORT

**AAIU Synoptic Report No: 2009-011**

<b>Aircraft Type and Registration:</b>	Rollason Condor D.62B, EI-BXT	
<b>No. and Type of Engines:</b>	1 x Rolls Royce Continental 0-200-A	
<b>Aircraft Serial Number:</b>	RAE 626	
<b>Year of Manufacture:</b>	1967	
<b>Date and Time (UTC):</b>	2 September 2008 @ 13.55 hrs	
<b>Location:</b>	Colehill, Co. Longford	
<b>Type of Flight:</b>	Private	
<b>Persons on Board:</b>	Crew - 1	Passengers - 1
<b>Injuries:</b>	Crew - Serious	Passengers - Serious
<b>Nature of Damage:</b>	Aircraft Destroyed	
<b>Commander's Licence:</b>	ATPL	
<b>Commander's Details:</b>	Male, aged 27 years	
<b>Commander's Flying Experience:</b>	2,153 hours, of which 84 were on type	
<b>Notification Source:</b>	An Garda Síochána, Longford	
<b>Information Source:</b>	AAIU Pilot Report Form submitted by Pilot. AAIU Field Investigation

## **SYNOPSIS**

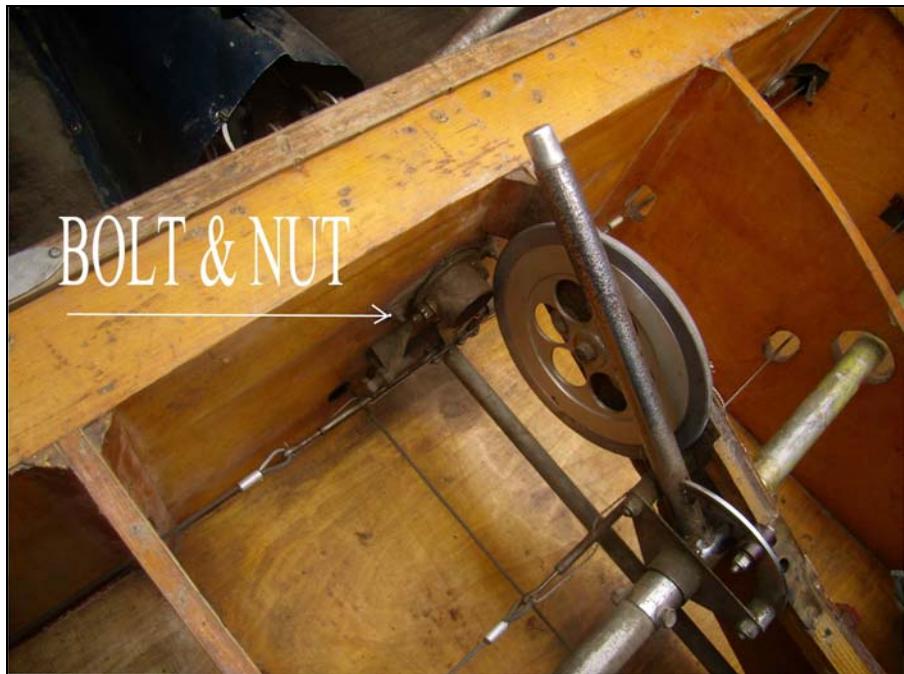
**Photo No 1.**

A correctly assembled aileron control system installed on a serviceable aircraft. The torque shaft from the pilot's control column enters through the main timber spar and is attached to the aileron rockshaft by a  $\frac{1}{4}$  inch bolt with slotted nut, split pin and washer. (See schematic below)

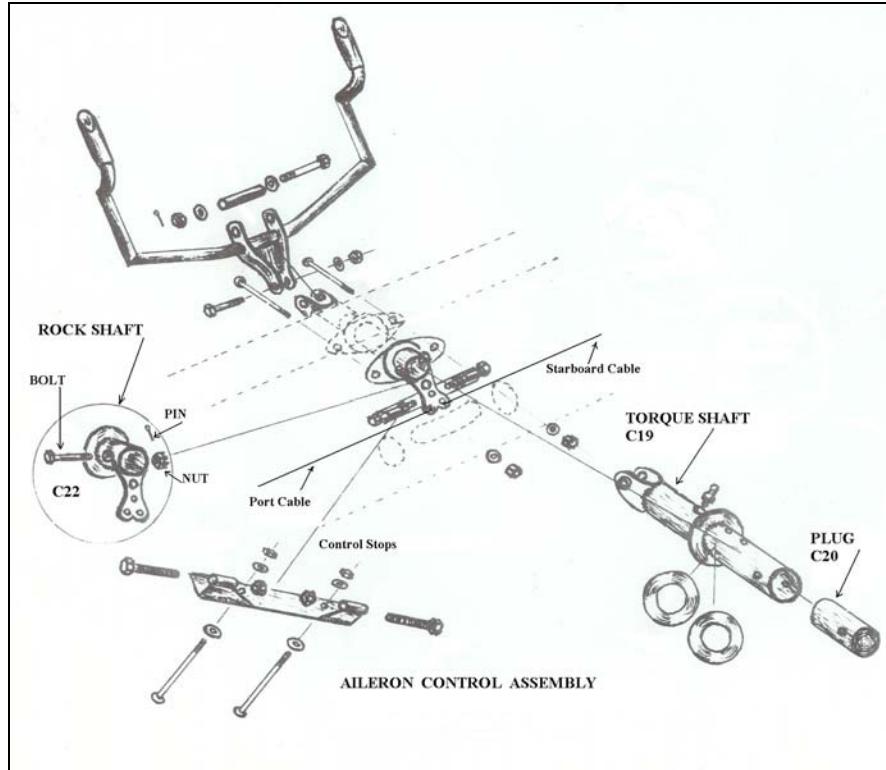
**Sketch No. 1**

A photograph (**Photo No. 1**) of a correctly assembled aileron control system and a sketch (**Sketch No. 1**) of the control system from the aircraft illustrated parts catalogue (IPC) is shown for reference at **Appendix A**. The one-piece pilot control column is attached to a torque shaft (C19), which protrudes through the No. 2 fuselage frame and main spar. At its rear end, this shaft is bolted to the rockshaft (Sketch No. 1 - C22). The aileron control cables port and starboard are attached to this rockshaft through turnbuckles. The plug (Sketch No. 1 - C20) is designed to be a slide fit into the internal bore of the torque shaft. It is pushed into the shaft so that the bolt holes in the plug, torque shaft and rockshaft are aligned to take a  $\frac{1}{4}$  inch bolt, slotted nut and split pin (Sketch No. 1 - C22). The plug is designed to stiffen and strengthen the coupling of the two shafts together. This bolt (Part No. AGS/17E) is supplied without a hole for the split pin. The hole is then drilled for the split pin following assembly of the two shafts together.

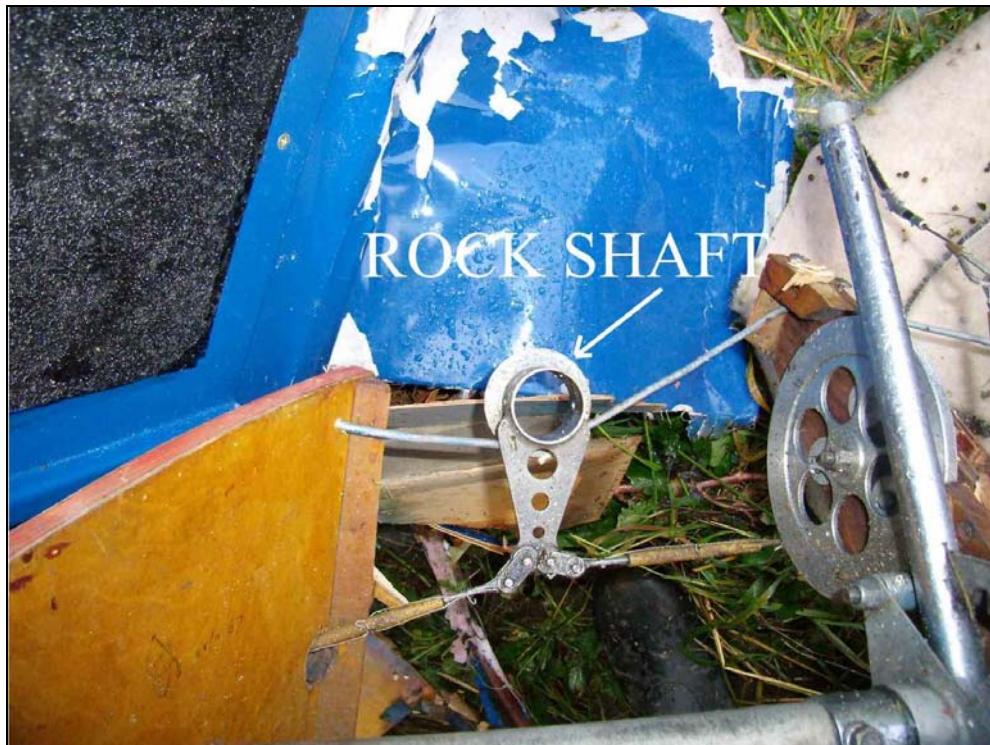
**Photo No 2.**

6. An examination of the flight control system determined that the bolt and the associated slotted nut and split pin, which locks the aileron rockshaft and the control column torque shaft together, was missing from the assembly.

The failure of the locking mechanism between the torque shaft and the rockshaft of the aileron control assembly led to the Pilot's loss of all aileron control.

The aileron rockshaft of EI-BXT found at the crash site. The shaft had separated from the pilot's control column torque shaft. The aileron cable turnbuckles are attached to the rockshaft.

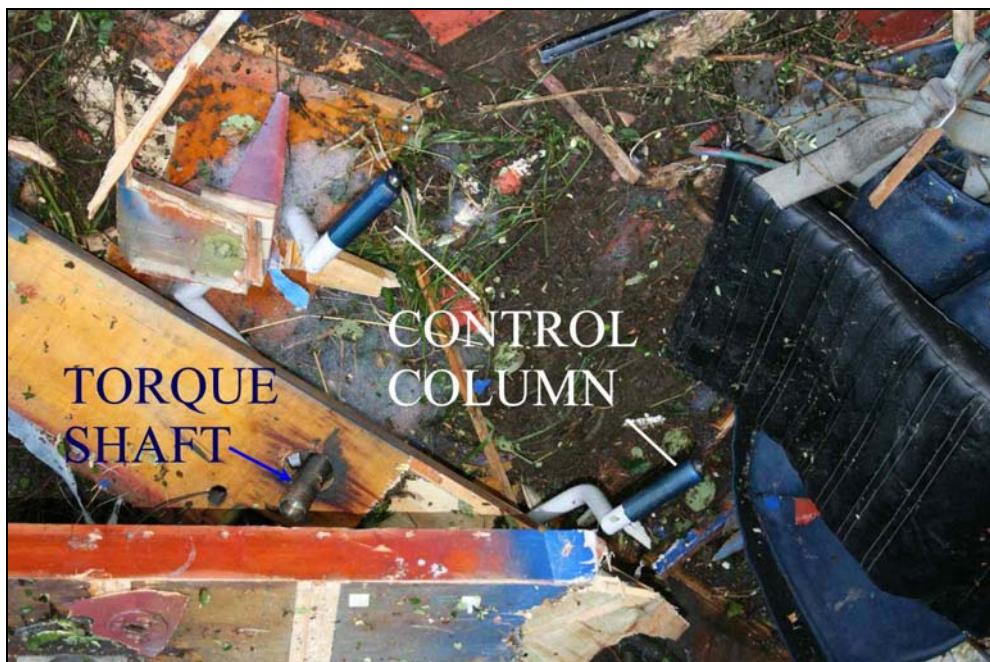
**Photo No 3.**

The aileron torque shaft and its attachment to the rockshaft were examined in more detail. The pilot's control column torque shaft had separated from the main spar and from the aileron rockshaft. The  $\frac{1}{4}$  inch bolt, slotted nut, washers and split pin used to couple the two shafts were not found in the crash debris (**Appendix B**). Using a metal detector, the Investigation carried out an intensive second search of the crash site but failed to find the 1.7 inch long bolt. However, the indentation marks left by the washers could be seen on the rockshaft. The inside surface of the tubular portion of the rockshaft had some longitudinal scratch marks coincident with the boltholes. There were no circumferential scratches in the tube. There was no indication of ovality in any of the boltholes of the rockshaft to torque shaft assembly. The plug (C20) was found pushed further into the bore of the torque shaft such that the  $\frac{1}{4}$  inch bolt could not have connected with this plug (**Appendix C**). A metallurgical Consultant examined the aileron control assembly, particularly the shaft boltholes, and subsequently issued his Report.

The pilot's control column torque shaft separated from the main timber spar, seen in the foreground, and is protruding from the No. 2 timber fuselage frame.

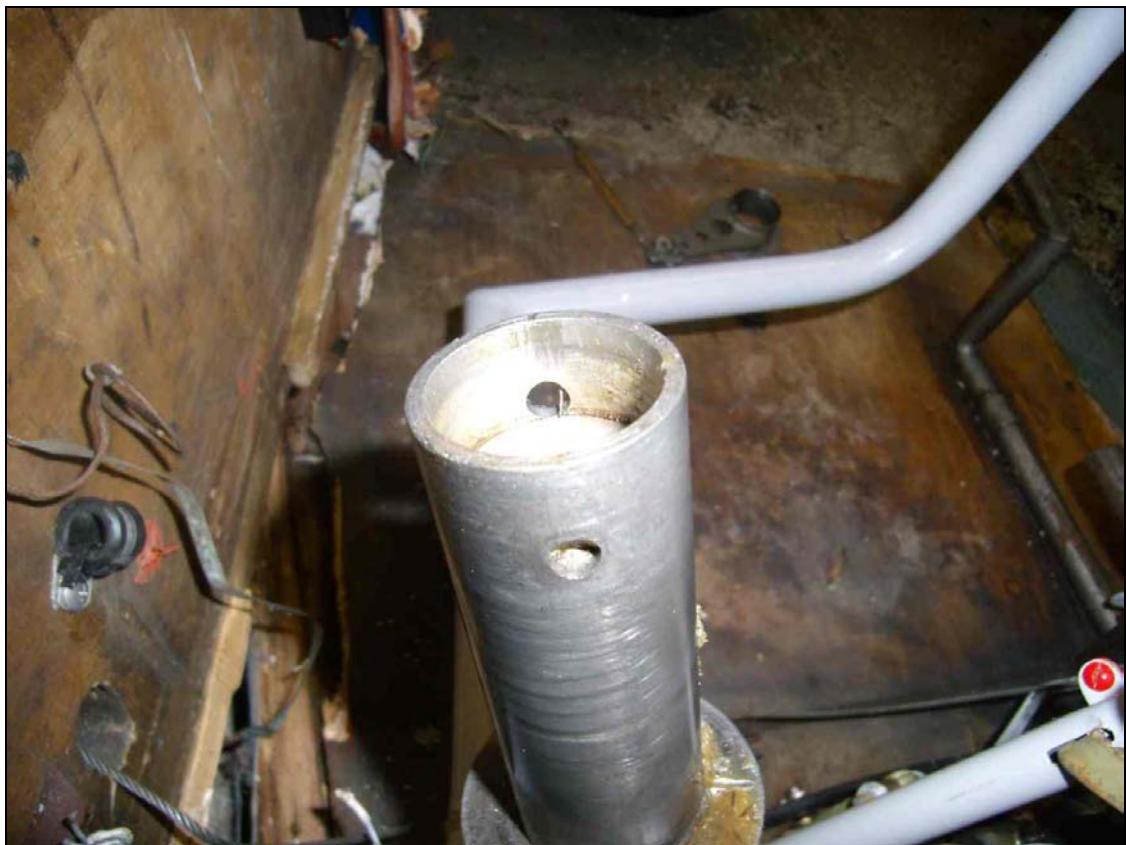
**Photo No 4.**

*As there is no evidence of ovality of the boltholes or circumferential marking to support failure of the bolt in the crash it would appear that the bolt worked its way out of the assembly. This implies that the nut and / or split pin had not been fitted when the components were last assembled.*

9. The Investigation found that the plug was pushed too far into the bore of the shaft, such that the holes in the plug were not aligned with the holes in the torque shaft, prior to assembly of the aileron system.

Picture of control column torque shaft taken following the accident. The plug was pushed too far into the bore of the shaft, such that the holes in the plug were not aligned with the holes in the torque shaft, prior to assembly of the aileron system.
