AAIU Synoptic Report No: 2009-013
State File No: IRL00908091
Published: 07/05/09

Aircraft Type and Registration:	TECNAM - P-2002- JF, EI-WAT
No. and Type of Engines:	1 x ROTAX 912S
Aircraft Serial Number:	086
Year of Manufacture:	2008
Date and Time (UTC):	05 December 2008 @ 14.04 hrs
Location:	Waterford Airport (EIWF), Runway (RWY) 21
Type of Flight:	General Aviation – Flight Training - Solo
Persons on Board:	Crew – 1 Passengers – 0
Injuries:	Crew – Nil Passengers – N/A
Nature of Damage:	Minor
Commander's Licence:	Student Pilot Licence (SPL)
Commander's Flying Experience:	36 hours, of which 36 were on type
Notification Source:	Waterford Airport Duty ATCO
Information Source:	Waterford Airport AAIU Incident Report Form submitted by Pilot

SYNOPSIS

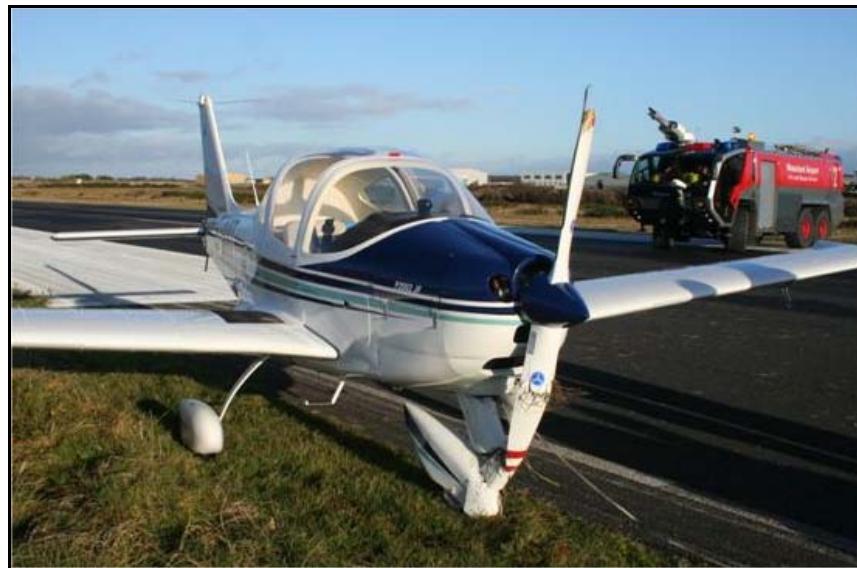
Photo No. 1

The Student Pilot said that he applied brakes after landing while coming towards the end of the runway. He candidly stated that he lost directional control, as he had probably not applied sufficient rudder to keep the aircraft straight during the crosswind landing. As a result when he lowered the nose of the aircraft it was pointing towards the side of the runway and it subsequently departed over the edge. The propeller, an engine support, nose wheel spat and pitot tube base were damaged as a result (**Photo No. 1**).

The wind recorded at 320°/15 kts translates into a crosswind component of 14 kts and a 5 kts tailwind component. The landing was reported by ATC as being well down the runway, probably due to the combination of the tailwind component and the inexperience of the Student Pilot. For an experienced pilot the wind conditions were well within the manufacturer crosswind limit. However, a Student Pilot with a total flying time of 36 hours cannot be considered in that category.

Following this incident the Flying Club set a maximum crosswind limit of 10 kts for SPL licence holders. In view of this action no Safety Recommendation is considered necessary.
