## FINAL REPORT

**AAIU Synoptic Report No: 2009-015**

| <b>Aircraft Type and Registration:</b> | Britten-Norman Islander BN-2A-26,<br>EI-BCE | |
| <b>Location:</b> | Connemara Airport, Inverin , Co. Galway (EICA) | |

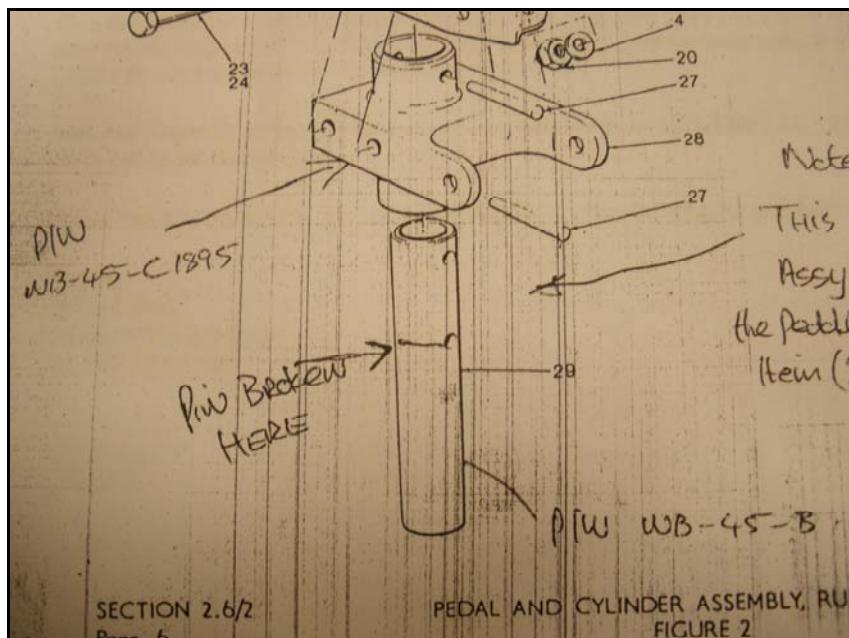
The aircraft was operated predominantly on short sector routes and had accrued 17,155 hours, and 81,287 landings since manufacture. The pedal pillar fractured at the area where taper pins attach the outer pedal assembly to the pillar. The Investigation noted that it is not possible to visually inspect the failure area (without dis-assembly) because the pedal mounting block Part No. (P/No). NB-45-C1895, slides over the failed pillar P/No. NB-45-B-1891, obscuring the pillar from view (**Figure No. 1**).

**Figure No. 1: Schematic of the pedal mounting block and the failed pillar.  
(Diagram courtesy of the Operator).**

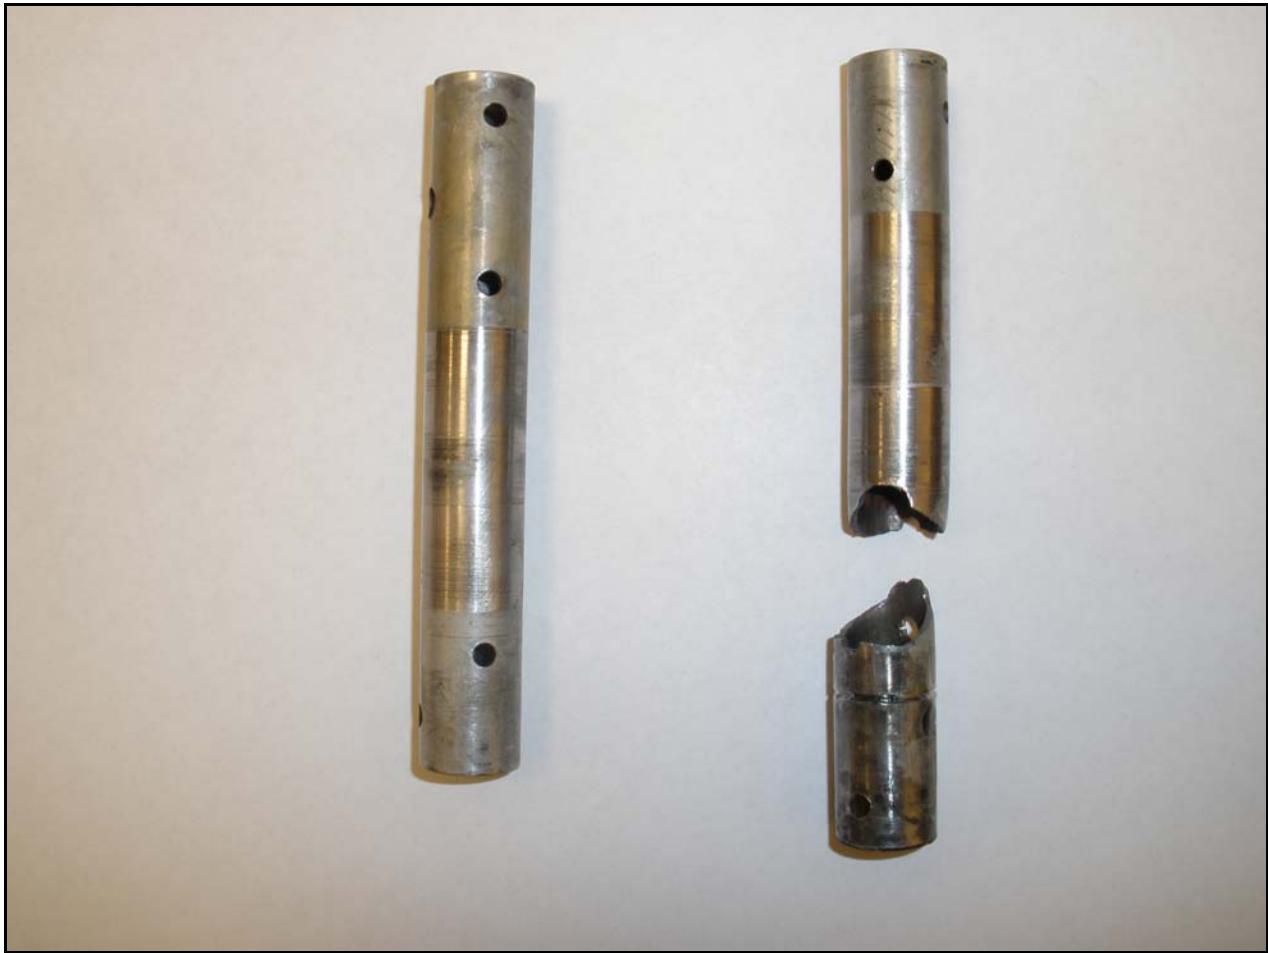
Both the failed RH brake pillar and the intact Left Hand (LH) pillar were removed from the aircraft. The Investigation sent the failed pillar and the intact LH pillar for metallurgical examination by an independent laboratory (**Photo No. 1**). This examination revealed that: -

**Photo No. 1: The intact LH pillar and the failed RH pillar.**

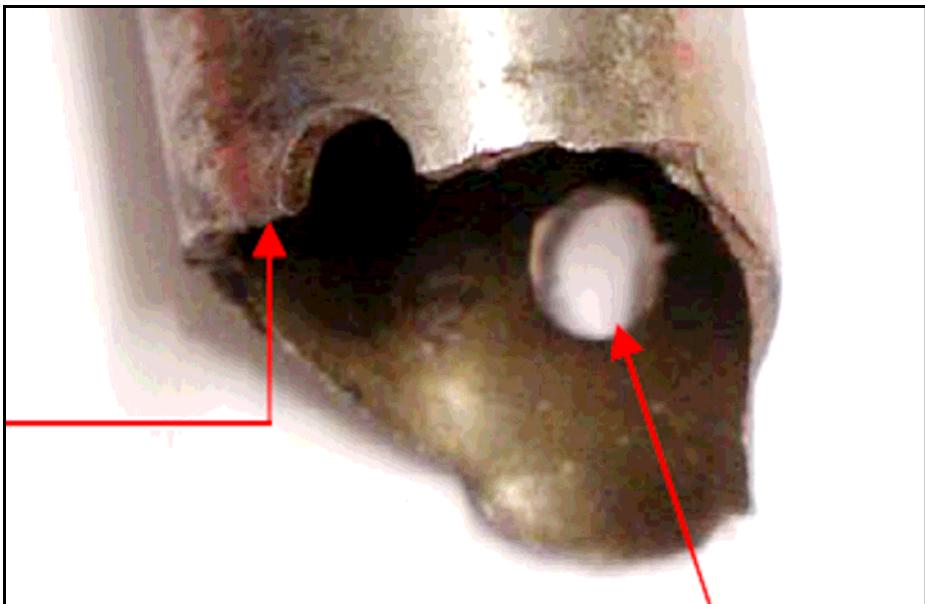
*The pillar failed due to fatigue<sup>1</sup> cracking, which initiated at a bolt hole (**Photo No. 2**).*

**Photo No. 2: Red arrows indicating the locations of failure through the bolt hole, and cracking initiated in the corresponding hole.**

The aircraft had accumulated an unusually high number of landings (81,287) and consequently would have experienced an unusually high number of brake pedal applications. Each brake application constitutes a stress cycle for the purposes of fatigue analysis, and as there could be several brake applications for each landing and also during taxi operations, the stress cycles accumulated by the brake pedal pillar would have been a multiple of the aircraft’s landing cycle total.

1. The pillar suffered a fatigue failure, consistent with the aircraft's high number of landings and consequent high number of brake applications.

*"Service Bulletin BN-2/SB 314 Rudder Pedal Assemblies – Inspection, was issued (October 2008) to all operators requesting a one-off inspection of the left and right shaft assemblies to examine the taper pin holes for cracks using borescope equipment. To date no additional failures have been reported."*

*A review of the original stress calculations was carried out and the following design changes made: The thickness of the tube has been increased from 0.056 inches to 0.080 inches for new build and “on condition” replacement shafts. This change was made to provide a greater margin on static strength and also improves the fatigue life.*

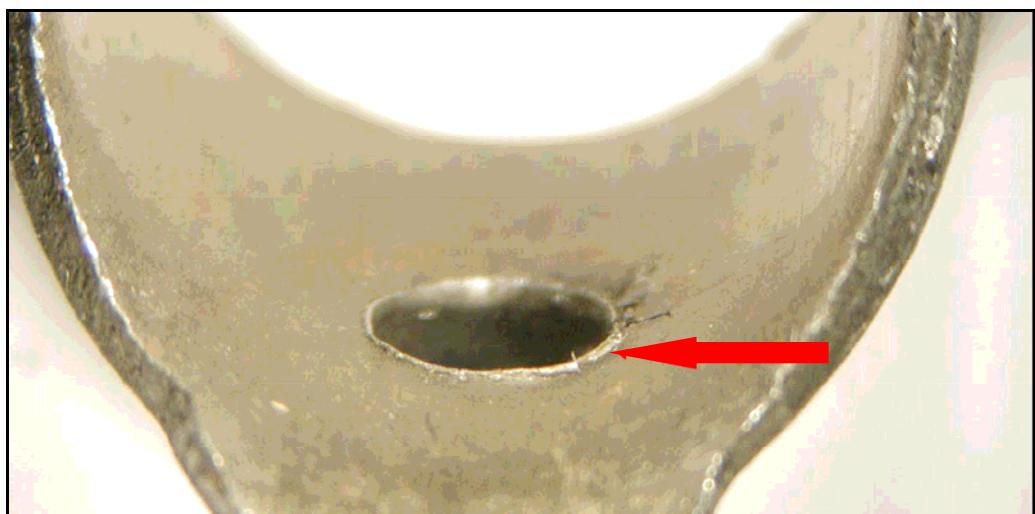
*Burrs<sup>2</sup> from machining were observed around the bolt holes of the failed component (**Photo No. 3**), and the holes of the intact pillar (from the left side of the aircraft); it is likely that failure to remove these burrs facilitated crack initiation.*

**Photo No. 3: Manufacturing burrs indicated by the arrow.**

1. The manufacturing burrs left around the holes in the pillar were likely to have facilitated crack initiation.
