FINAL REPORT

AAIU Synoptic Report No: 2009-016
State File No: IRL00908062
Published: 05/08/09

Aircraft Type and Registration:	Piper PA 28-151, EI-WRN
No. and Type of Engines:	1 x Lycoming O-320-E3D
Aircraft Serial Number:	28-7615212
Year of Manufacture:	1976
Date and Time (UTC):	20 August 2008 @ 12.58 hrs
Location:	Trim Airfield (EITM), Co Meath
Type of Flight:	Private
Persons on Board:	Crew - 1 Passengers - 1
Injuries:	Crew - 0 Passengers - 0
Nature of Damage:	Substantial
Commander's Licence:	Commercial Pilot's Licence (Aeroplanes)
Commander's Details:	Male, aged 28 years
Commander's Flying Experience:	4,472 hours, of which 280 were on type
Notification Source:	Trim Airfield owner
Information Source:	AAIU Field Investigation

SYNOPSIS

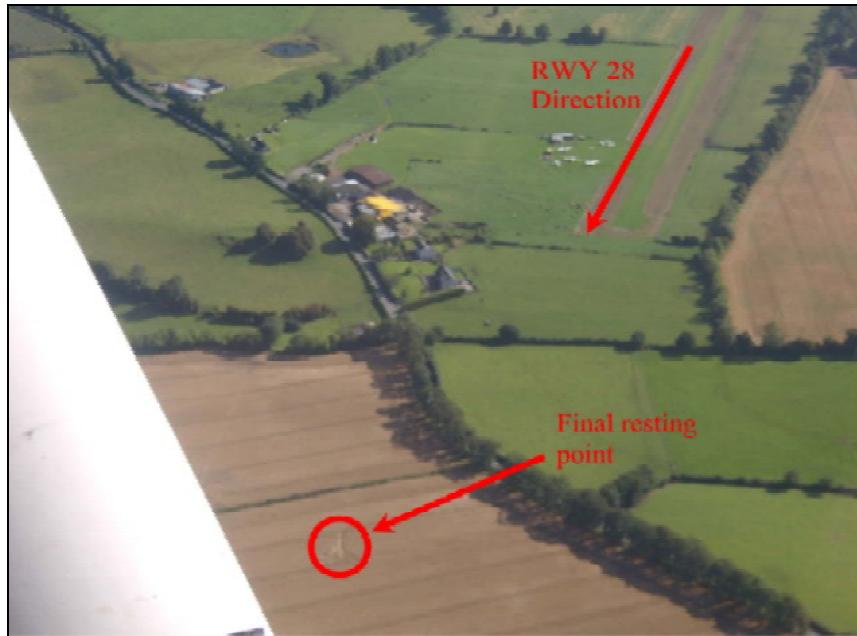
Photo No. 1 shows the flight path of EI-WRN following its departure from RWY 28 until the impact point in the field of barley.

Photo No. 1: Final flight path of EI-WRN

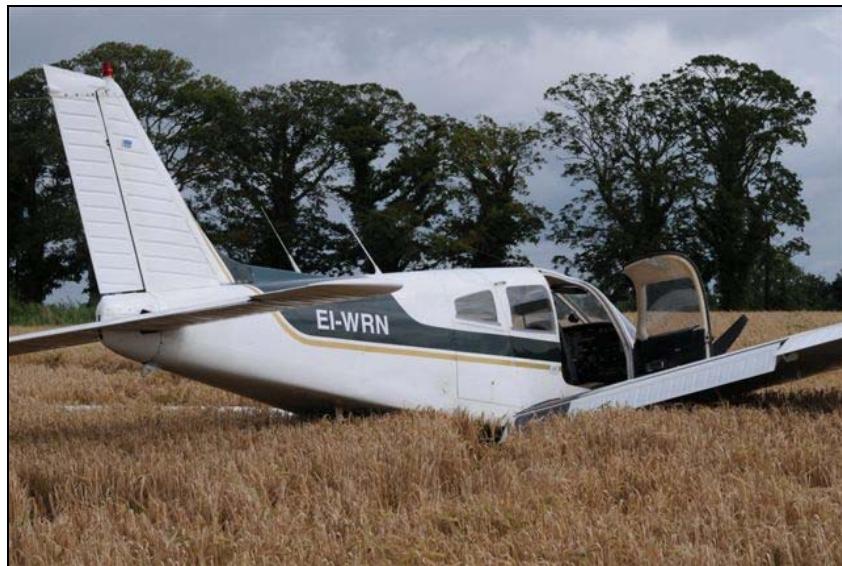
The aircraft came to a stop in the field resting on its fuselage and left wing on a heading of 145° magnetic (**Photo No. 2**).

Photo No. 2: EI-WRN final position following forced landing

The aircraft was substantially damaged in the accident, possibly beyond economic repair. The nosewheel had detached at impact and the port main wheel was found detached, underneath the port wing, still attached to the aircraft by the brake hose. The port flap was badly damaged. The top skin of the port wing around the landing gear attachment point was buckled and the fuselage longerons aft of the firewall were damaged. The engine firewall was distorted. One of the propeller blades was substantially bent back while the second blade had a slight rearward distortion.

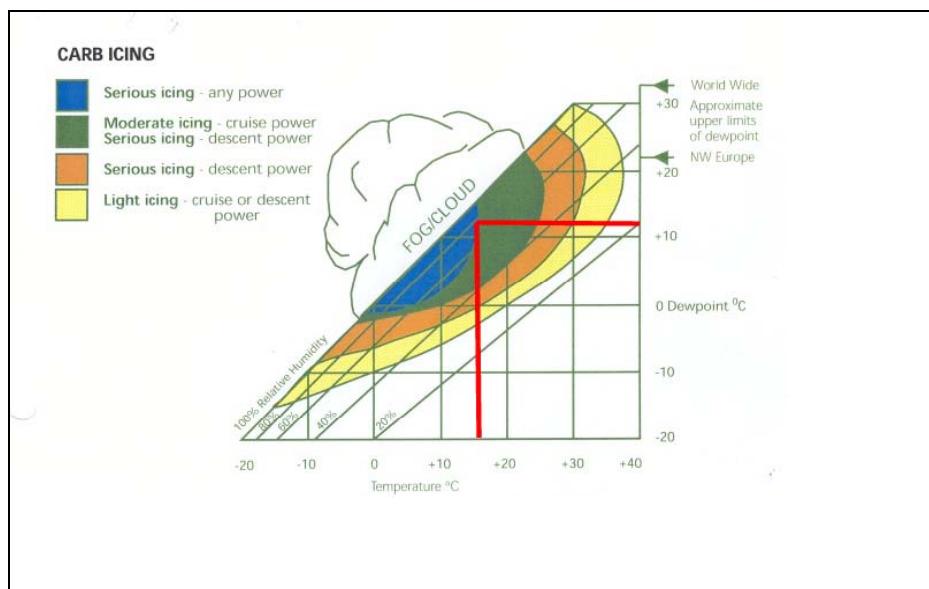
The air temperature of 16°C combined with a dewpoint of 12°C represents a serious risk of carburettor icing at any power.

The Met Éireann aftercast specifically commented on the fact that the combination of the air temperature and dewpoint temperature at the time represented a “*serious risk of carburettor icing at any power*”, (see **Figure No. 1**). Furthermore after the accident the Pilot reported that there was no standing water on the grass runway but that the grass was wet with dew.

Figure No. 1: Carburettor Icing Temperature/Dewpoint Graph

The two red lines in Figure No. 1 represent the air temperature of 16°C and dewpoint temperature of 12°C as provided by the aftercast. The point at which they intersect illustrates that the conditions present at the time of the accident presented a risk of serious icing at any engine power setting.

The aircraft suffered an engine power loss as a result of carburettor icing upsetting the fuel / air ratio to the engine.

Unfortunately the application of carburettor heat after the formation of significant levels of ice has formed in the venturi can have the effect of causing the engine to stop. Thus it is essential that carburettor heat be applied prior to the onset of icing, to prevent its formation. The IAA Aeronautical Information Circular No. 11/97 and the UK CAA Circular AIC 145/1997 (Pink 161) (see http://www.nats-uk.ead-it.com/aip/current/aic/pink/EG_Circ_1997_P_145_en.pdf) contain useful information of the hazards associated with carburettor icing and should be studied by all pilots of piston-engined aircraft.
