FINAL REPORT

AAIU Synoptic Report No: 2009-019
State File No: IRL00900972
AAIU File No: 2007/0107
Published: 15/10/09

Aircraft Type and Registration:	Lambada UFM-11, EI-DGP	
No. and Type of Engines:	1 x Jabiru 2200A	
Aircraft Serial Number:	15/11	
Year of Manufacture:	2003	
Date and Time (UTC):	19 December 2007 @ 11.45 hrs	
Location:	Abbeyshrule Airfield, Co. Longford	
Type of Flight:	Private	
Persons on Board:	Crew - One	Passengers - Nil
Injuries:	Crew - Nil	Passengers - Nil
Nature of Damage:	Nose gear assembly collapsed and propeller tips damaged	
Commander's Licence:	SPL (Student Pilot Licence)	
Commander's Details:	Male, aged 41 years	
Commander's Flying Experience:	45 hours, all of which were on Lambada and Samba types	
Notification:	Operator of aircraft	
Information Source:	AAIU Investigation

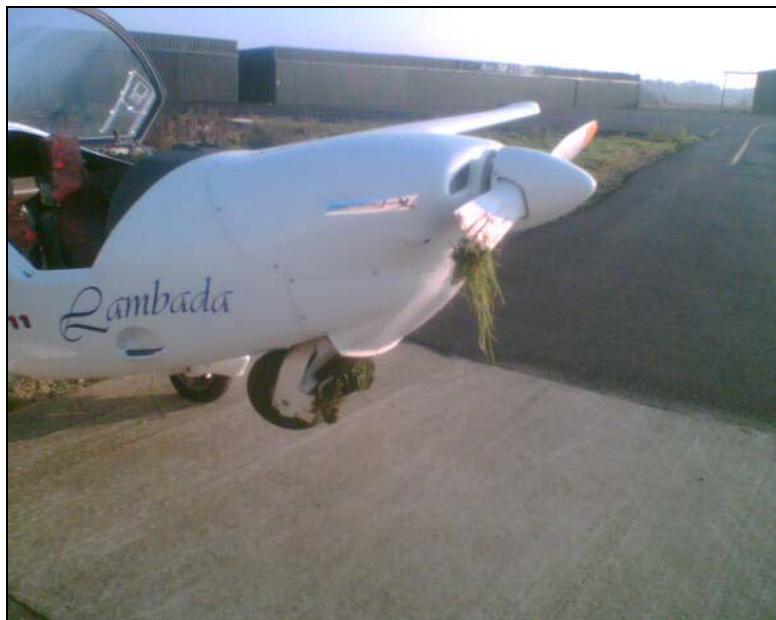
The steering fork of the nose wheel bent rearwards following wheel impact with rough terrain. This allowed the spat, complete with wheel, to rub off the grass as the aircraft rolled to a halt. One of the wooden propeller blades contacted the grass/ground following the landing and was severely damaged.

Photo No. 1: Damage to aircraft EI-DGP following its runway excursion

In this particular event however, fracture of the fork tube did not take place and the lower fork bent rearwards with the nose wheel attached (**Photo No. 1**).

In this particular case, the wind conditions were calm, and as such, controllability of the aircraft should not have been directly influenced by an external force. Therefore, the likelihood exists that the Pilot, in response to an initial deviation to the right during the landing roll, over compensated with a rudder control input to the left and directional control was lost. The damage occurred after the aircraft departed the paved surface, imparting abnormal loads to the nose steering fork.

1. The Student Pilot was properly licensed.
2. While the Pilot was making a correctional control input during the landing roll, directional control was lost and the aircraft departed the runway
3. The aircraft suffered damage as a result of the nose steering fork being subjected to abnormal loads.
