FINAL REPORT

AAIU Synoptic Report No: 2009-022
State File No: IRL00909058
Published: 27/11/09

Aircraft Type and Registration:	Cessna 172M, EI-BUA	
No. and Type of Engines:	1 x Lycoming O-320-E2D	
Aircraft Serial Number:	172-65451	
Year of Manufacture:	1975	
Date and Time (UTC):	22 July 2009 @ 10.20 hrs	
Location:	Weston Airport (EIWT), Co. Kildare	
Type of Flight:	Private	
Persons on Board:	Crew - 1	Passengers - 0
Injuries:	Crew - Nil	Passengers - Nil
Nature of Damage:	Substantial	
Commander's Licence:	PPL(A), issued by the Irish Aviation Authority (IAA)	
Commander's Details:	Male, aged 41 years	
Commander's Flying Experience:	204 hours, of which 20 were on type	
Notification Source:	Duty Manager, Weston Aerodrome	
Information Source:	Air Accident Report Form submitted by Instructor - AAIU Field Investigation

The Pilot was flying circuits in strengthening wind conditions. On landing off the fourth circuit the aircraft bounced twice. On the second bounce the nose undercarriage collapsed.

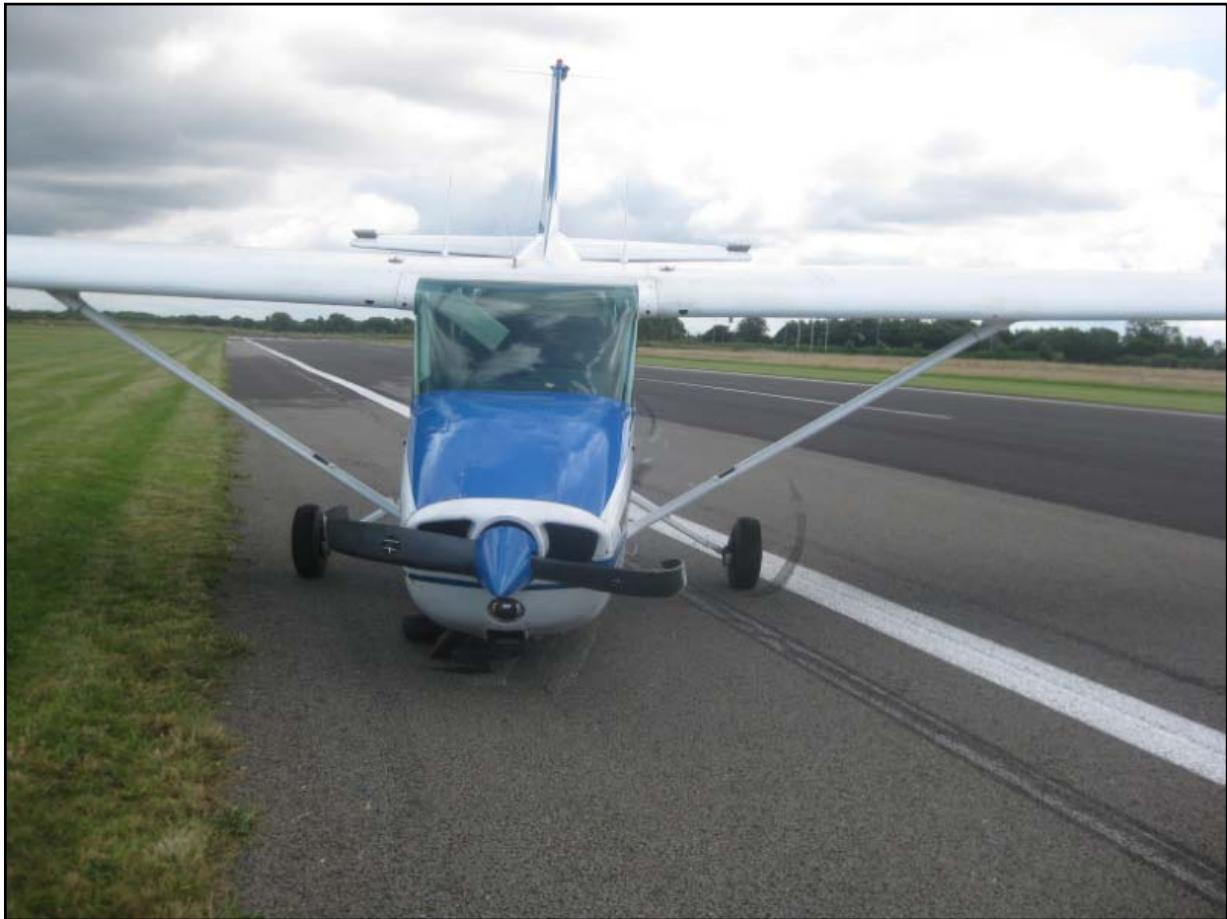
The aircraft suffered substantial damage with the nose wheel being fractured and the propeller suffering multiple strikes on both blades (**Photo No. 1**). Ground marks found on the runway were consistent with the accounts of bouncing and landing given by both the Pilot and the Witness.

Photo No. 1: Nose wheel and propeller damage

1. The aircraft was serviceable.
2. The Pilot held a valid PPL(A).
3. While landing the aircraft bounced twice, the nose wheel fractured and the propeller struck the runway, causing substantial damage to the aircraft.

Inappropriate recovery from a bounced landing.

Lack of recent flying experience/currency.
