## FINAL REPORT

**AAIU Synoptic Report No: 2009-023**  
**State File No: IRL00909072**  
**Published: 30/11/09**

| <b>Aircraft Type and Registration:</b> | Urban Air UFM-10 Samba XXL<br>Microlight, OK-KUA 26 |

### **SYNOPSIS**

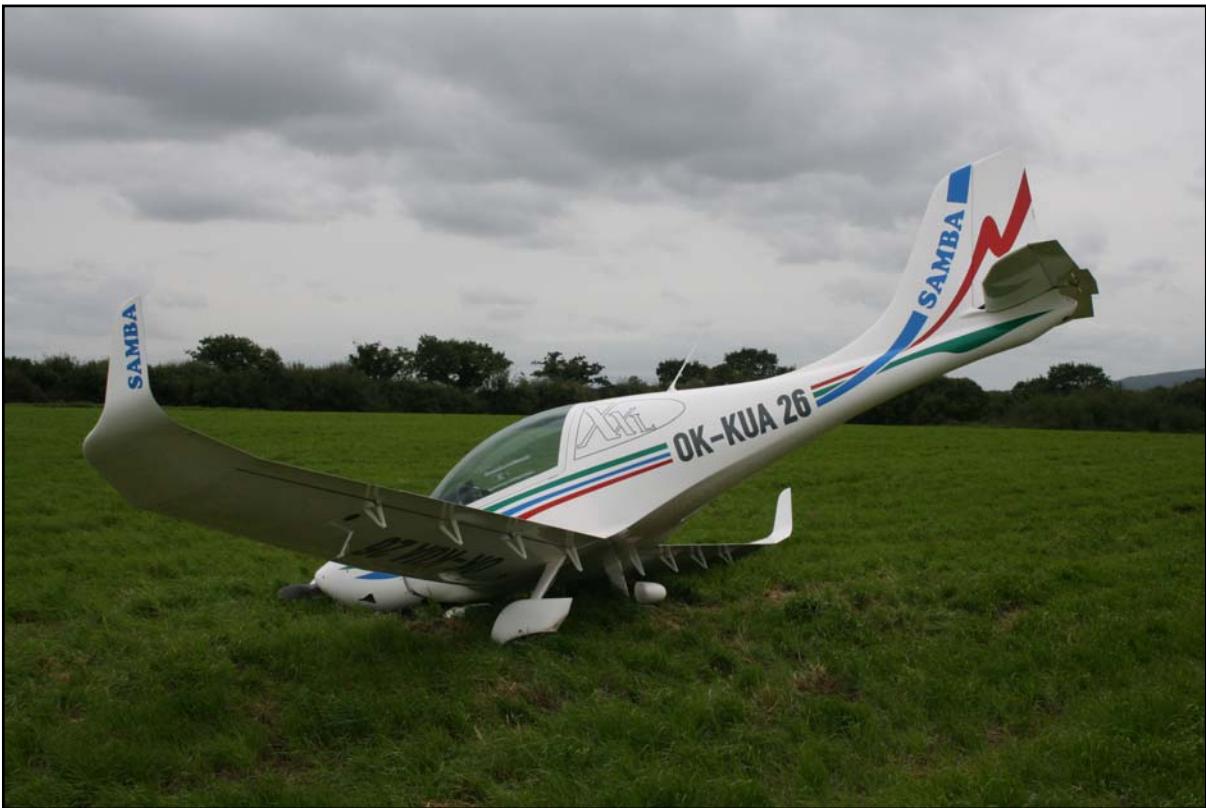
This instructional flight involved a local navigational exercise and concluded with circuits to runway (RWY 27) at EIKL. Meteorological conditions were wind 270°/10 kts, visibility greater than 10km with no significant weather. The navigational exercise was completed without incident, as were the first two circuits at EIKL. On the final circuit, with the student as handling pilot, both the Student Pilot and Instructor were satisfied that the aircraft was properly established on the approach. The round-out and subsequent hold-off were normal. Just prior to runway contact the aircraft was allowed to yaw to the left and touched down in a crabbed orientation. The Instructor intervened but it was too late to retrieve the situation. The aircraft skidded to the left, departed the runway into rougher terrain and sheared off the nose wheel and right undercarriage leg. The propeller and engine cowling were damaged when they contacted the ground (**Photo No. 1**). There were no injuries and the crew exited the aircraft unaided.

**Photo No. 1: Aircraft as it came to rest**

1. The Aircraft was serviceable and properly maintained.
2. The Aircraft operated on a Czech Republic Permit-to-Fly, which had been approved by the IAA for operation in Ireland.
3. The Pilot and Student Pilot held valid licences.
4. The aircraft yawed to the left just before touch down on the third circuit.
5. The instructor attempted to retrieve the situation.
6. The aircraft skidded left and departed the runway into rougher terrain.
7. The aircraft suffered significant damage with a broken nose undercarriage leg, a broken right undercarriage leg, and damage to the propeller and the engine cowling.
